To:	Geoff Strack, PE, Waste Connections	From:	Bradley W Sullivan, PE, Stantec Consulting Services Inc.
File:	Project #B3053-20-517	Date:	January 9, 2021

**Reference: WCI Austin Landfill, LLC 2020 Annual CCR Inspection Report****Purpose**

2020 Austin Landfill CCR Inspection

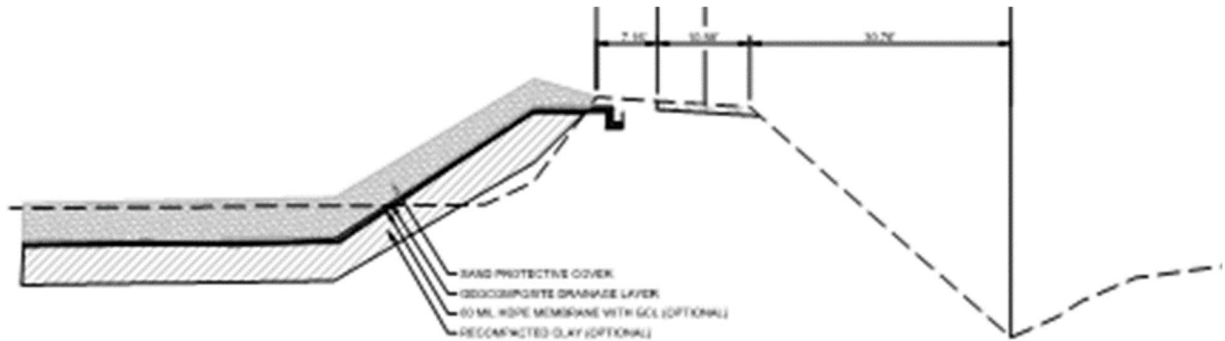
Typical Landfill Berm Detail

During the inspection, no signs of landfill cell embankment distress, no signs of waste slope instability, or other CCR landfill issues were observed. The landfill embankments and interim covered slopes were generally in good condition with a well-established vegetation cover and no signs of significant erosion.

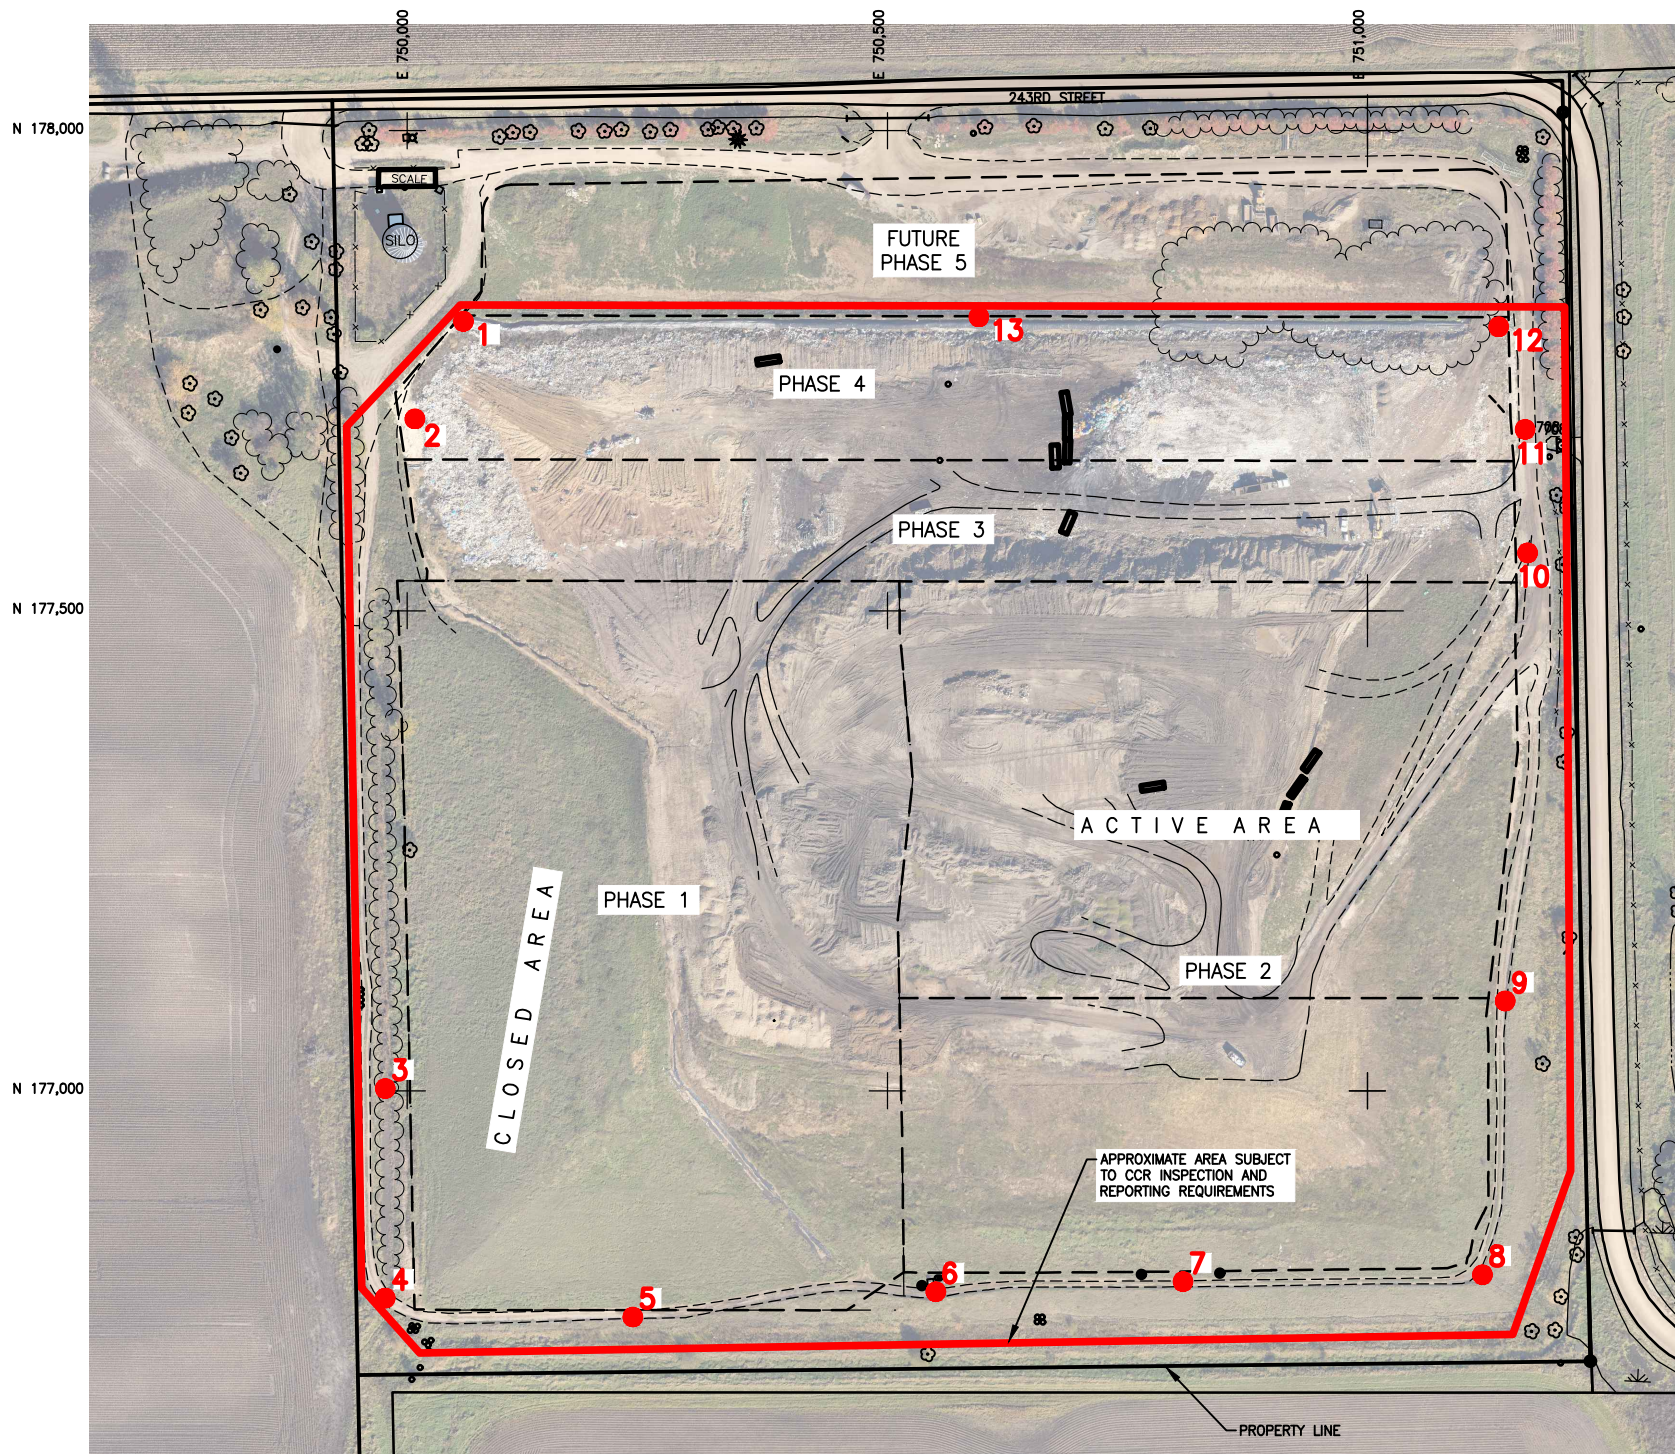
SHEET TITLE PHOTO LOCATIONS			
DWN BY JJT	CHK'D TJS	APP'D BWS	DWG DATE JAN. 2021
PROJECT NO. 3053-20-517	SHEET NO. FIGURE 1	SCALE AS NOTED	REV NO. 0

Photos were taken during the inspection. Figure 1 presents the photo locations, and Attachment 1 contains a photo log and the photos taken.

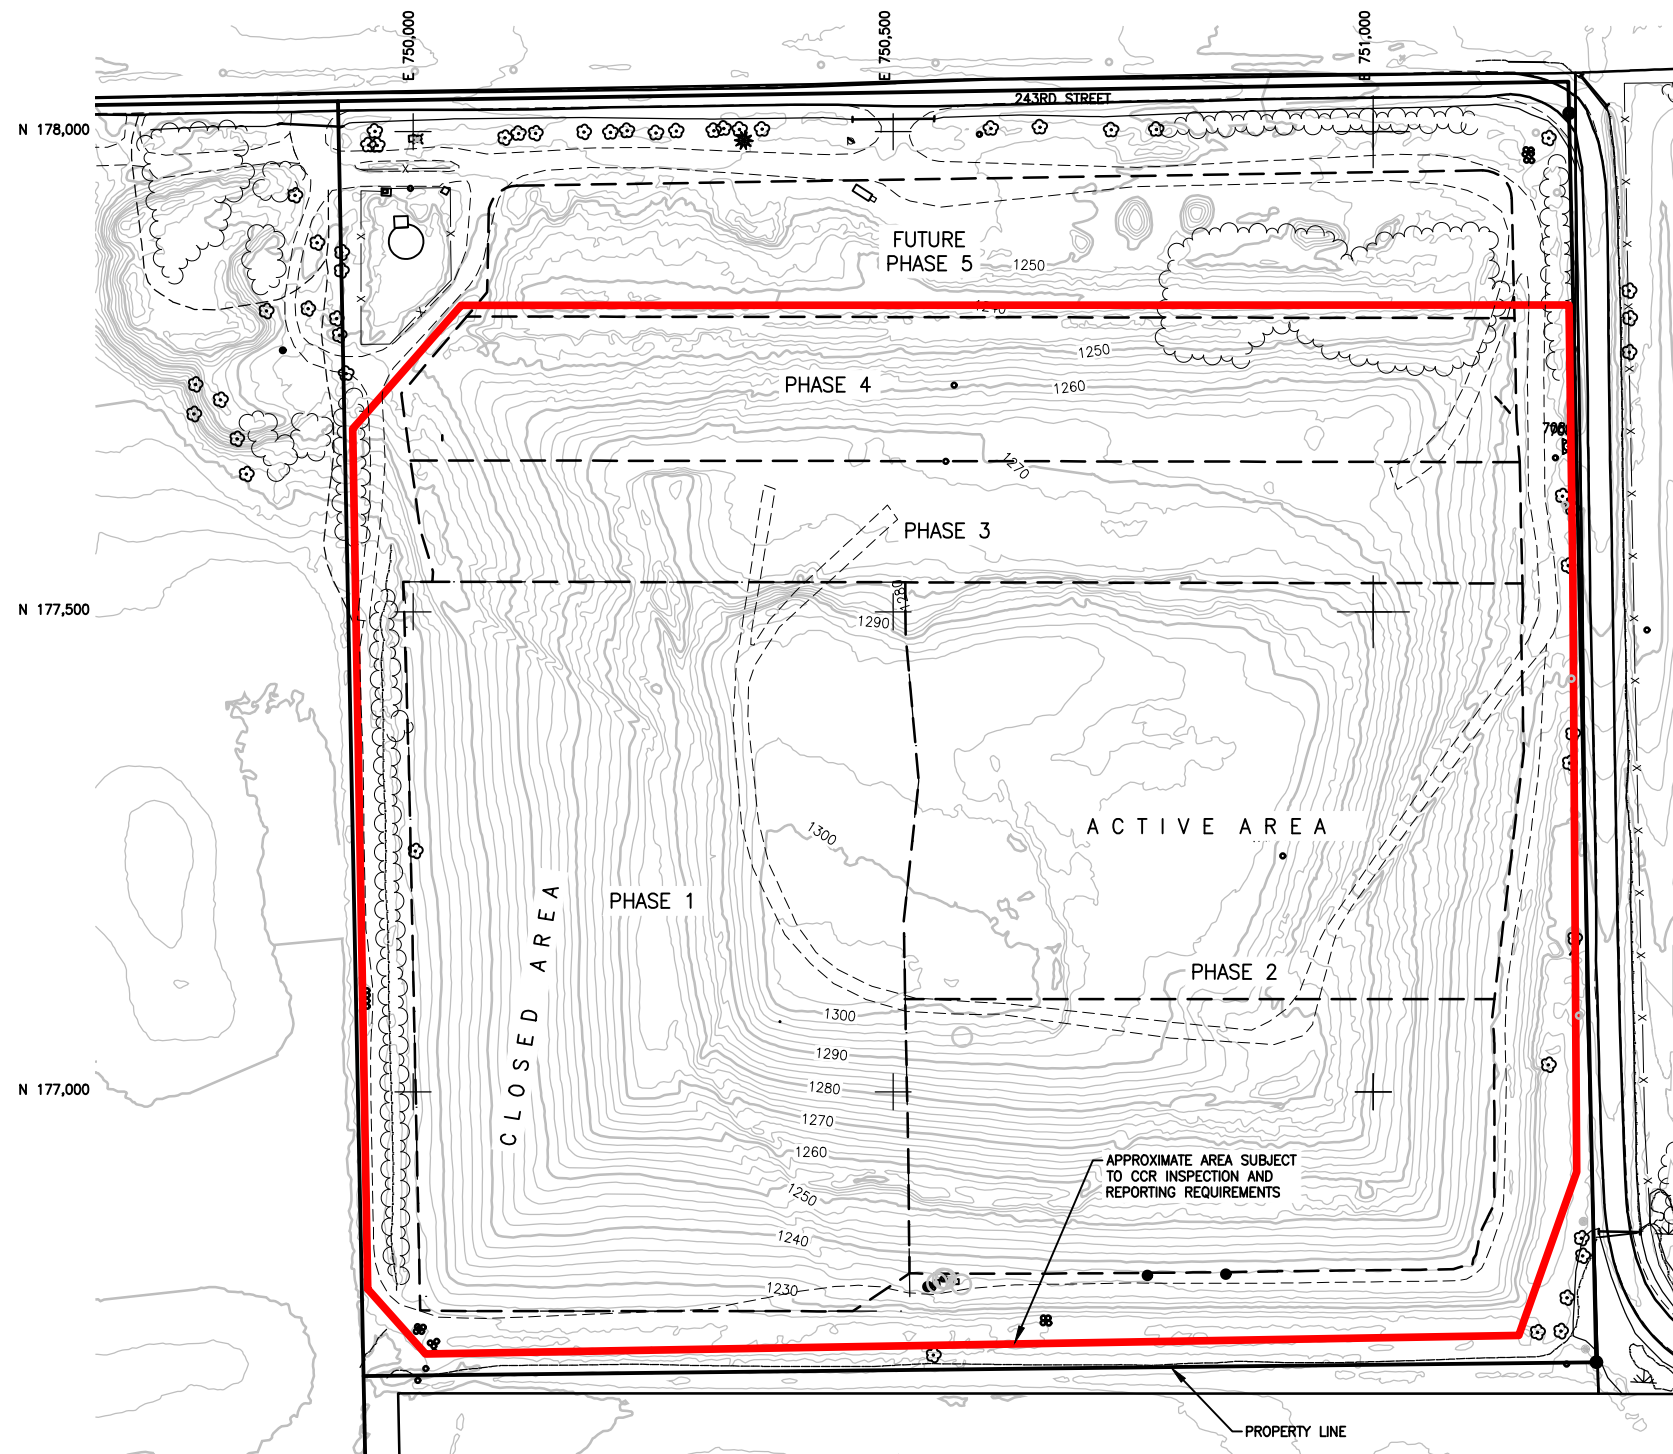
SHEET TITLE			
SITE MAP			
DWN BY	CHK'D	APP'D	DWG DATE
JJT	TJS	BWS	JAN. 2021
PROJECT NO.		SCALE	
3053-20-517		AS NOTED	
SHEET NO.		REV NO.	
FIGURE 2		0

There were no apparent changes to the embankment geometry of Cells 1, 2, 3, or 4 when compared to the permit drawings or the past inspection reports. This year's annual aerial photogrammetry survey was performed on October 28, 2020, which the estimated in-place volume is based on. A comparison 2020 and 2019 aerial survey

confirm that the embankment and slope topography is substantially unchanged with no significant movement. The 2020 aerial survey is included as Figure 2.

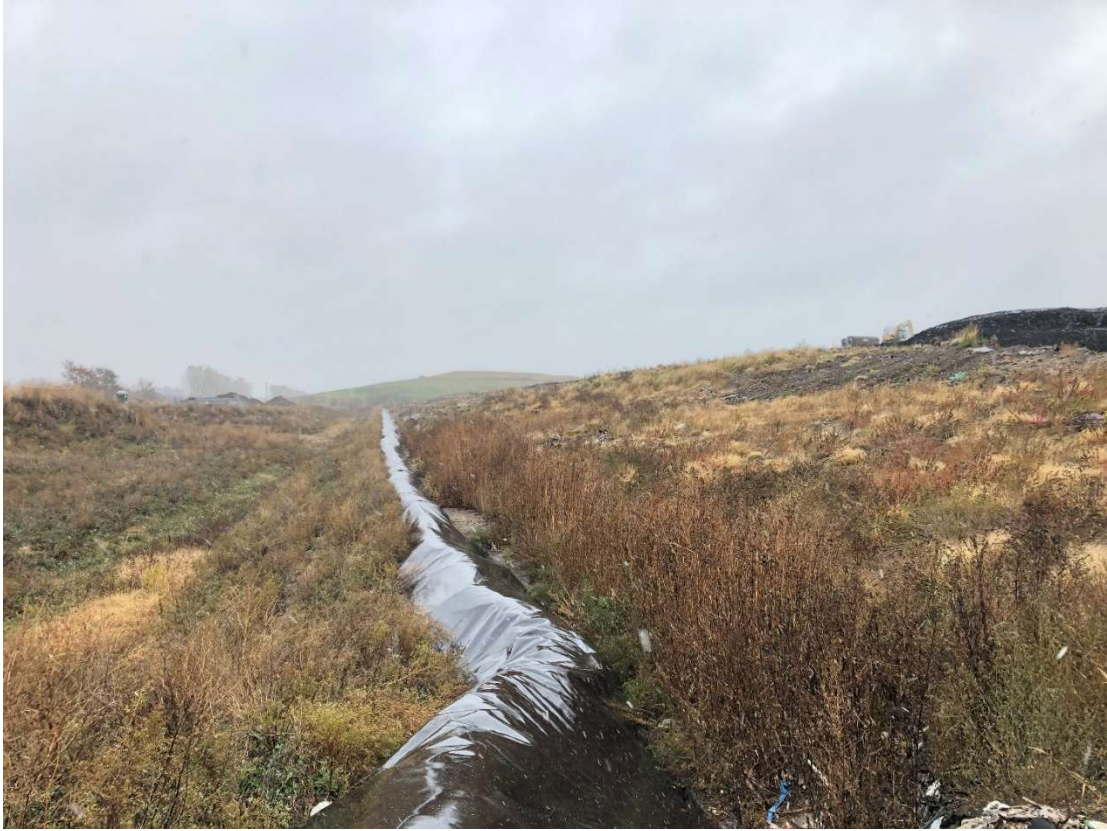
Phase 4 is the most recently constructed landfill cell, which was completed in 2018. The northern limit of the expansion is terminated with "rain flap" with the primary liner running out for future connection. The east and west embankments appeared per the Record Drawings.

Location 1 – Looking East, Phase 4 Northern Rain Flap

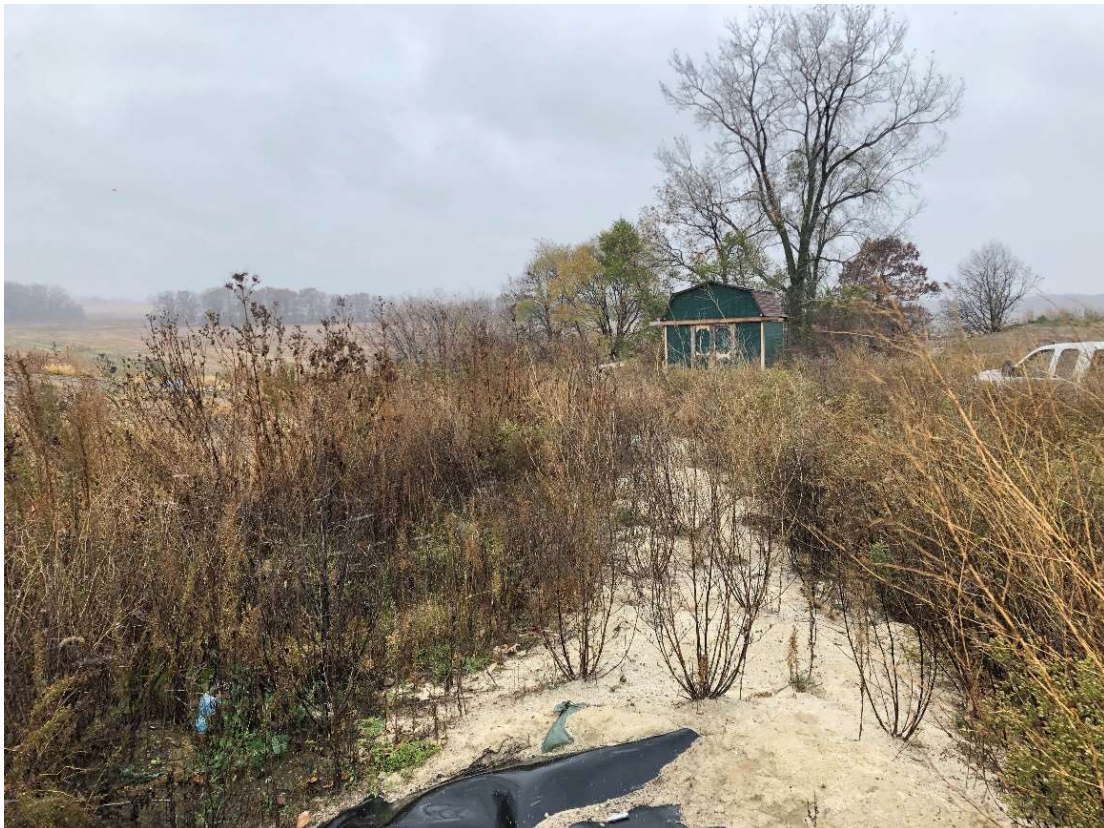
Location 1 – Looking Southwest, Phase 4 Anchor Trench

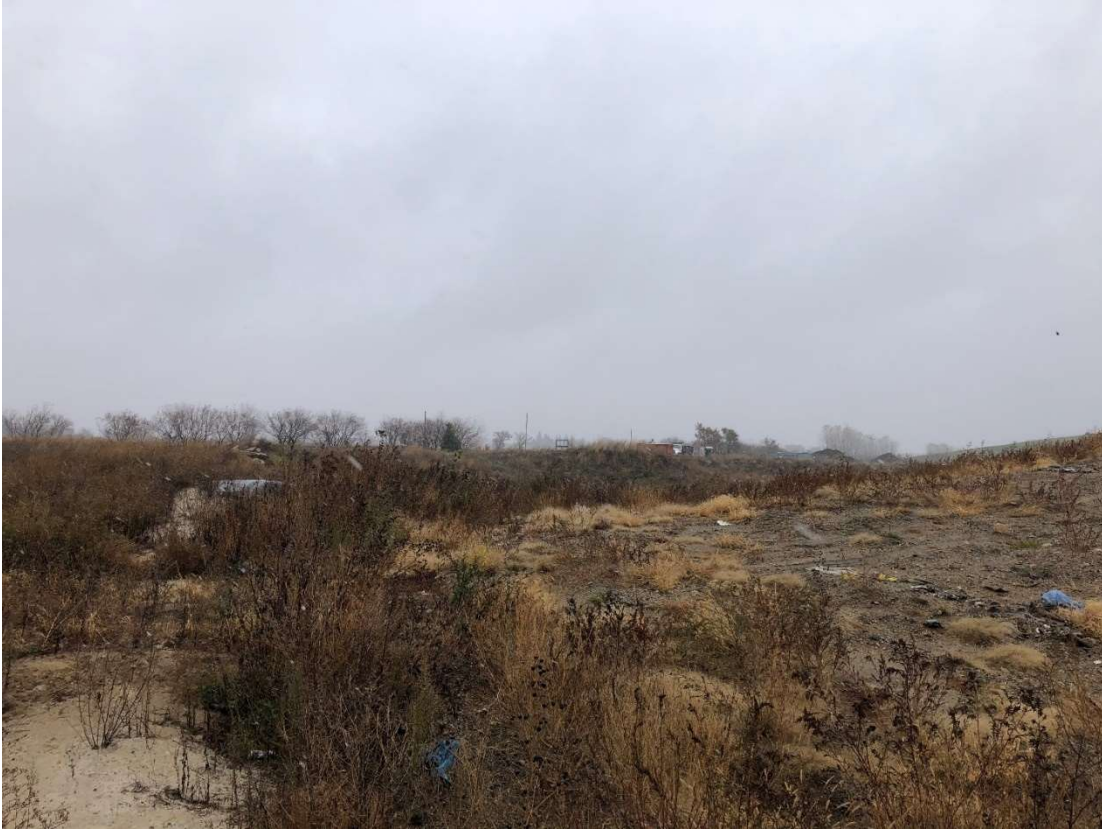
Location 2 – Looking Northeast, Phase 4 Anchor Trench

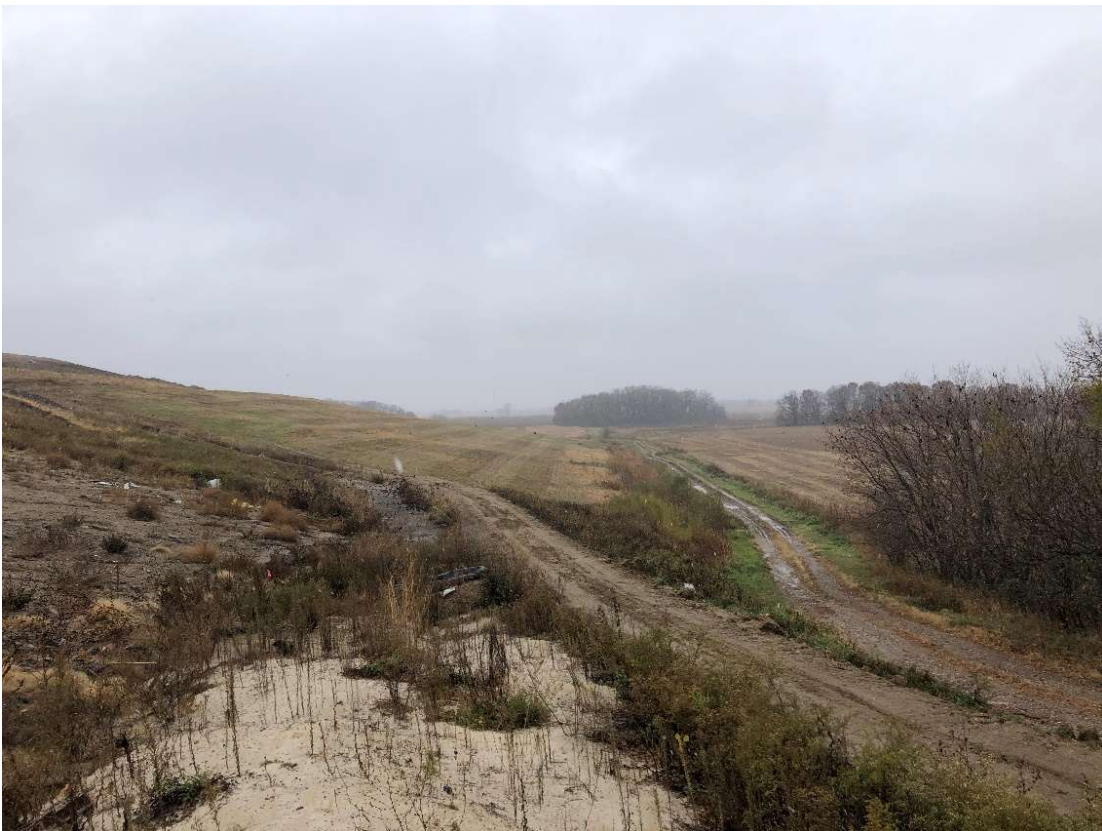
Location 2 – Looking South, Phase 3/1 Western Perimeter

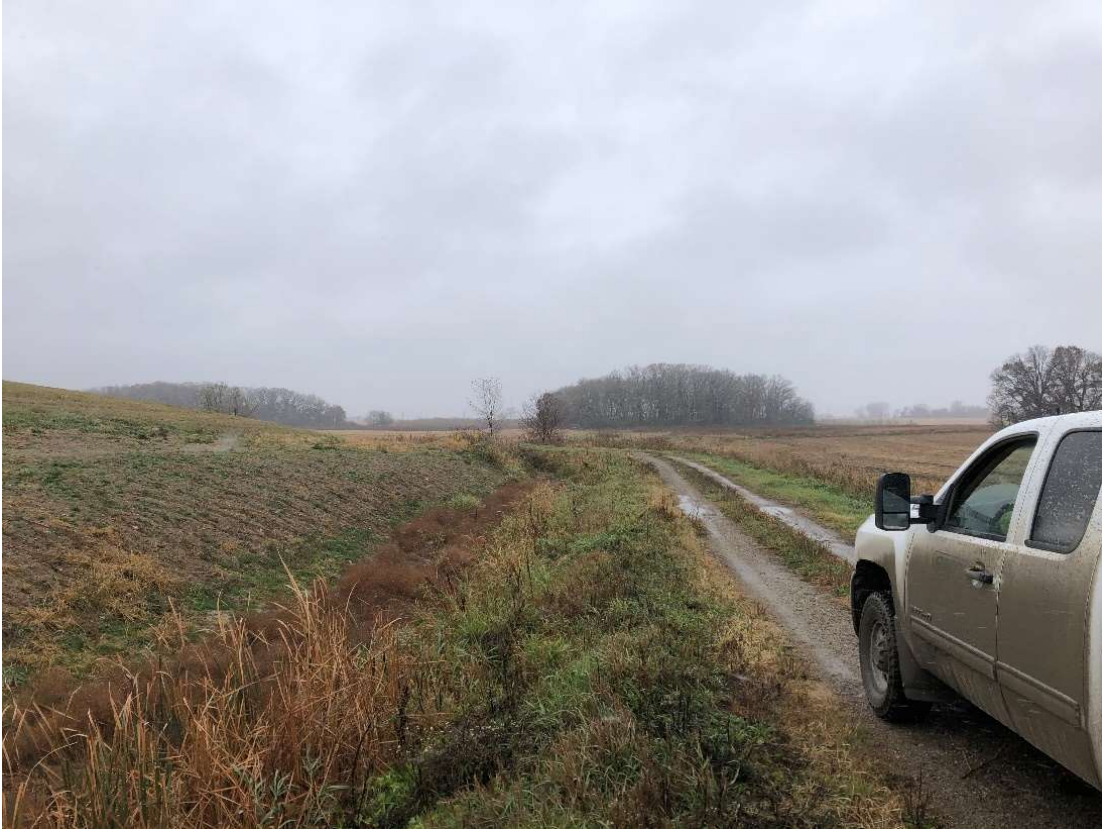
Location 3 – Looking South, Toe of Phase 1 Western Slope

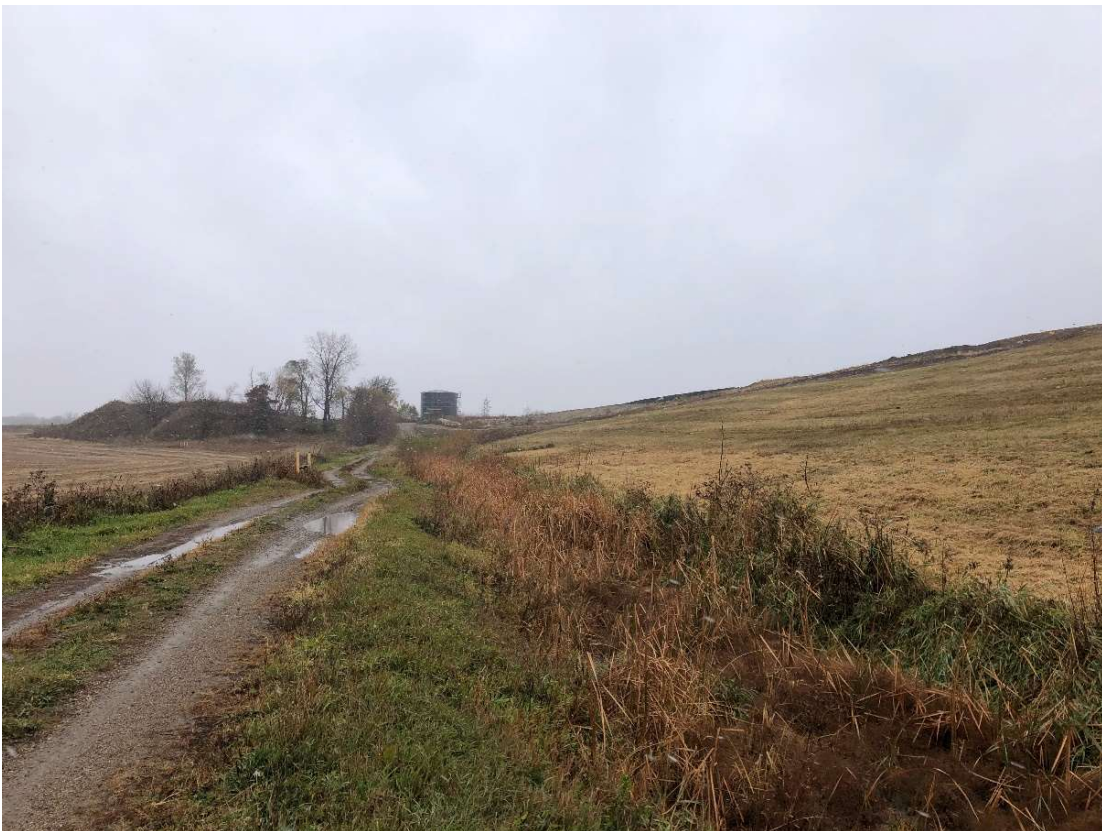
Location 3 – Looking North, Toe of Phase 1 Western Slope

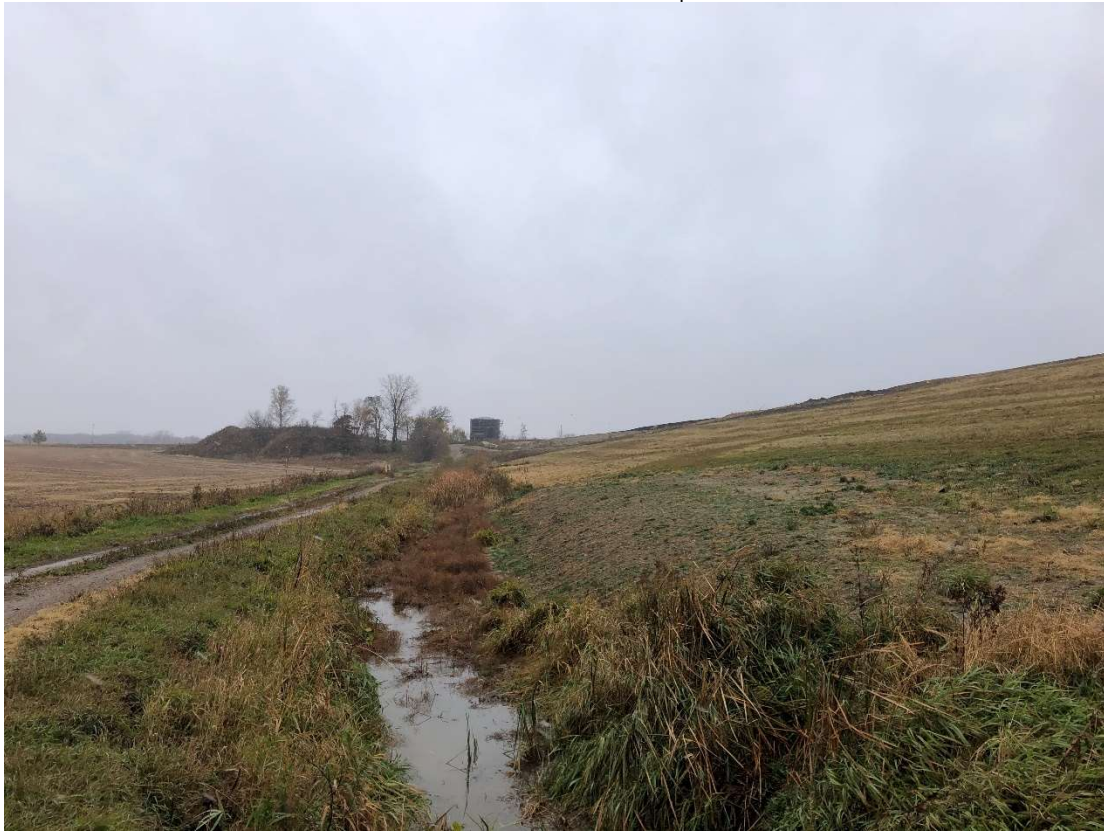
Location 4 – Looking North, Toe of Phase 1 Western Slope

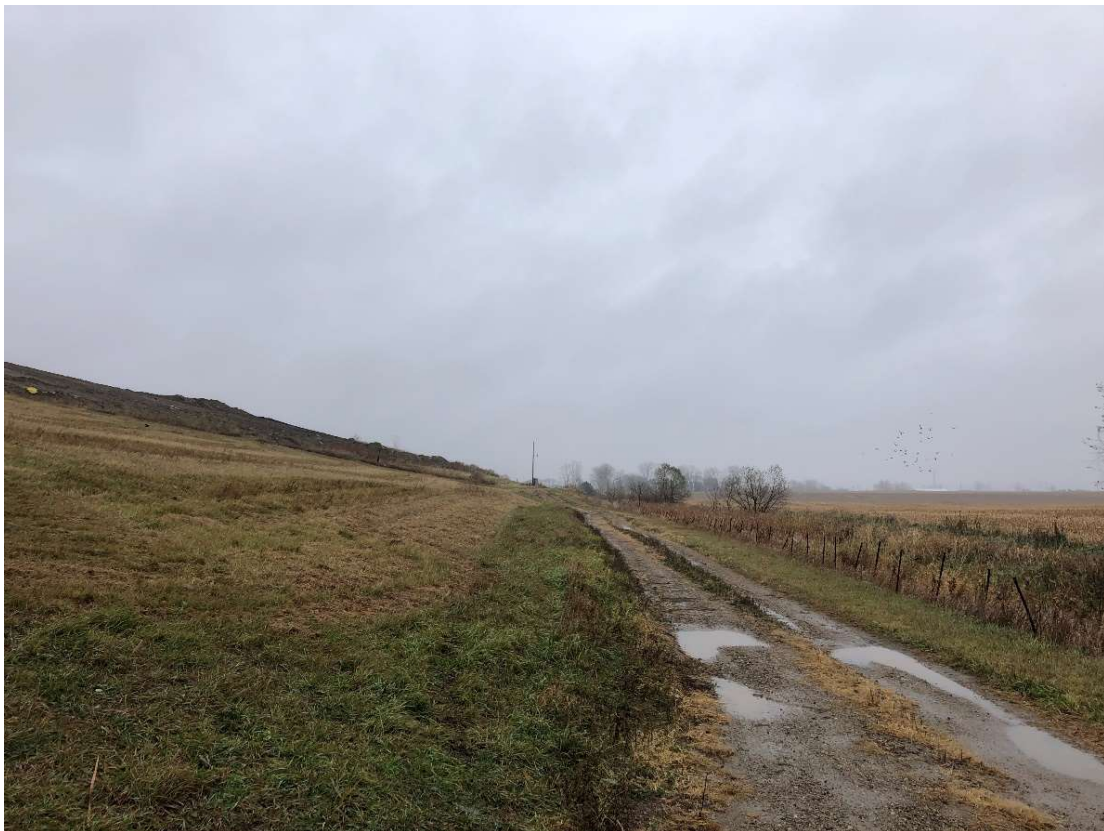
Location 4 – Looking East, Toe of Phase 1 Southern Slope

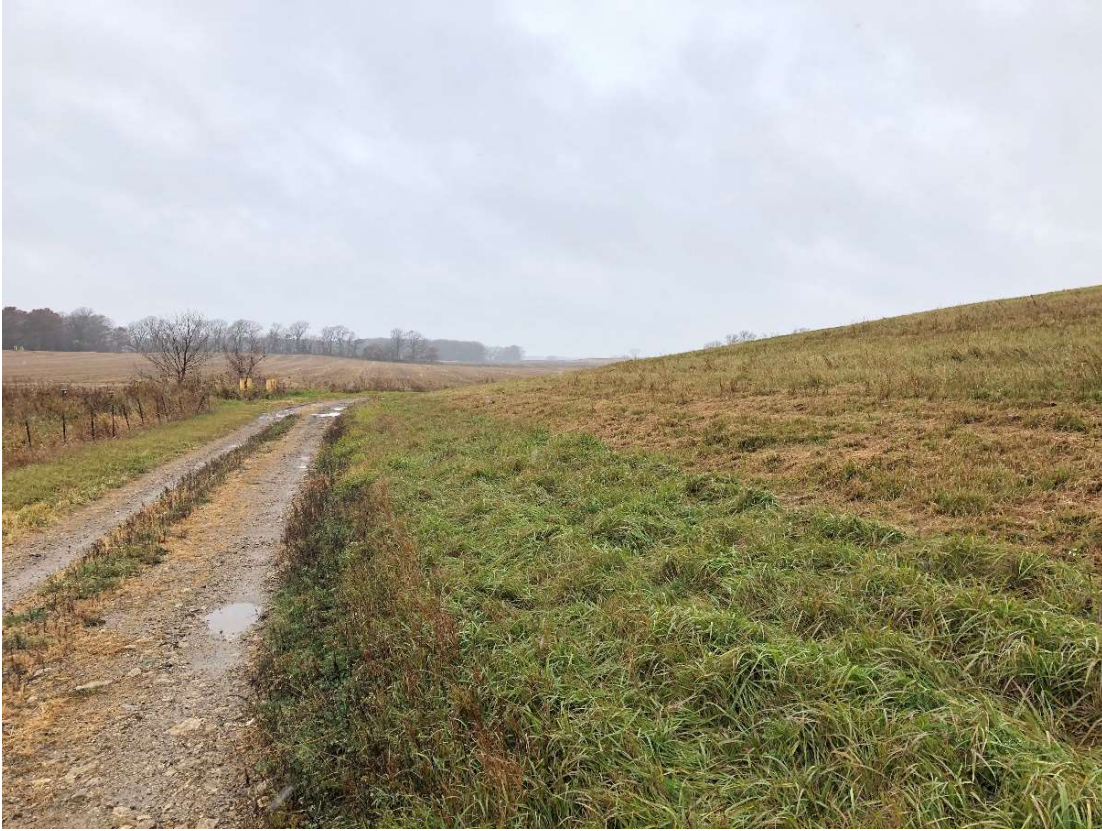
Location 5 – Looking West, Toe of Phase 1 Southern Slope

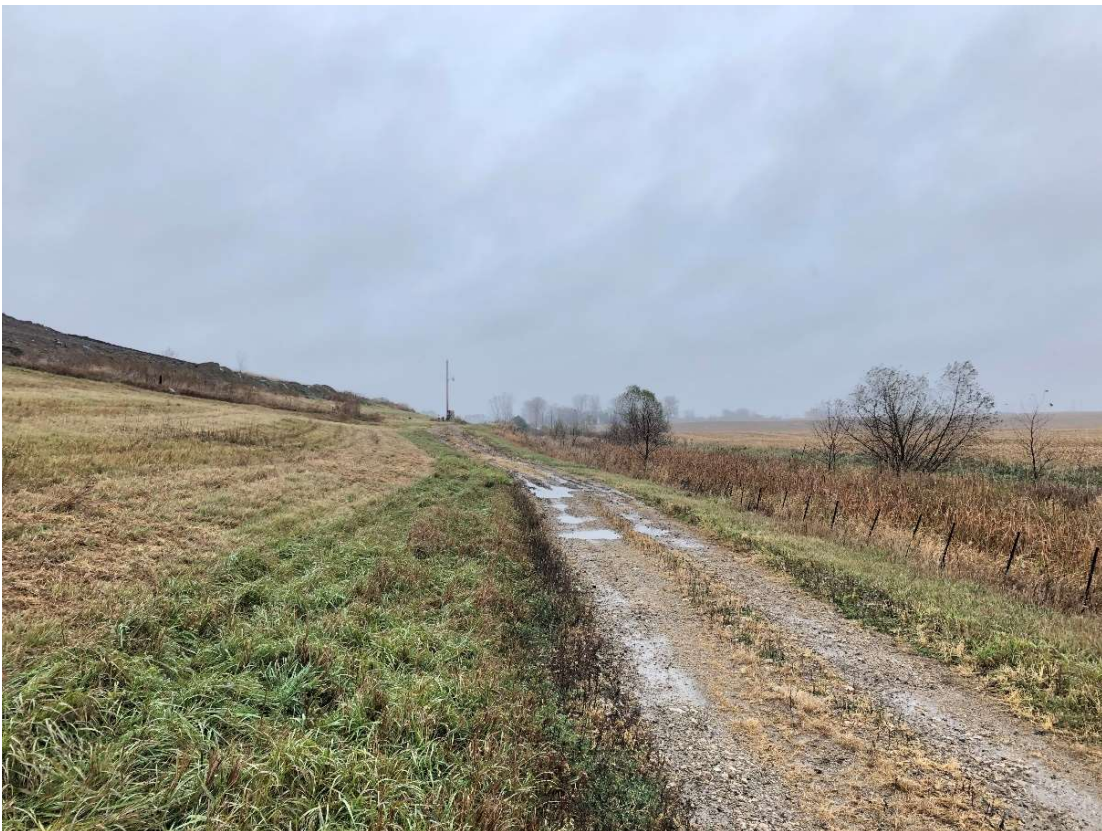
Location 5 – Looking East, Toe of Phase 1 Southern Slope

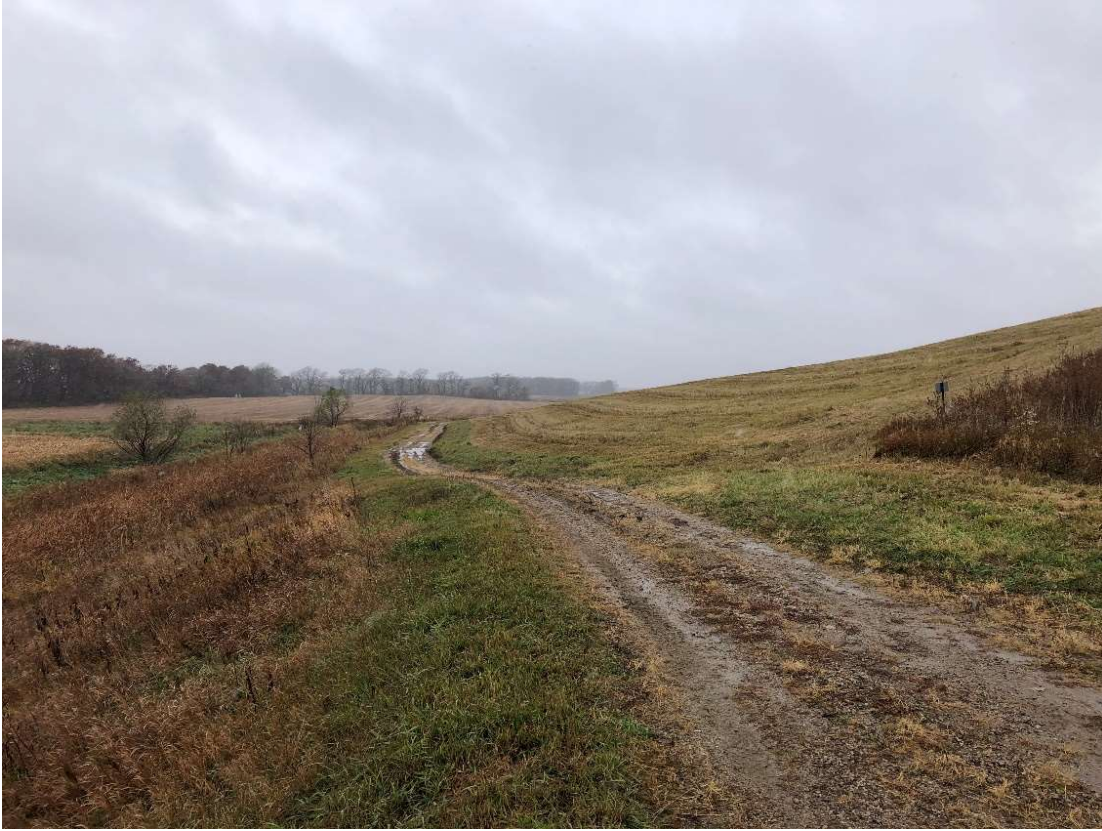
Location 6 – Looking West, Phase 1 Southern Slope

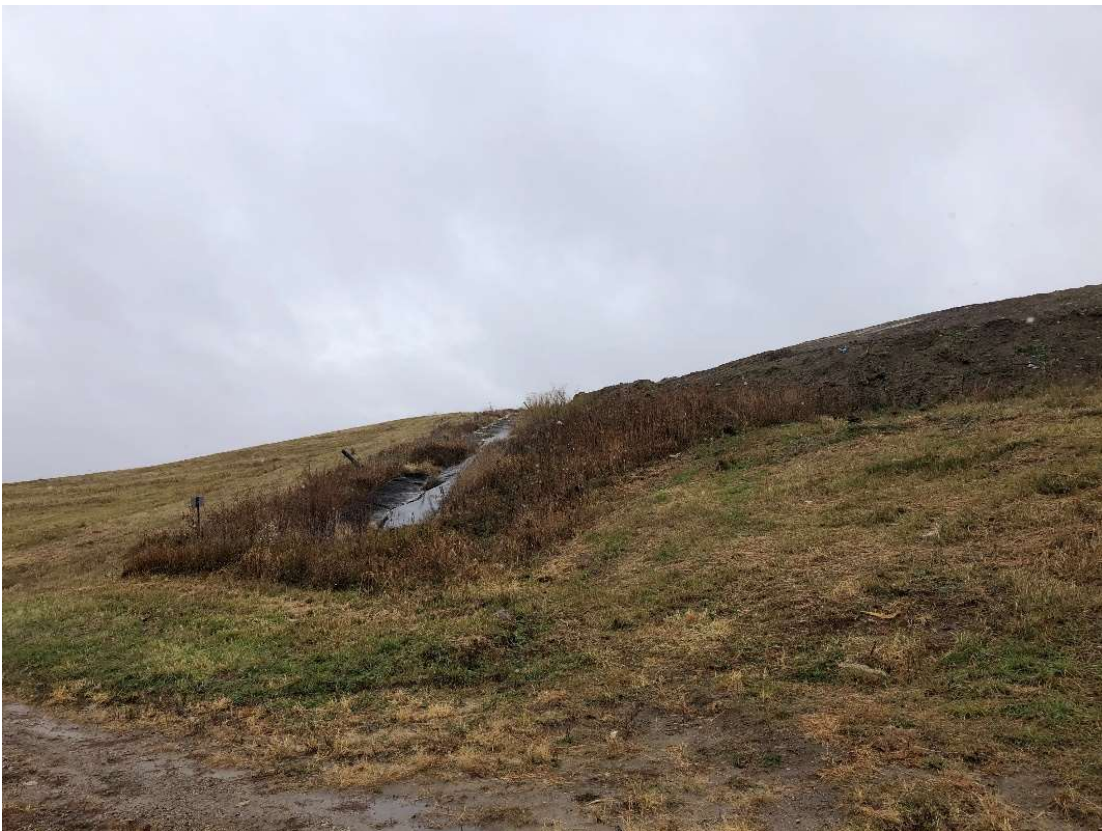
Location 6 – Looking West, Phase 1/2 Overlay Liner & Southern Slope

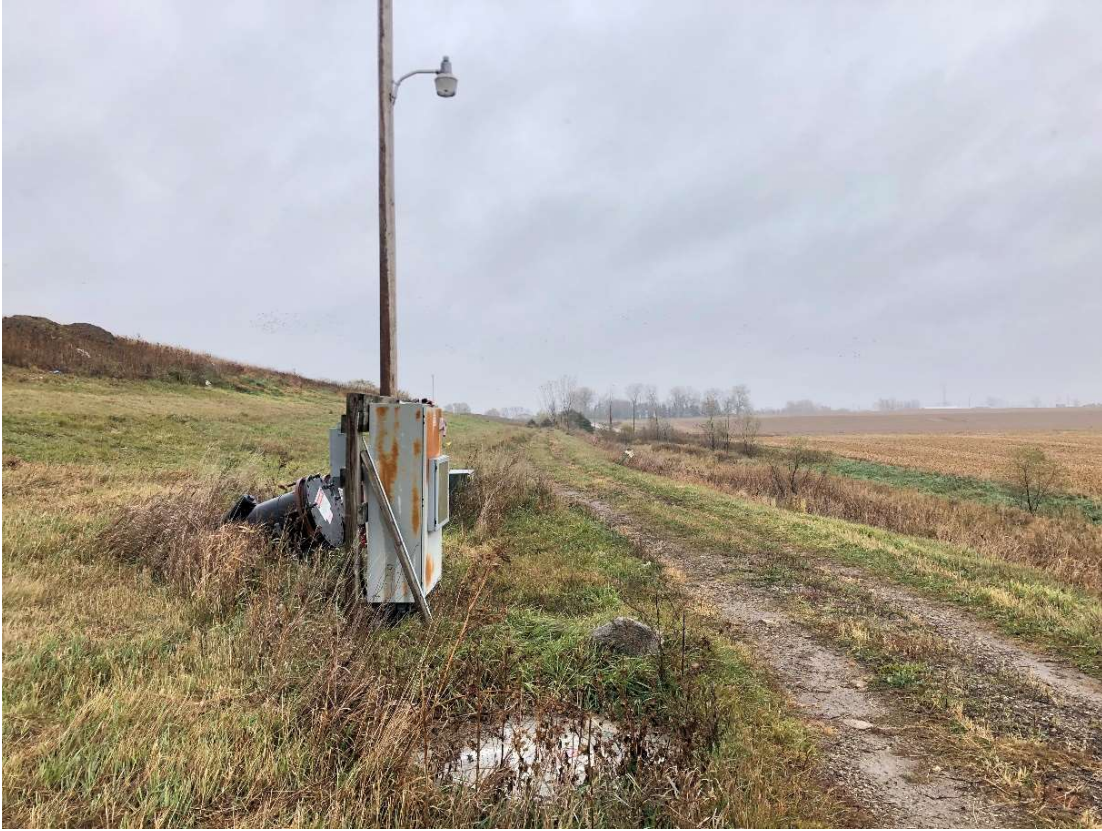
Location 6 – Looking East, Phase 2 Southern Slope

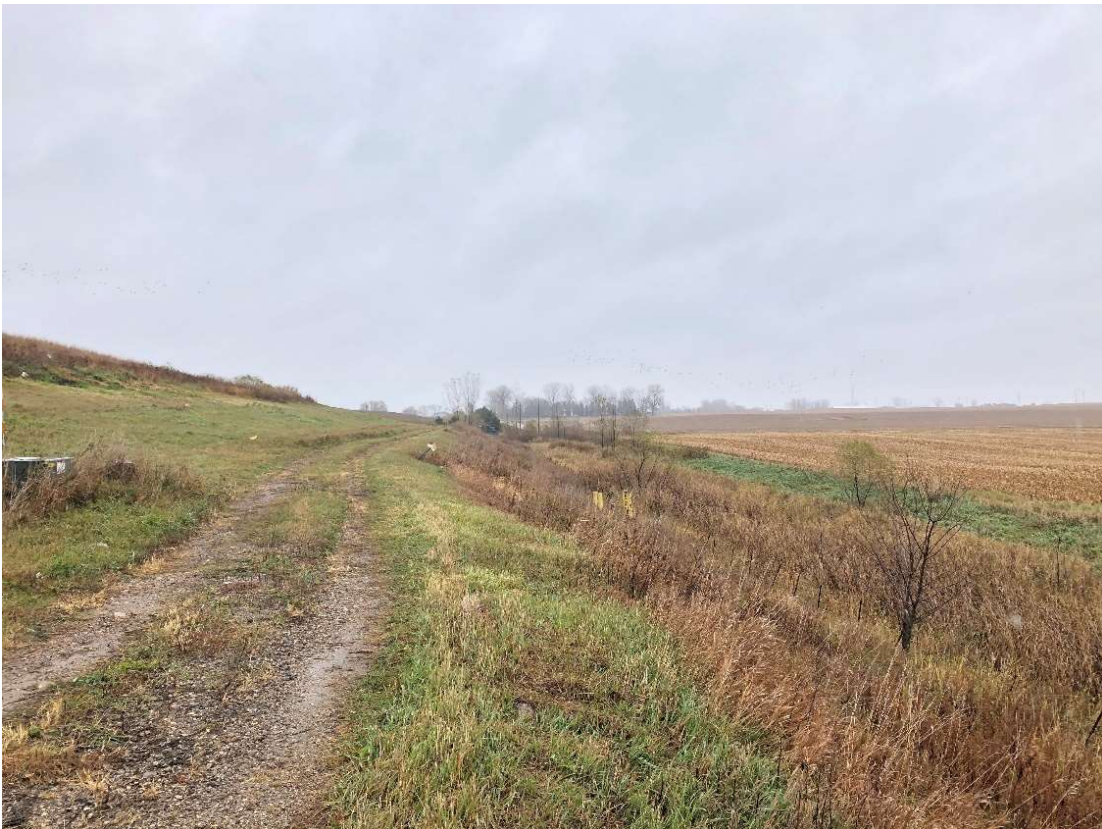
Photo 14: Location 6 – Looking East, Phase 2 Southern Berm

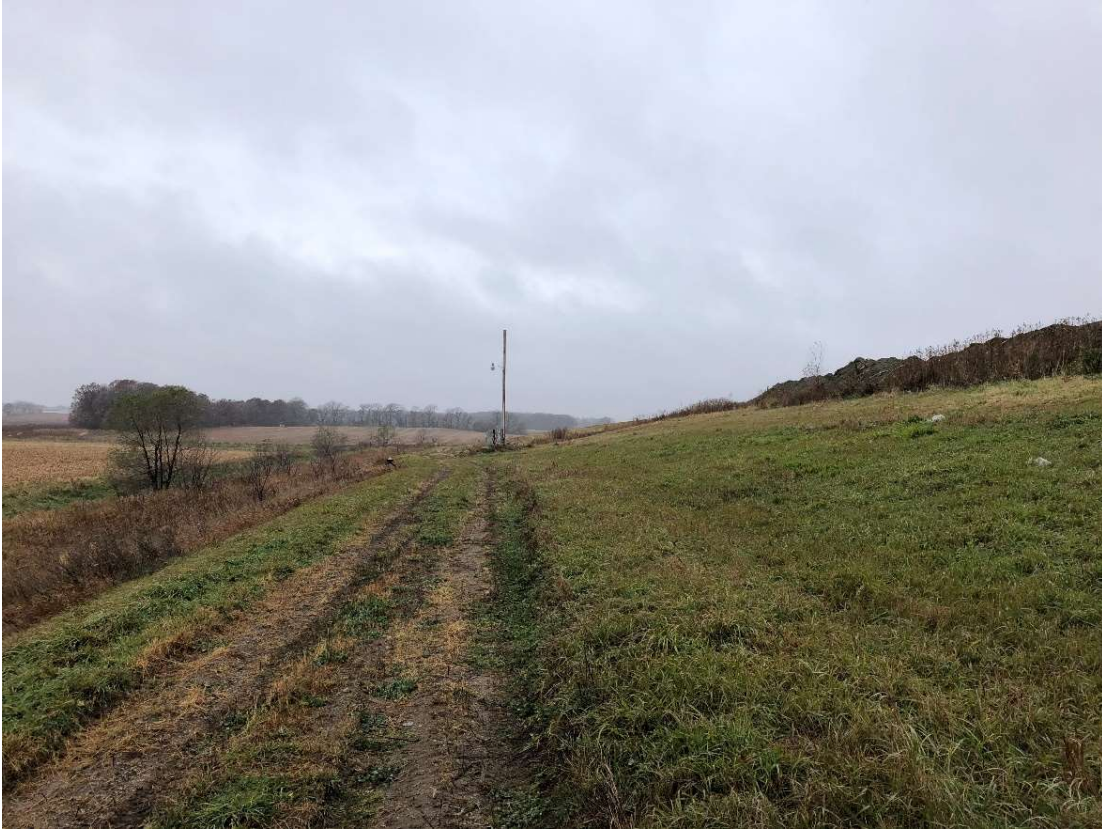
Location 7 – Looking West, Phase 2 Southern Perimeter Road and Slope

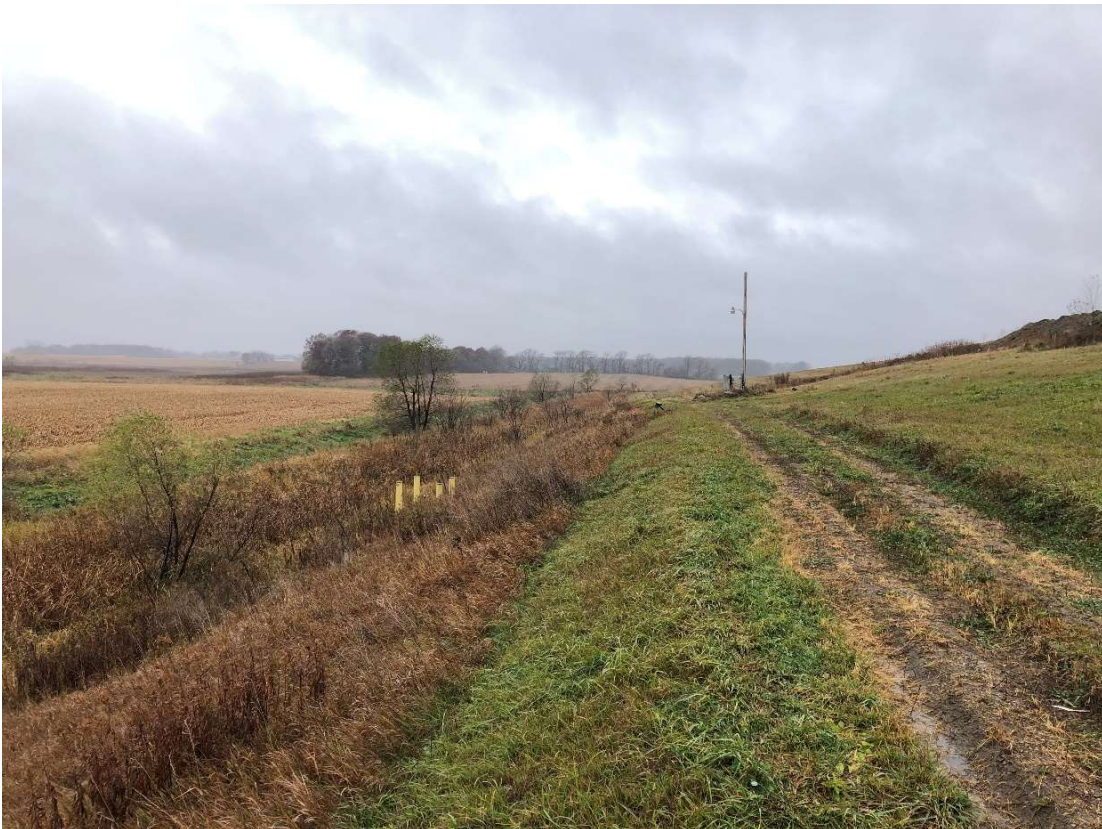
Location 7 – Looking West, Phase 2 Southern Berm

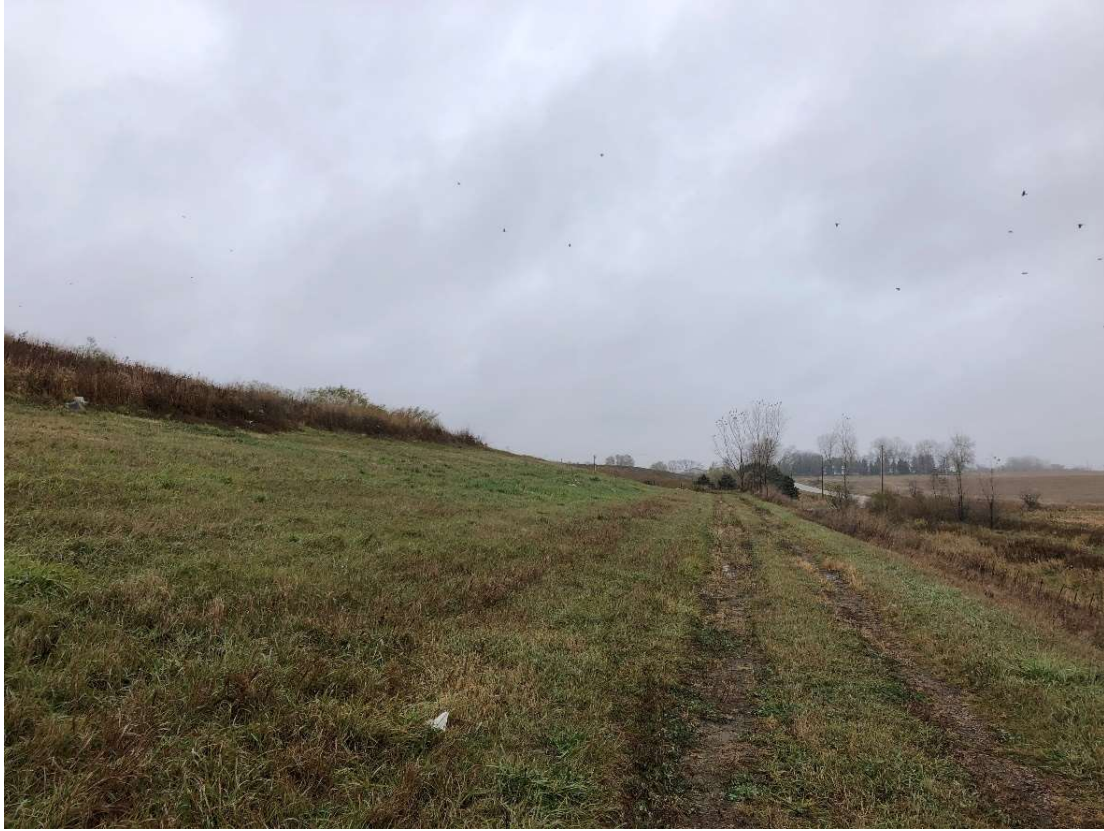
Location 7 – Looking East, Phase 2 Southern Perimeter Road and Slope

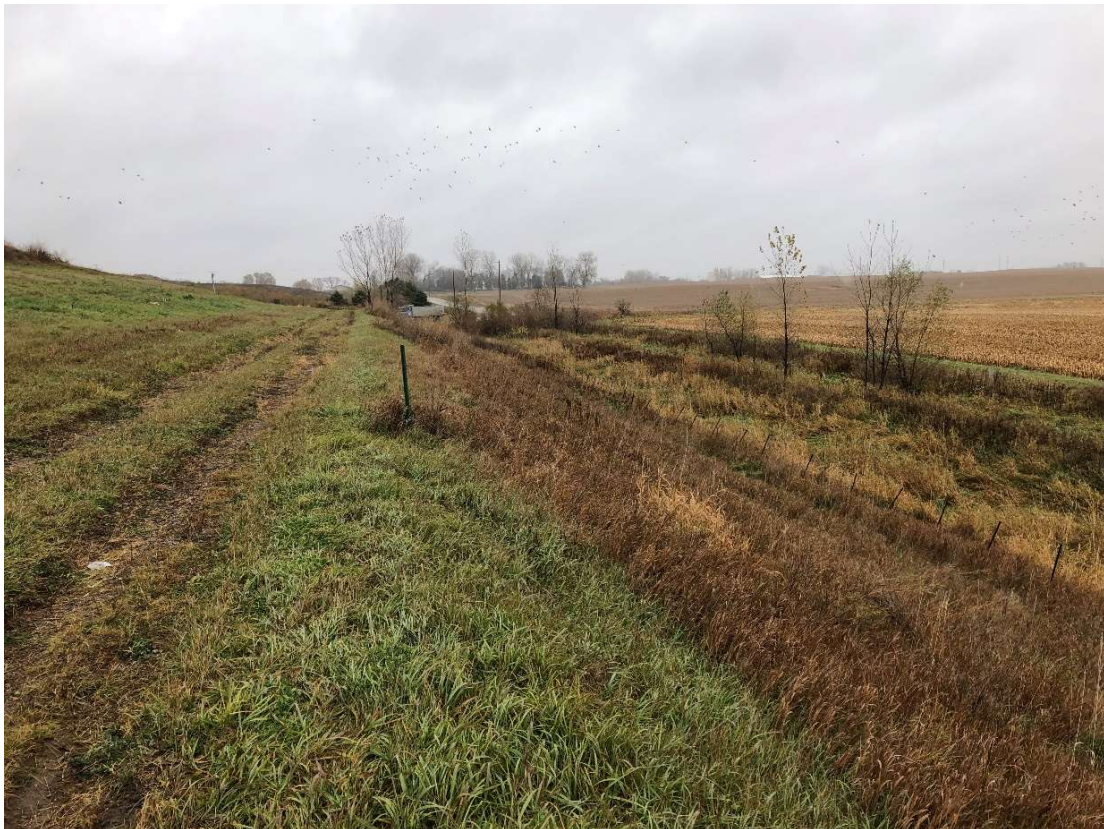
Location 7 – Looking East, Phase 2 Southern Berm
