To:	Geoff Strack, PE, Waste Connections	From:	Bradley W Sullivan, PE, Stantec Consulting Services Inc.
File:	Project #B3053-20-517	Date:	January 9, 2021

**Reference: WCI Austin Landfill, LLC 2020 Annual CCR Inspection Report****Purpose**

2020 Austin Landfill CCR Inspection

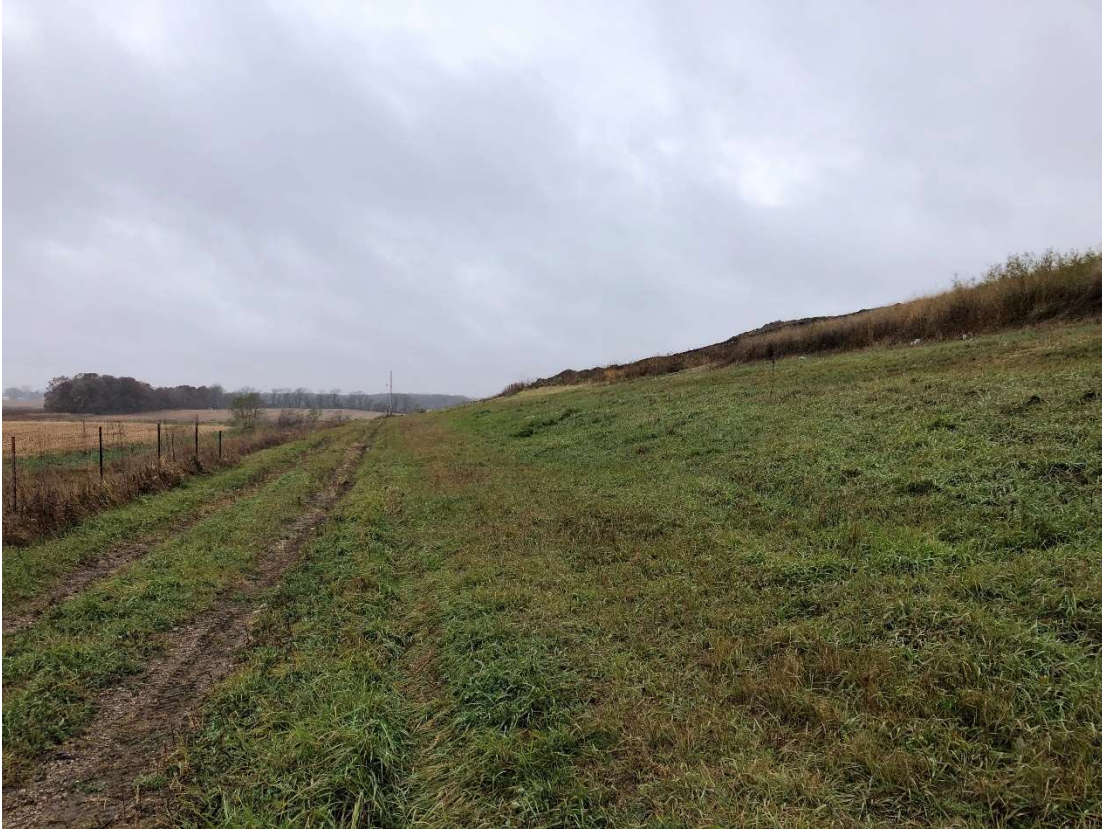
Location 8 – Looking West, Phase 2 Southern Perimeter Road and Slope

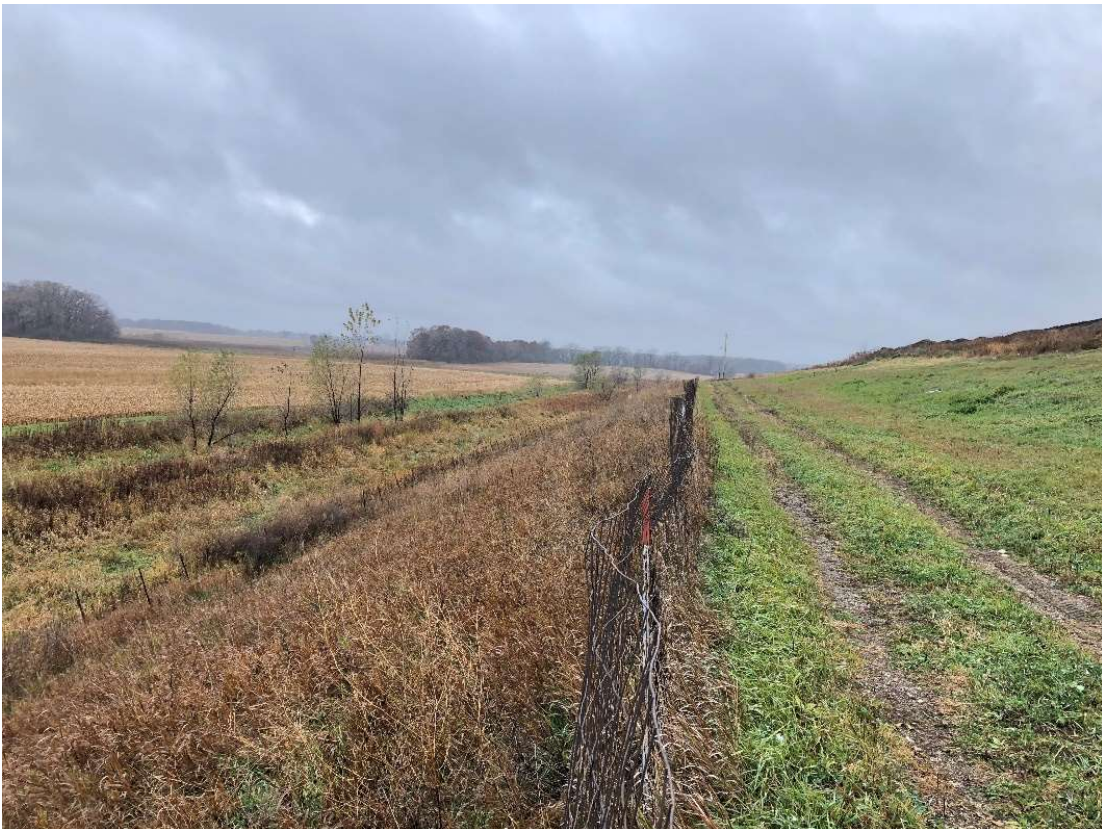
Location 8 – Looking West, Phase 2 Southern Berm

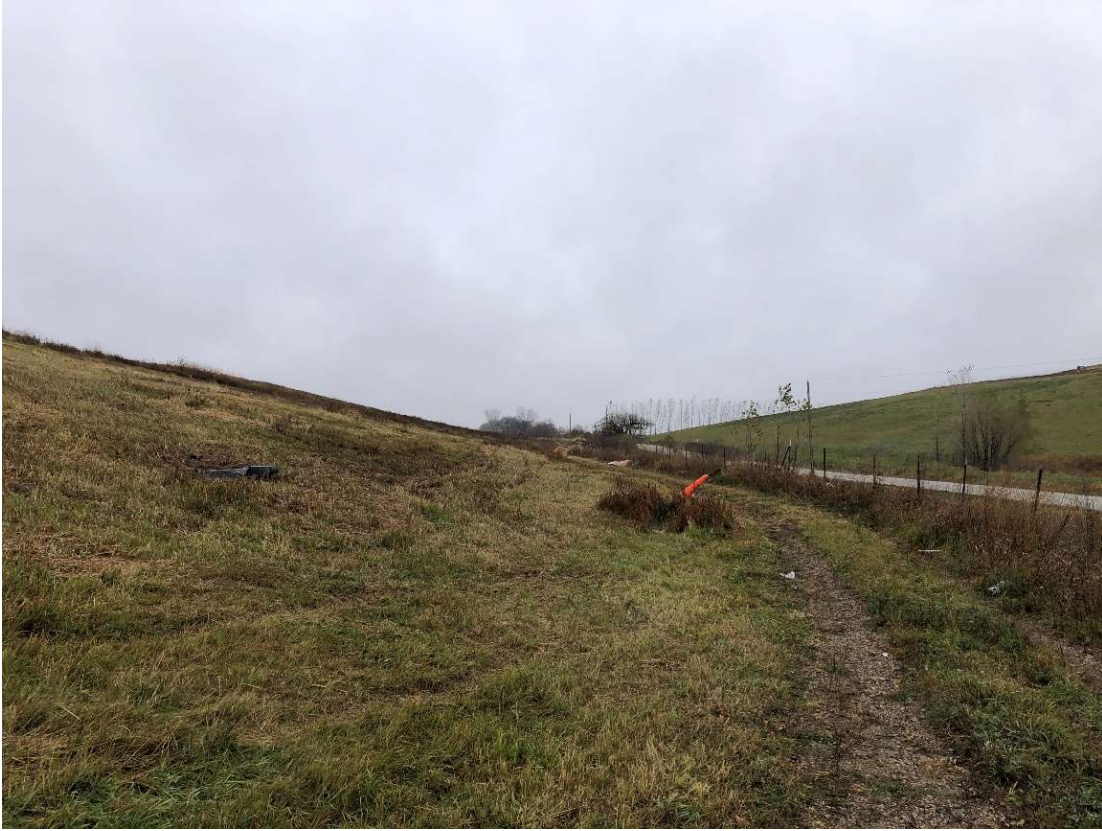
Location 8 – Looking North, Phase 2 Eastern Slope

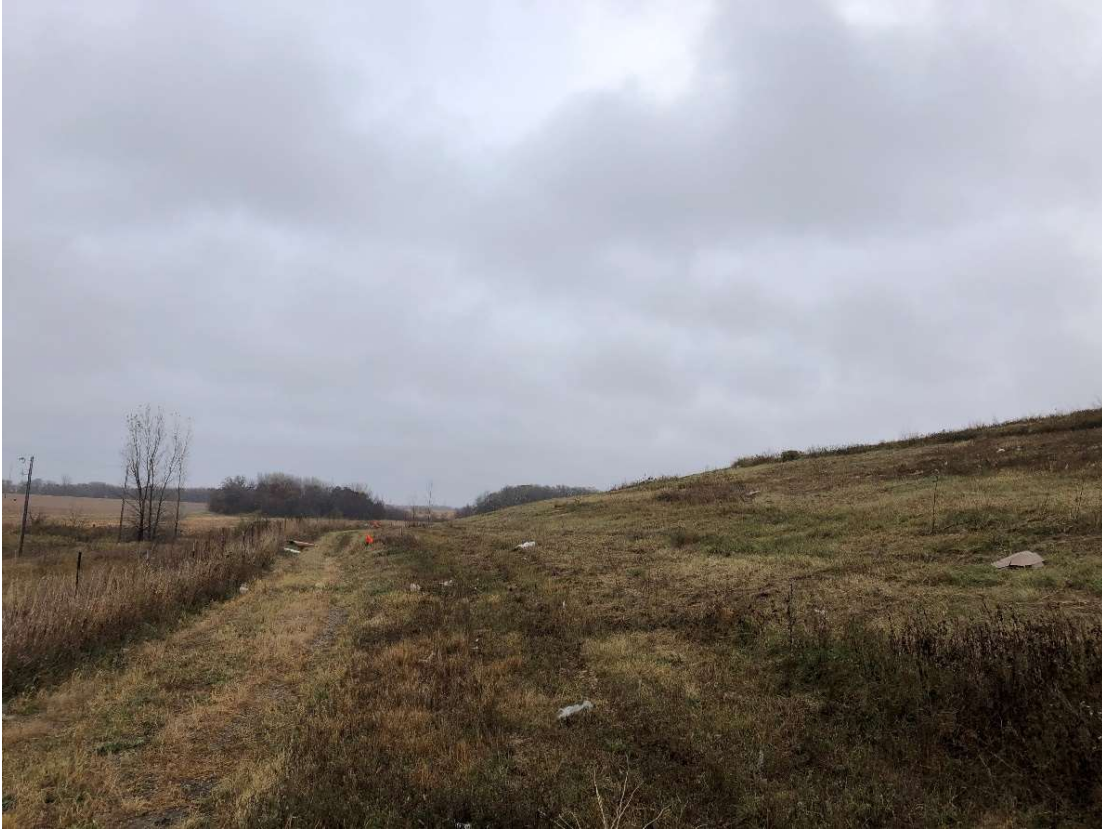
Location 9 – Looking South, Phase 2 Eastern Perimeter Road & Slope

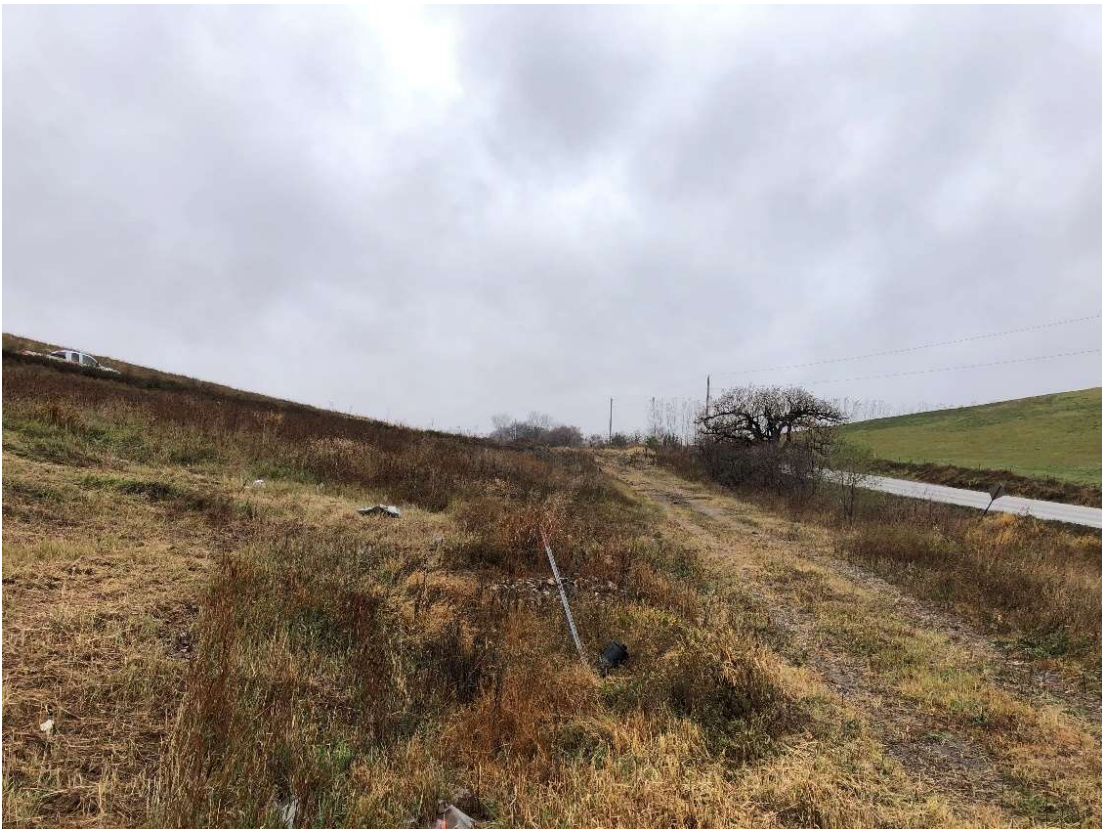
Location 9 – Looking North, Phase 2 Eastern Perimeter Road & Slope

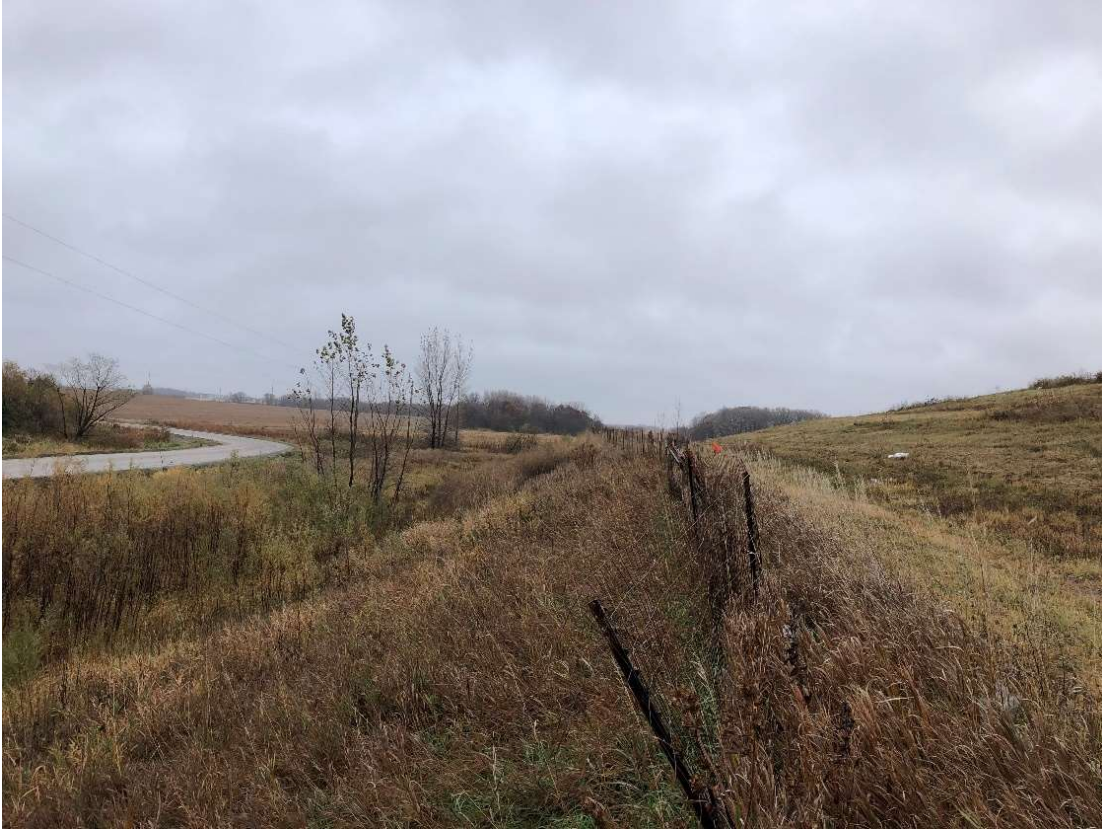
Location 9 – Looking South, Phase 2 Eastern Berm

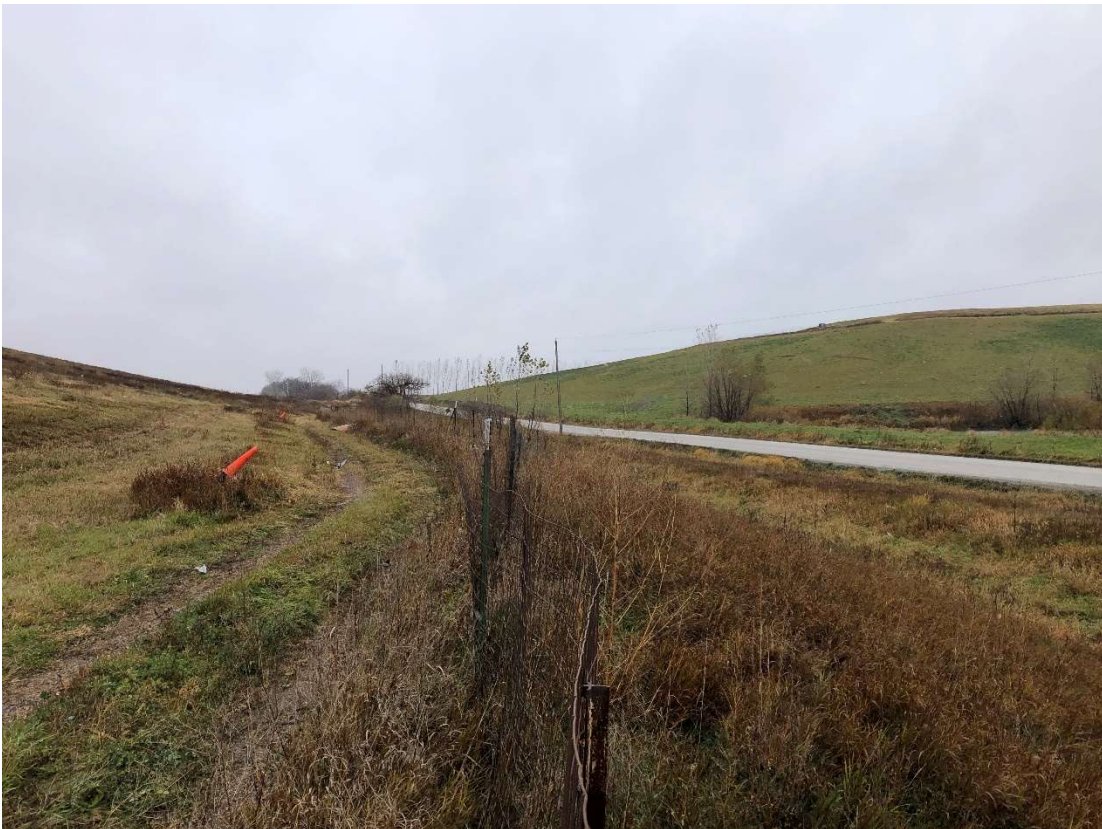
Location 9 – Looking North, Phase 2 Eastern Berm

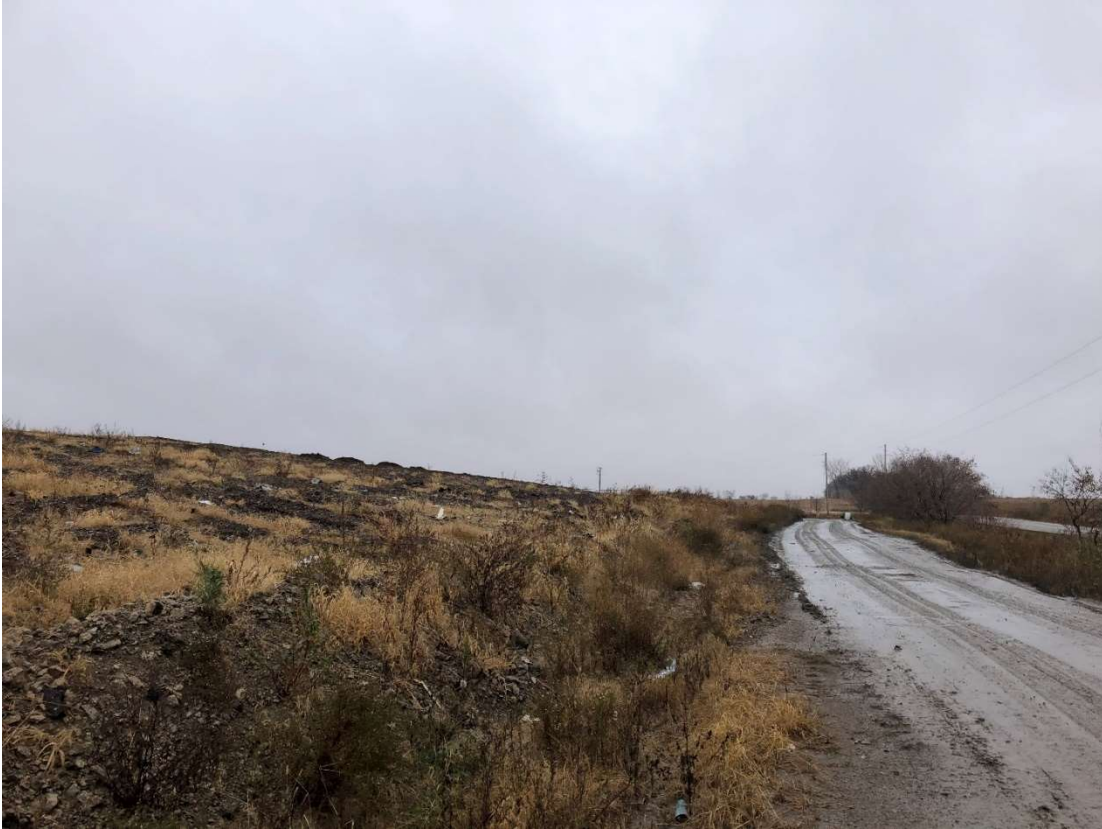
Location 10 – Looking North, Eastern Perimeter Road

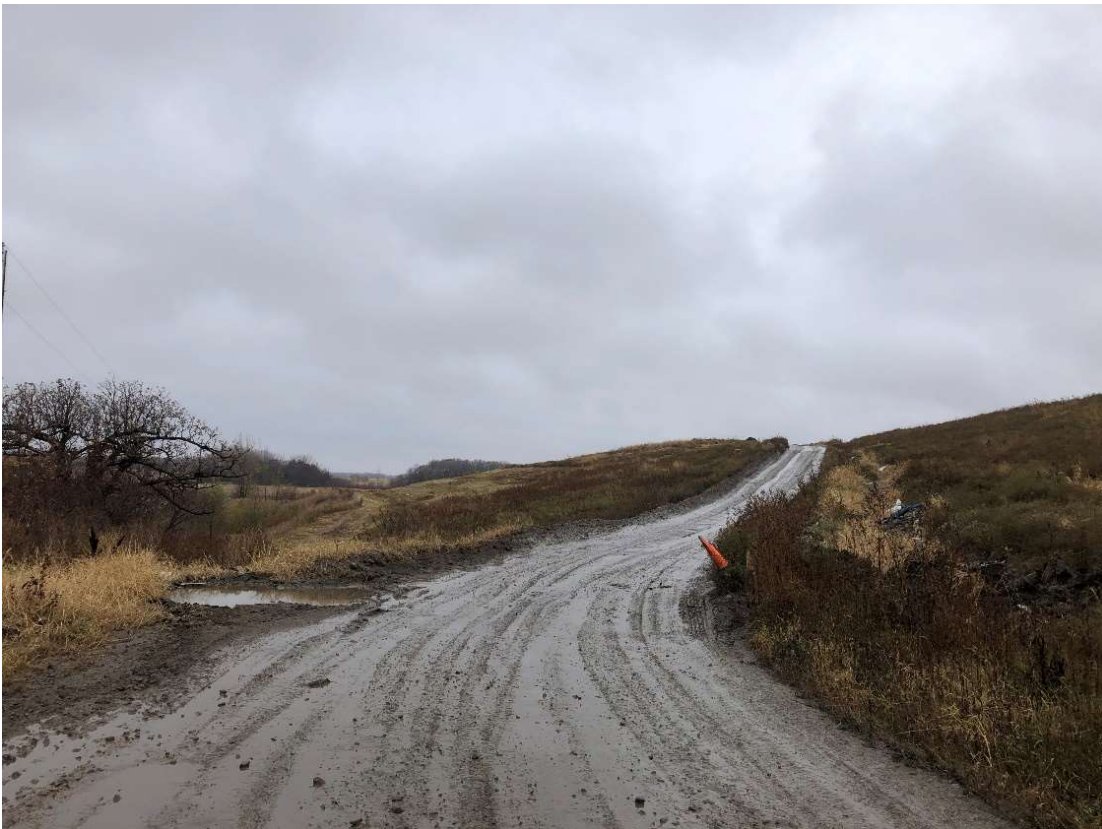
Location 10 – Looking South, Phase 2 Eastern Slope and Interior Access Road Entrance

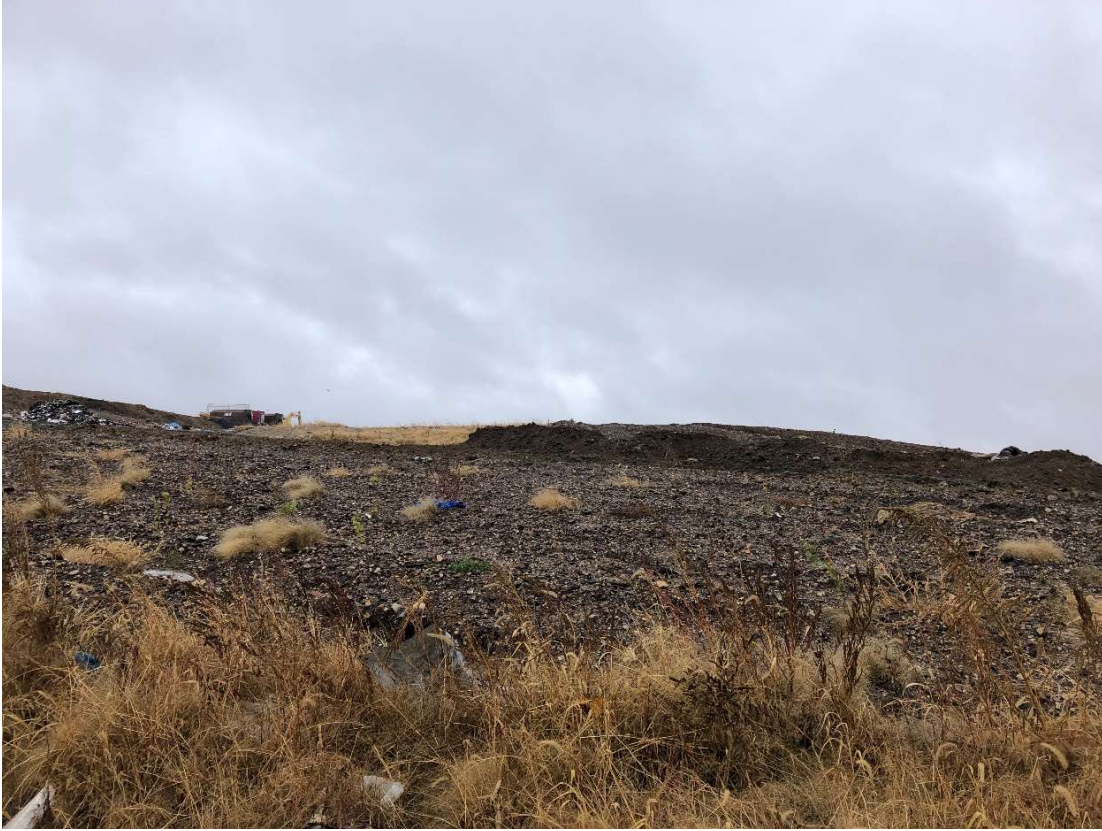
Location 11 – Looking West, Phase 3/4 Connection, Phase 3 Norther Interior Waste Slope

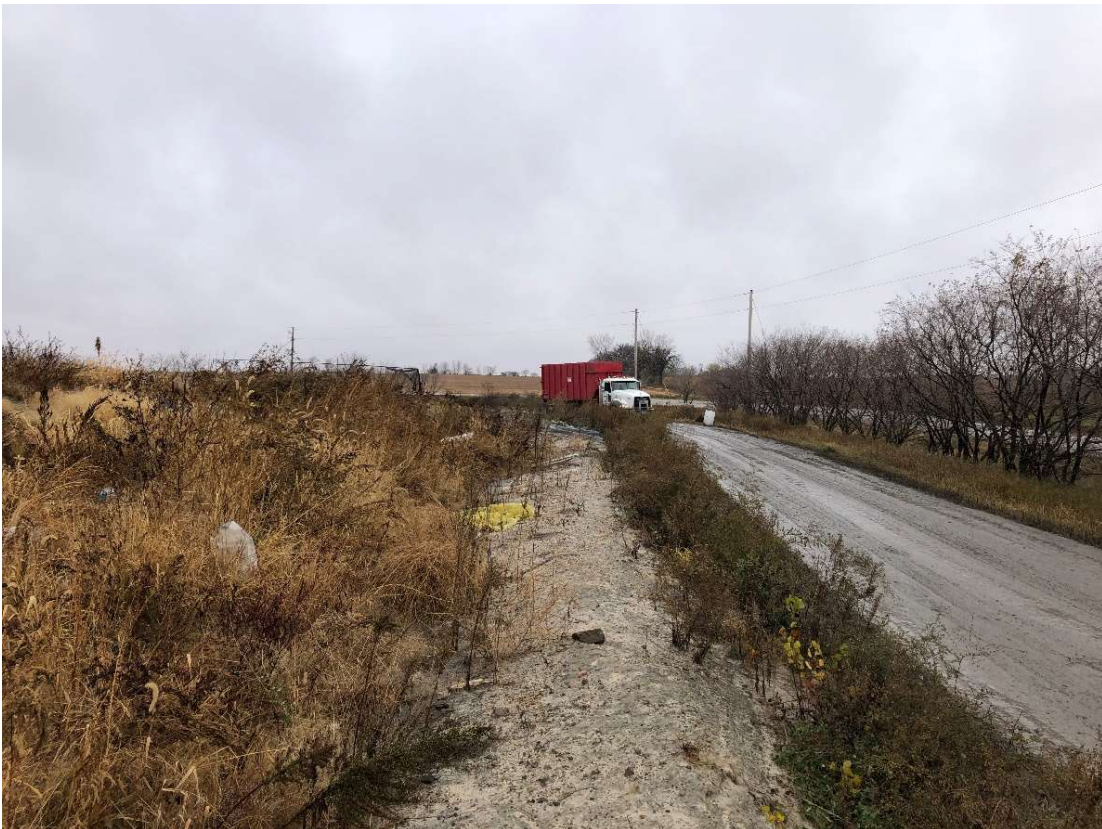
Photo 30: Location 11 – Looking North, Phase 4 Eastern Anchor Trench

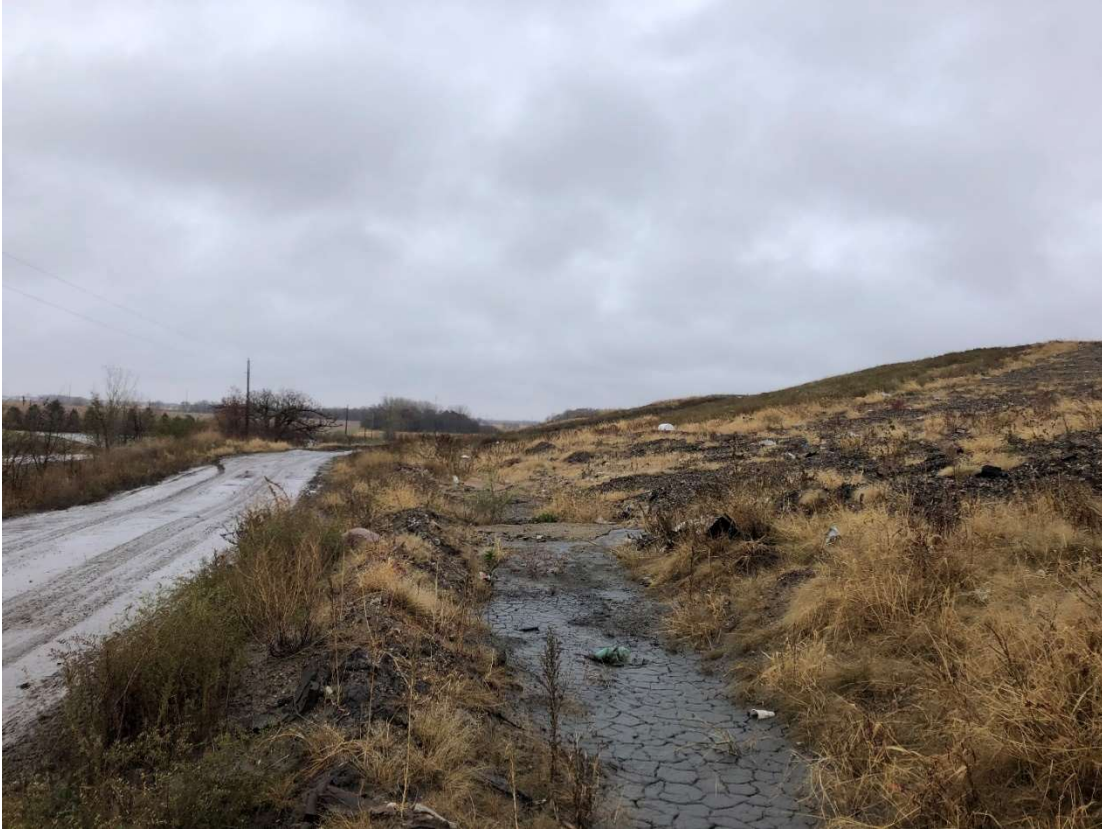
Location 12 – Looking South, Phase 4 Eastern Anchor Trench & Phase 3 Eastern Waste Slope

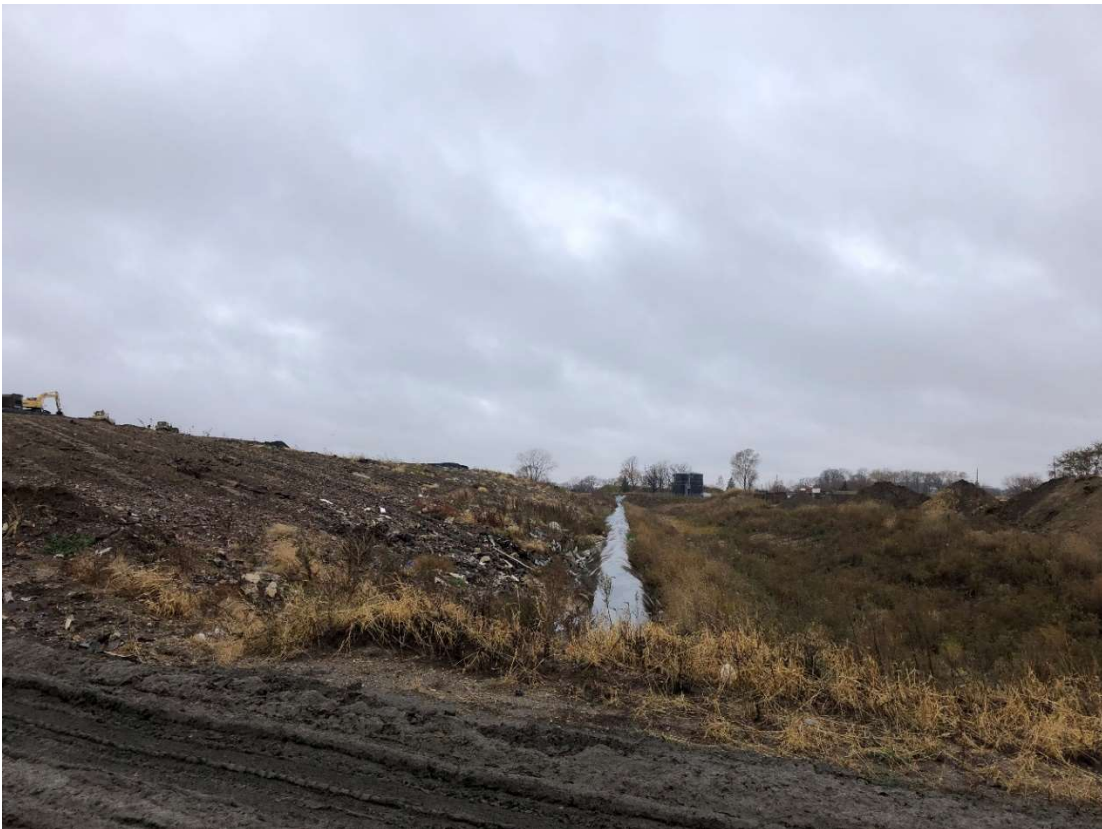
Location 12 – Looking West, Phase 4 Northern Rain Flap

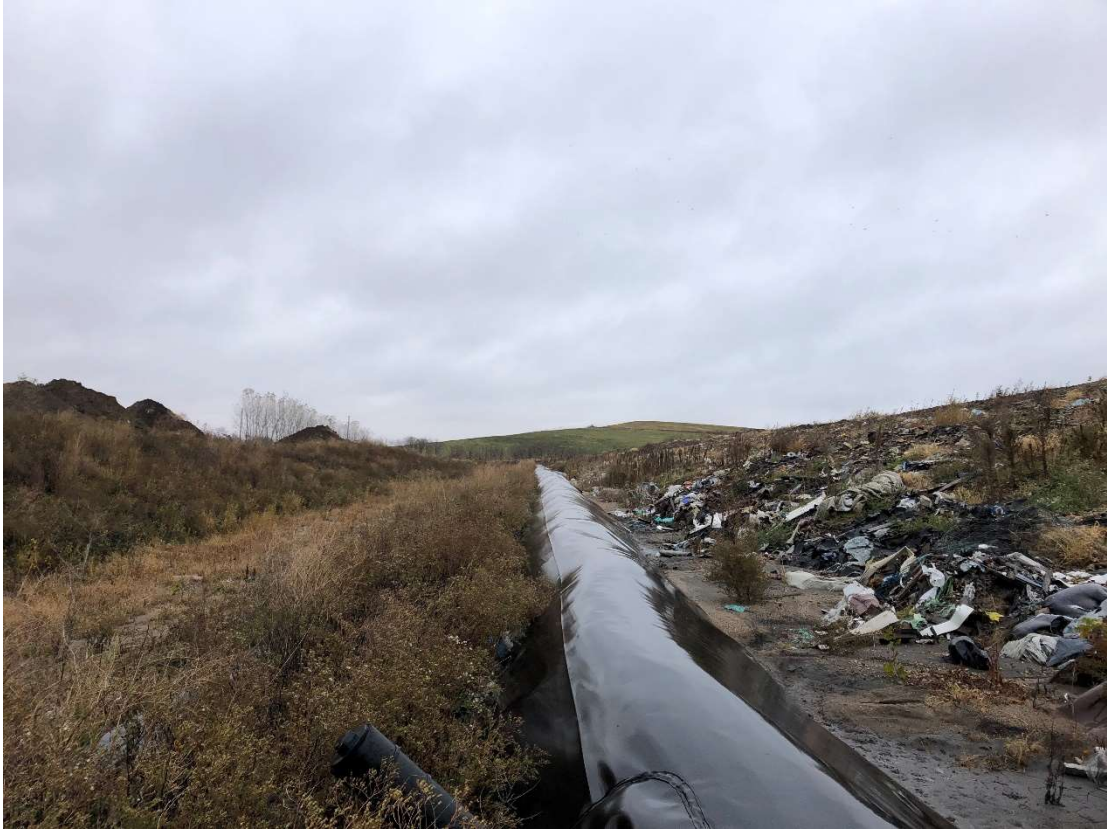
Location 13 – Looking East, Phase 4 Northern Rain Flap

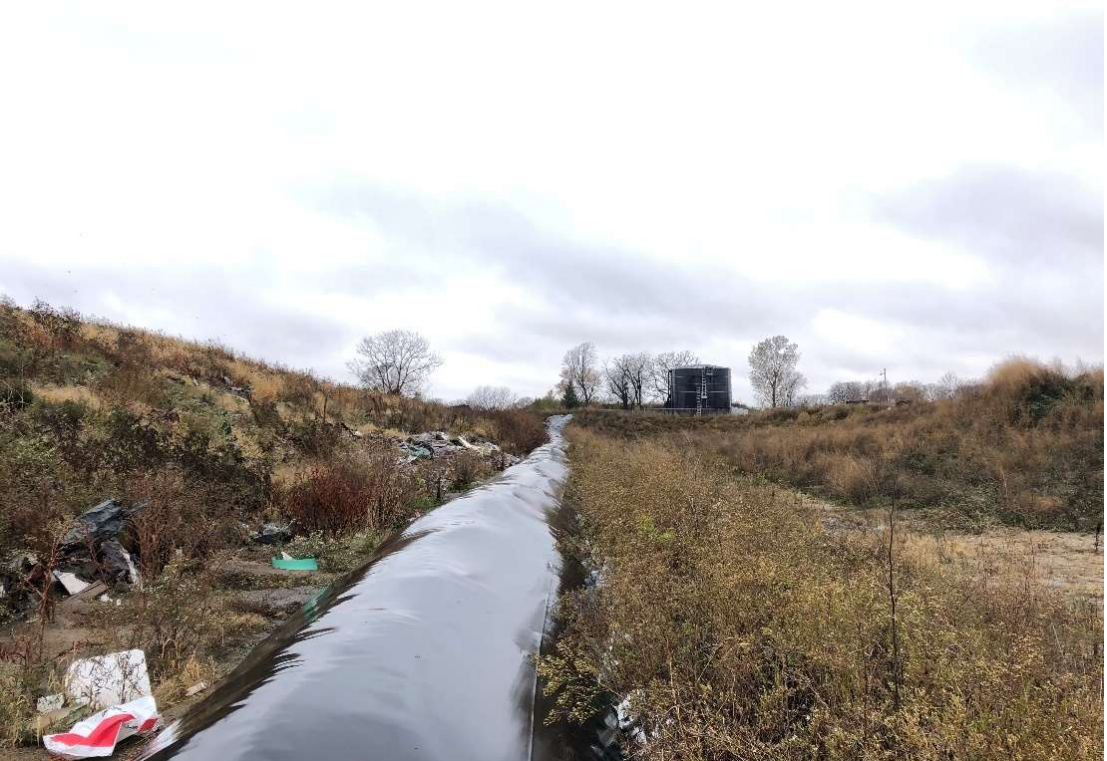
Location 13 – Looking West, Phase 4 Northern Rain Flap
