To: Geoff Strack, PE, Waste Connections      From: Brad Sullivan, PE, Stantec  
File: 227704387      Date: January 7, 2025

**Reference: WCI Austin Landfill, LLC 2024 Annual CCR Inspection Report****Purpose**

This memorandum fulfills the requirements of 40 CFR § 257.84 Inspection Requirements for CCR Surface Landfills, Part b, regarding an annual inspection by a qualified professional engineer.

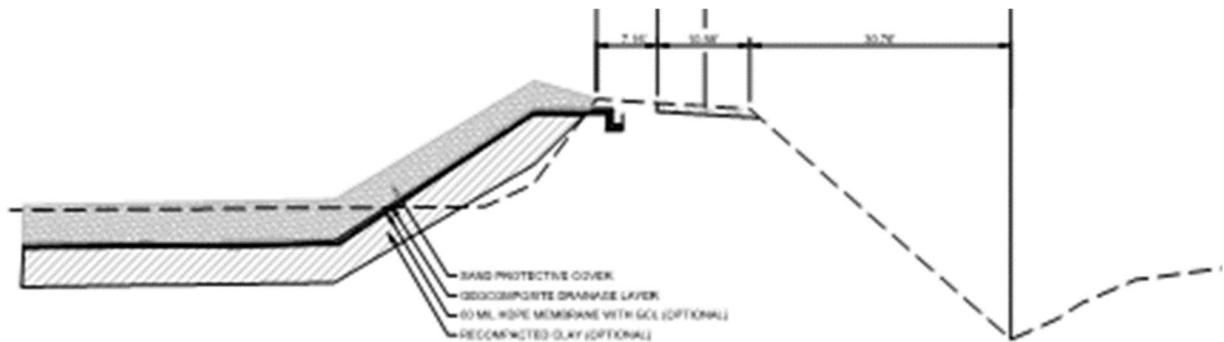
Typical Landfill Berm Detail

During the inspection there were no signs of landfill cell embankment distress, no signs of waste slope instability, or other CCR landfill issues observed. The landfill embankments and interim covered slopes were generally in good condition with a well-established vegetation cover and no signs of significant erosion.
