Technical Memo

To: Geoff Strack, SKB (Austin) Environmental, LLC.
From: Dave Parenteau, PE (MN), Wenck Associates, Inc.
Date: January 14, 2016
Subject: Annual Inspection SKB Lansing - Report of CCR Landfill Inspection
Wenck Project # B3053-0034

**Photos of Coal Ash Inspection
SKB Environmental Landfill, Lansing, MN
December 21, 2015**

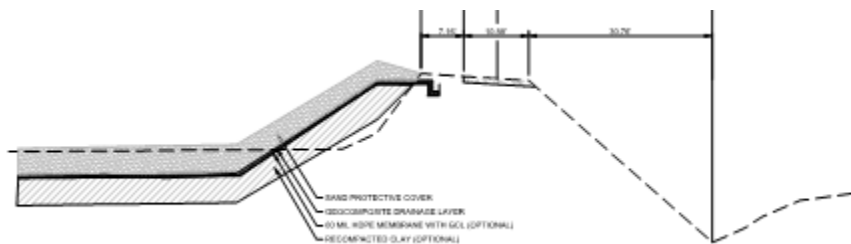
The landfill cell embankments were constructed using on-site and import controlled fill materials, and compacted in lifts. A typical perimeter section, taken from the Cell 2, Phase 2 Construction Documentation Report, prepared by CRA in November, 2012 is shown below.

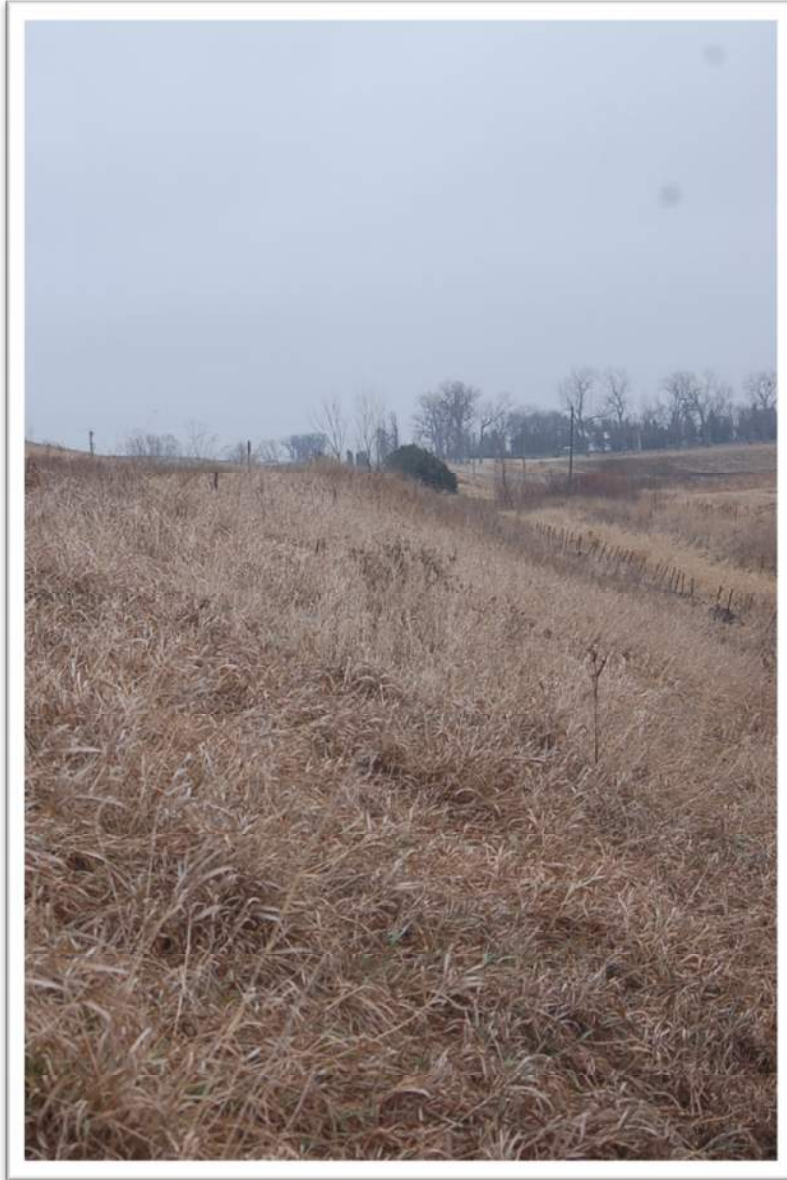
1. West End of South Slope
Facing East
Top of Slope

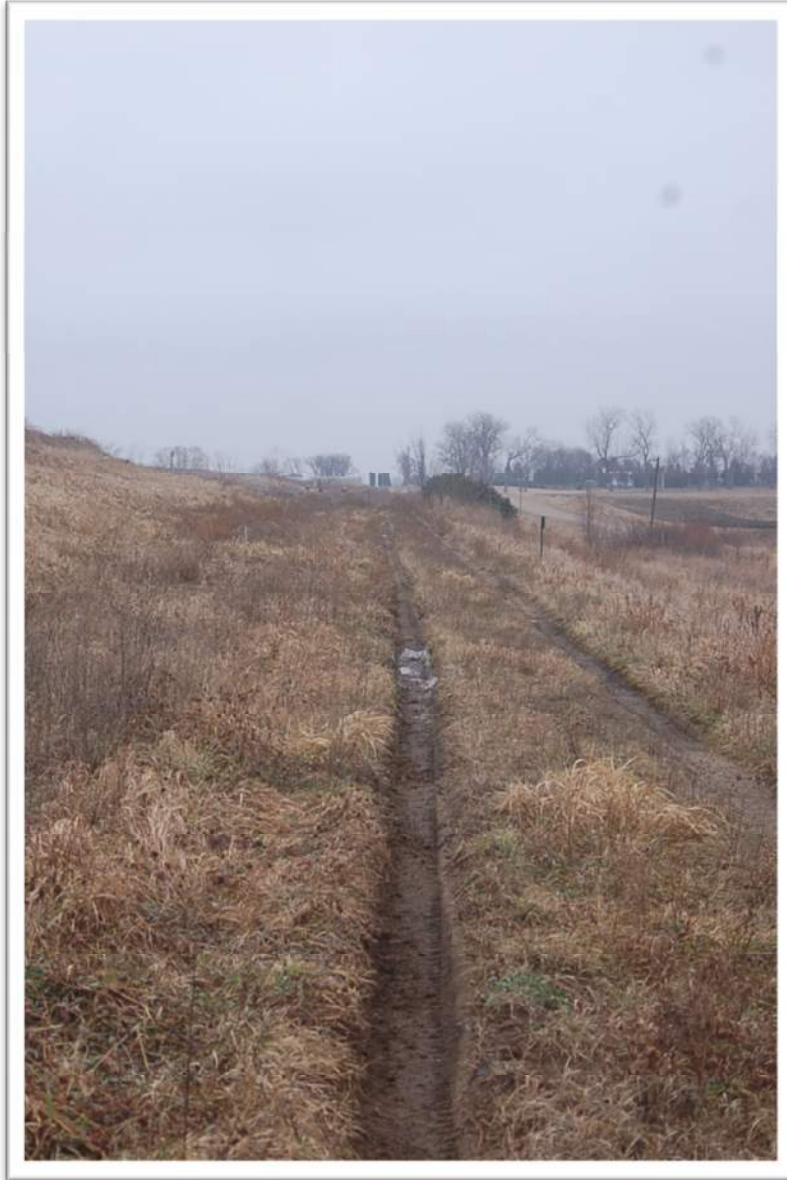
2. West End of South Slope
Facing East
Middle of Slope

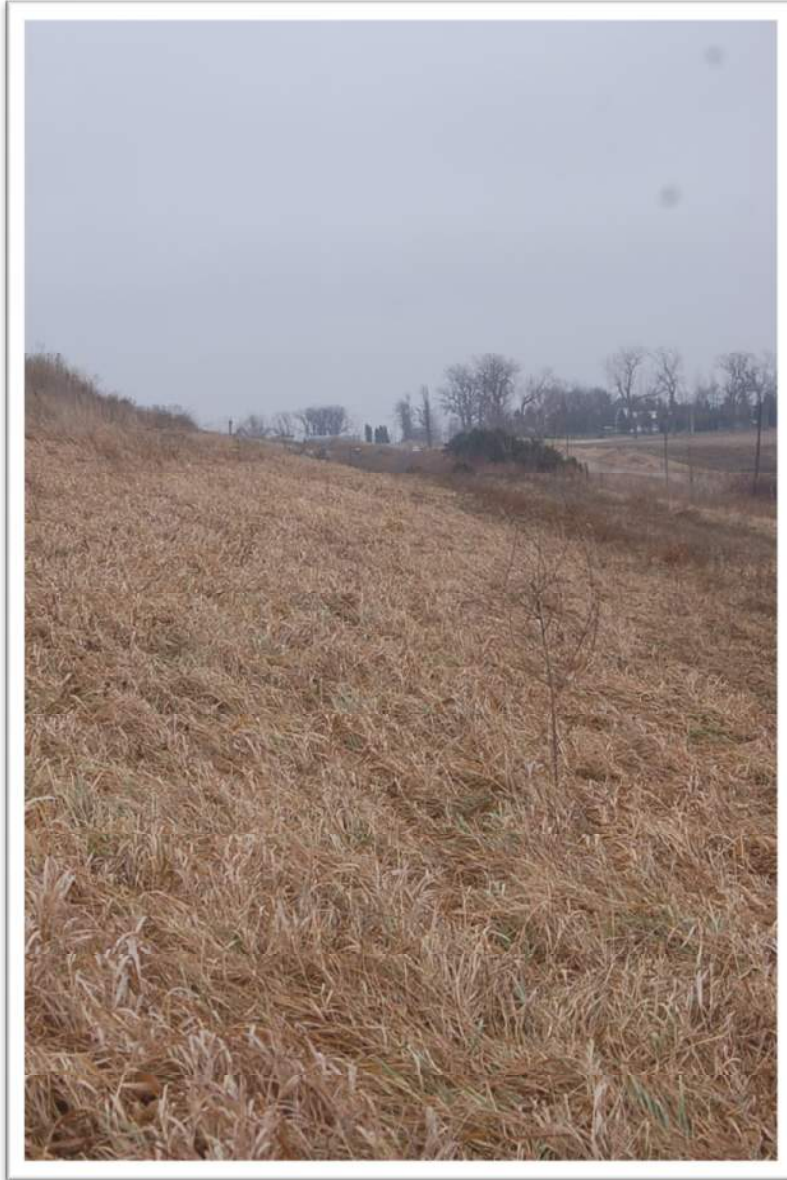
3. West End of South Slope
Facing East
Bottom of Slope

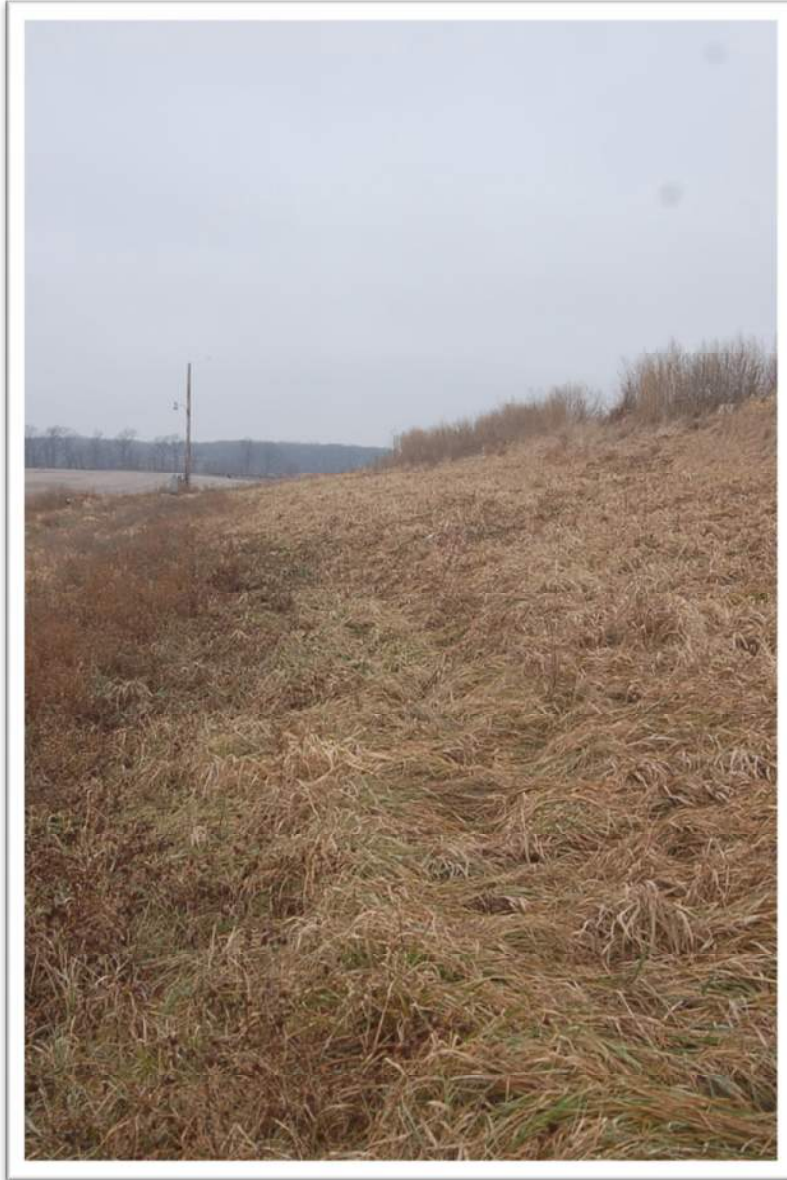
4. Mid section of South Slope
Facing West
Top of Slope

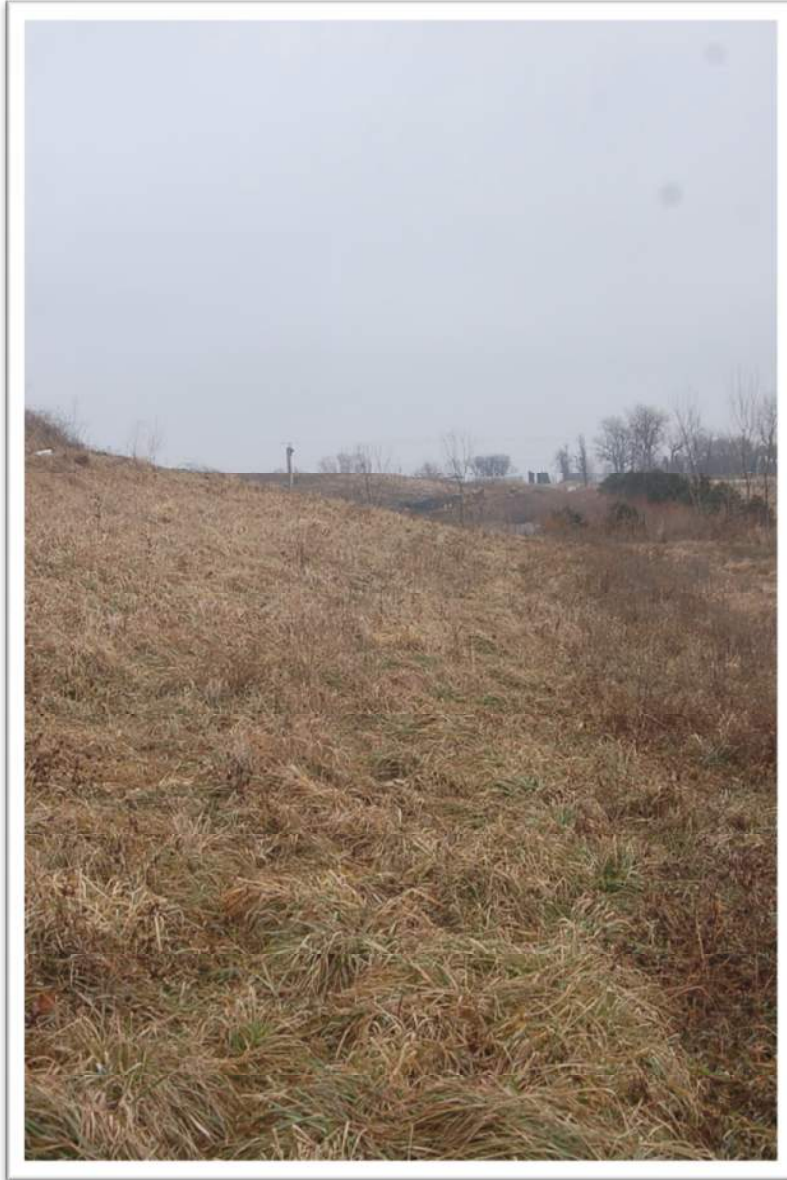
5. Mid section of South Slope
Facing East
Top of Slope

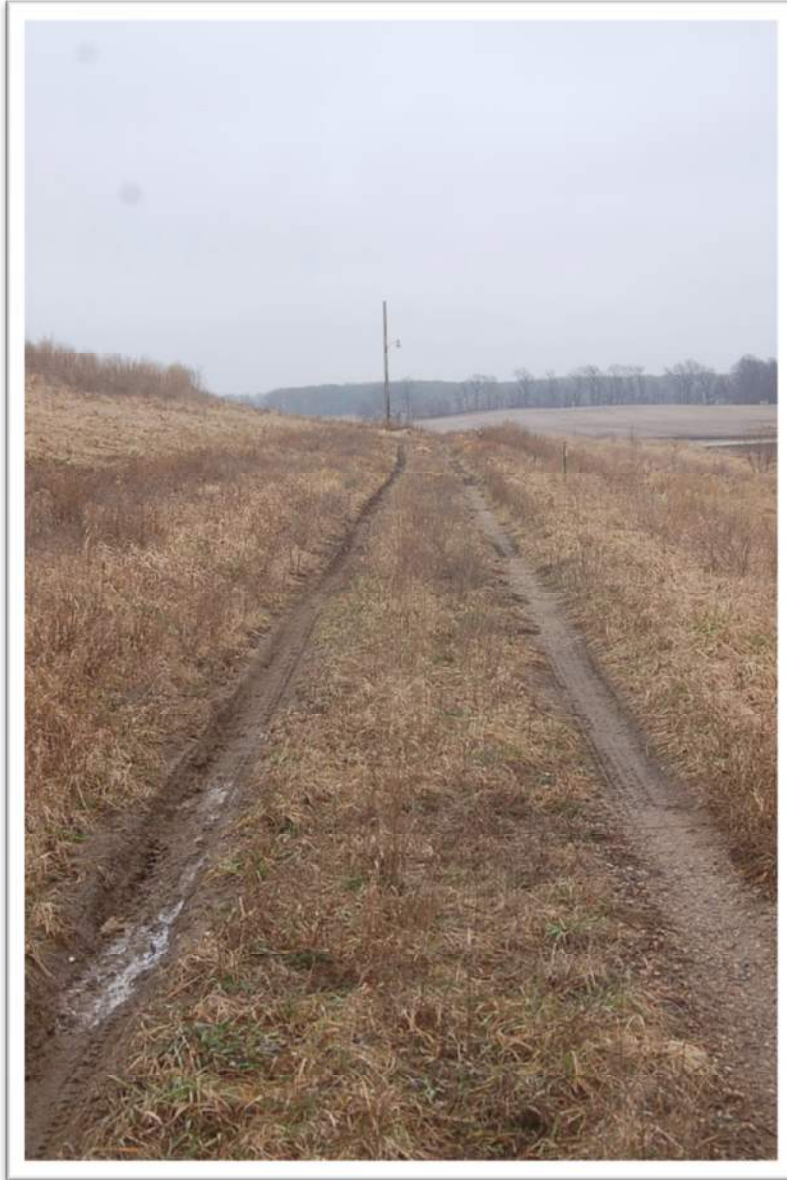
6. Mid section of South Slope
Facing West
Middle of Slope

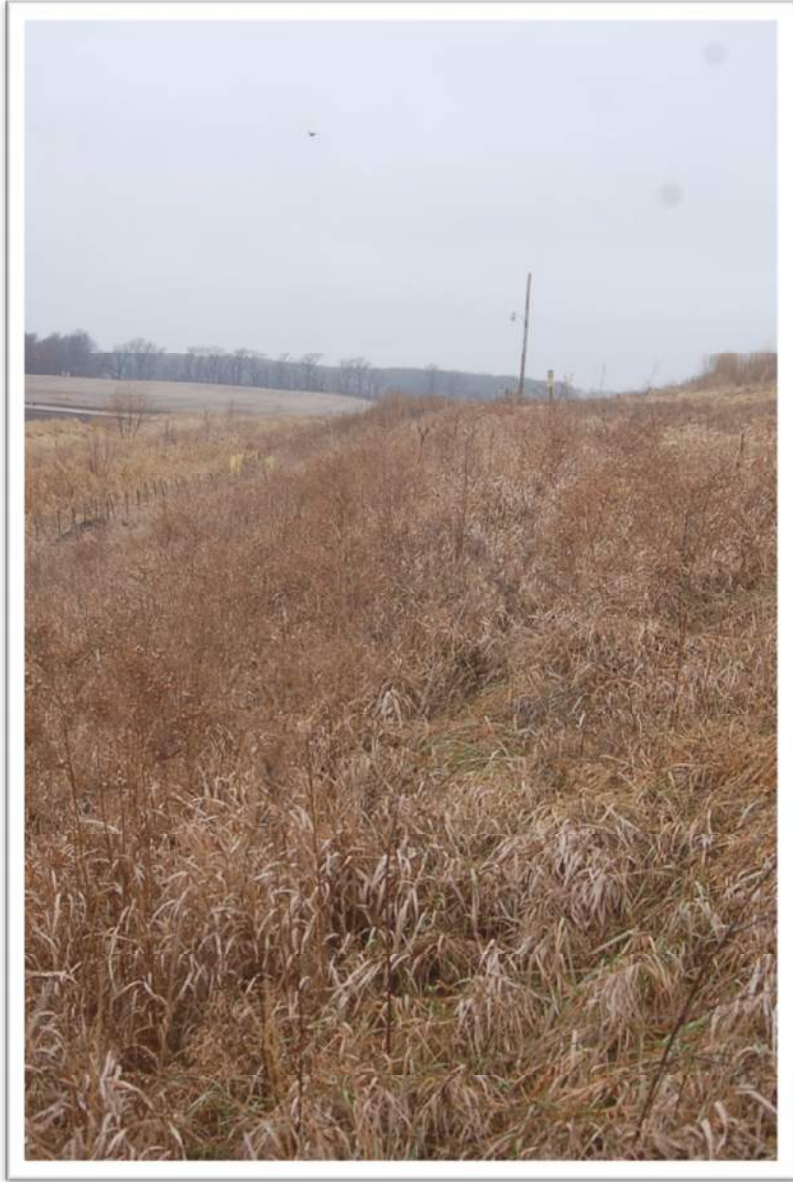
7. Mid Section of South Slope
Facing West
Bottom of Slope

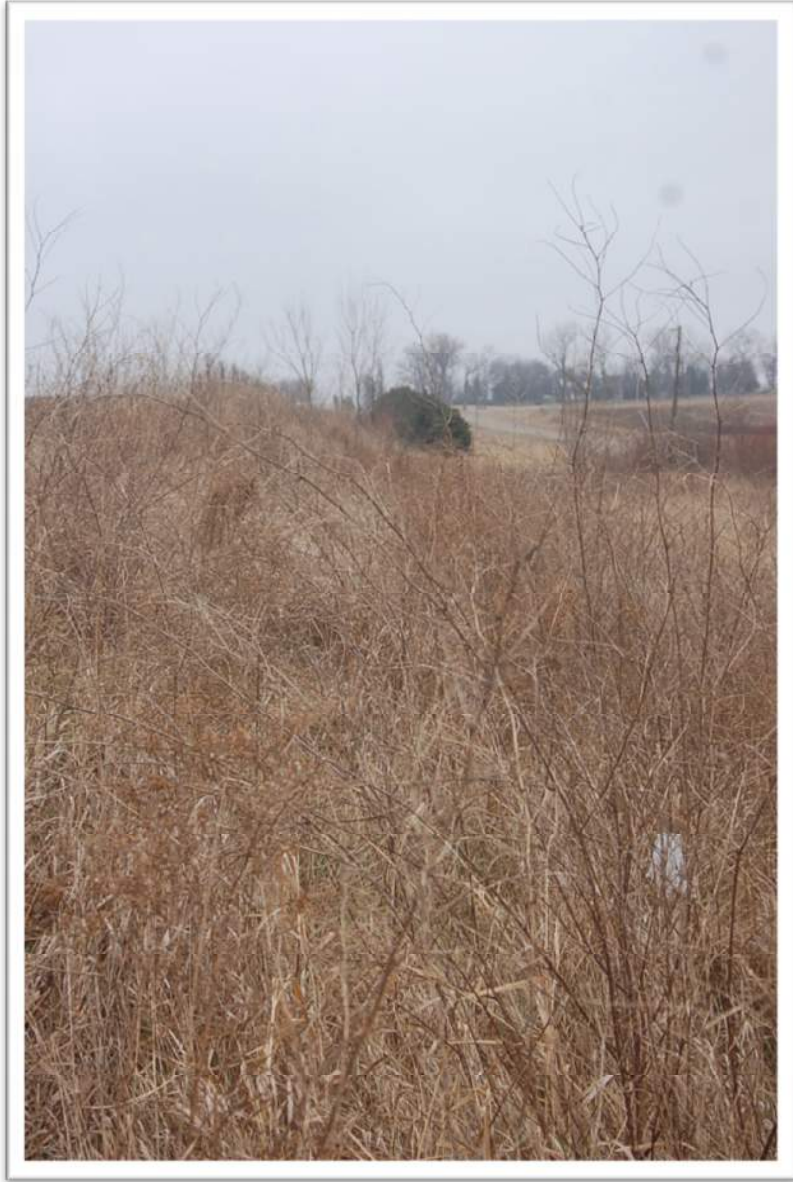
8. Mid Section of South Slope
Facing East
Bottom of Slope

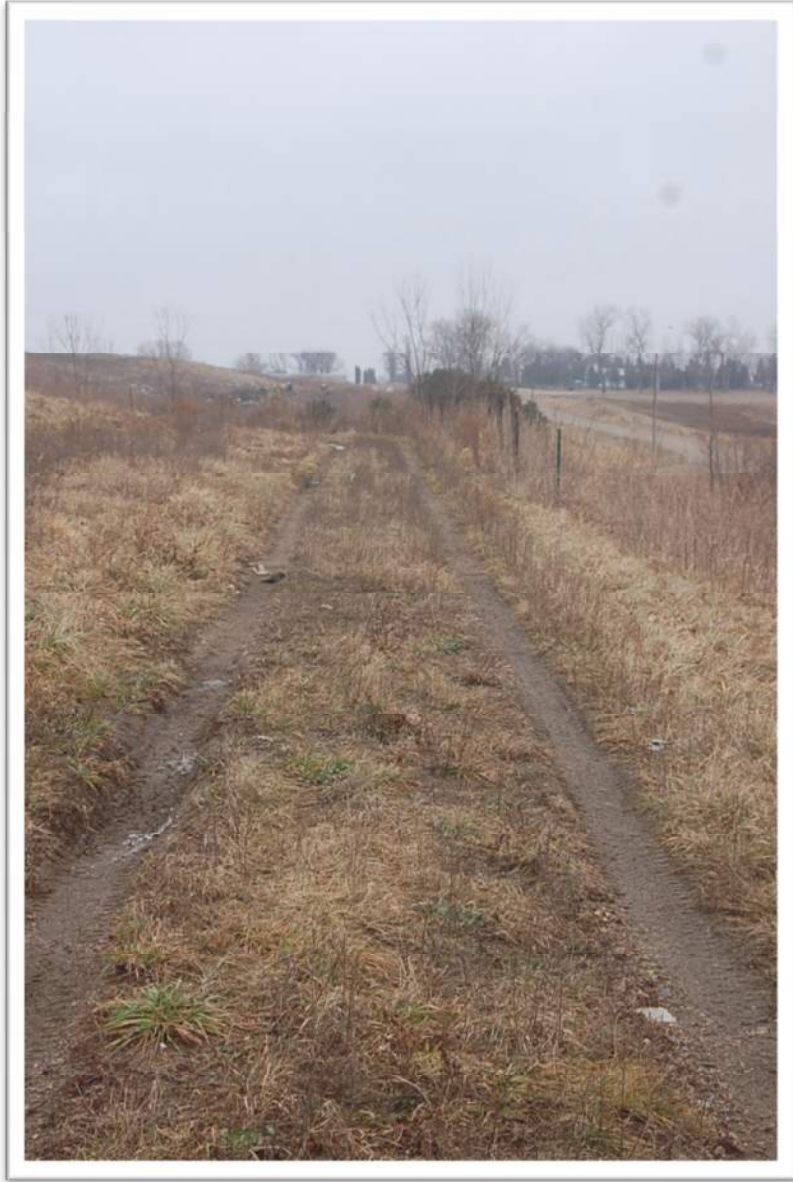
9. Mid Section of South Slope
Facing East
Middle of Slope

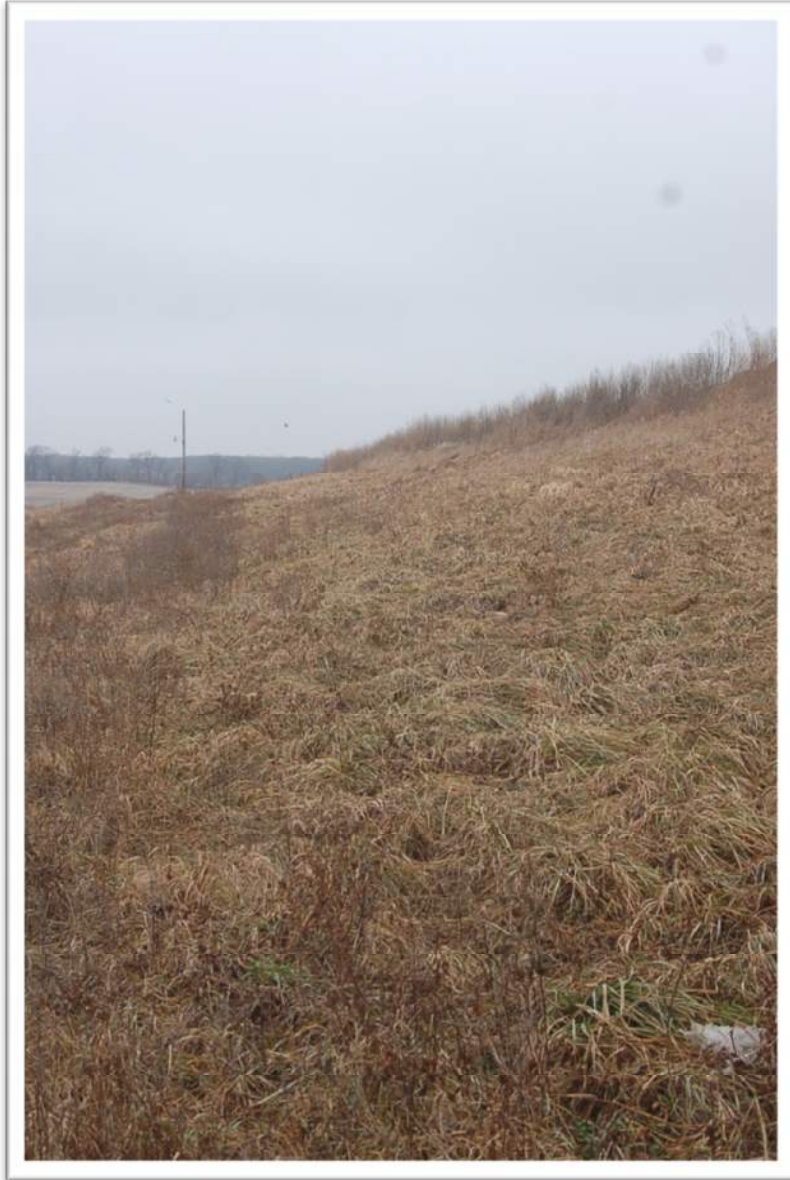
10. East End of South Slope
Facing West
Top of Slope

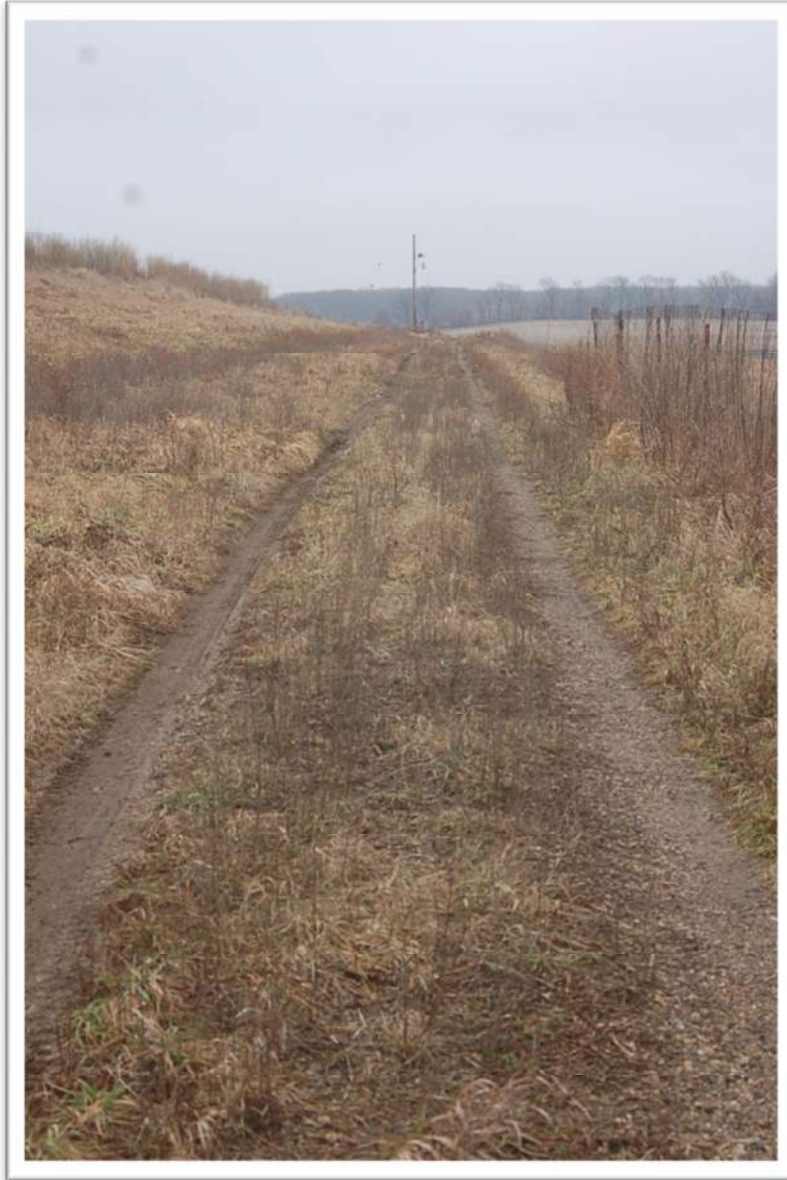
11. East End of South Slope
Facing West
Middle of Slope

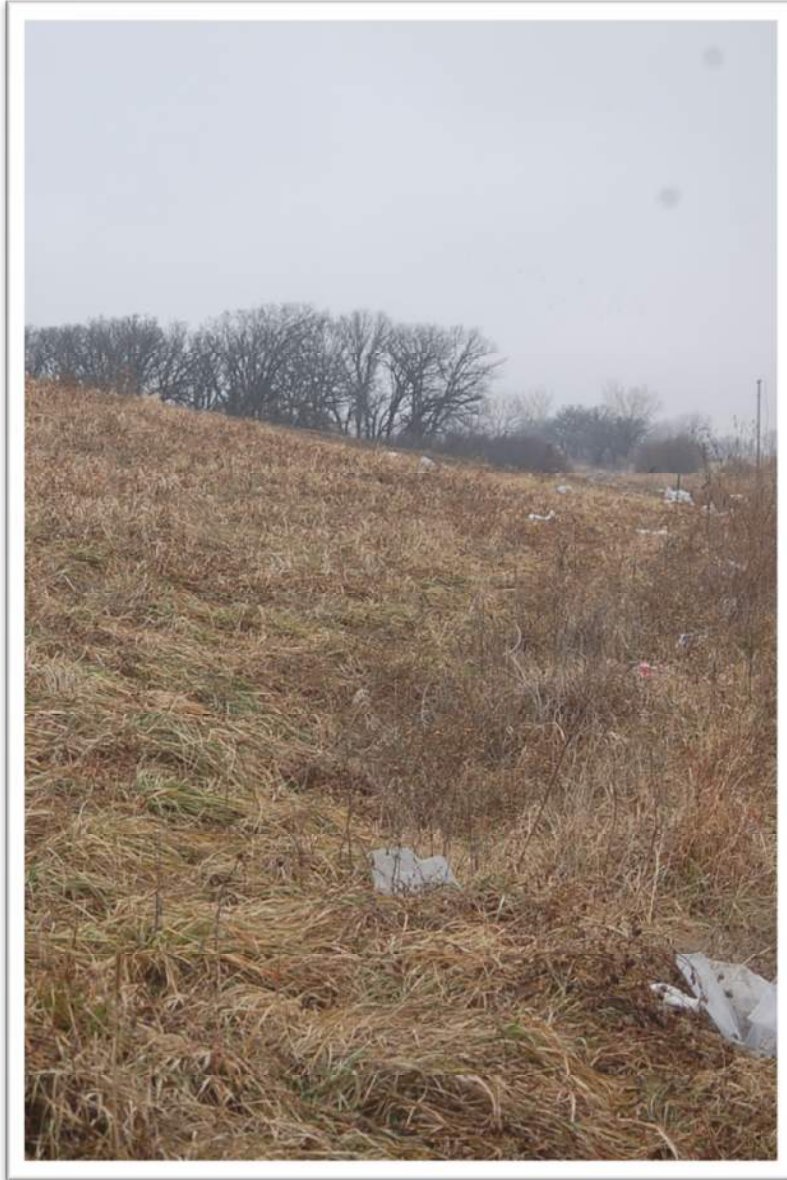
12. South End of East Slope
Facing North
Top of Slope

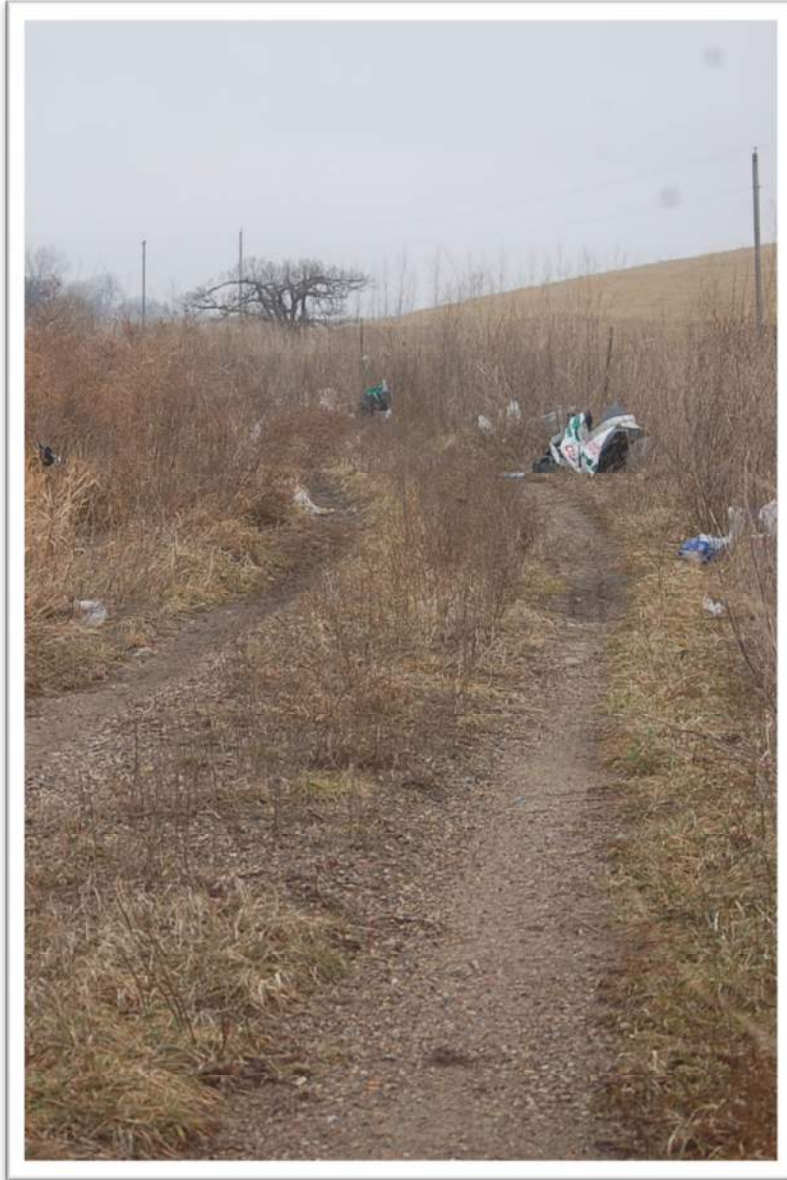
13. South End of East Slope
Facing North
Middle of Slope

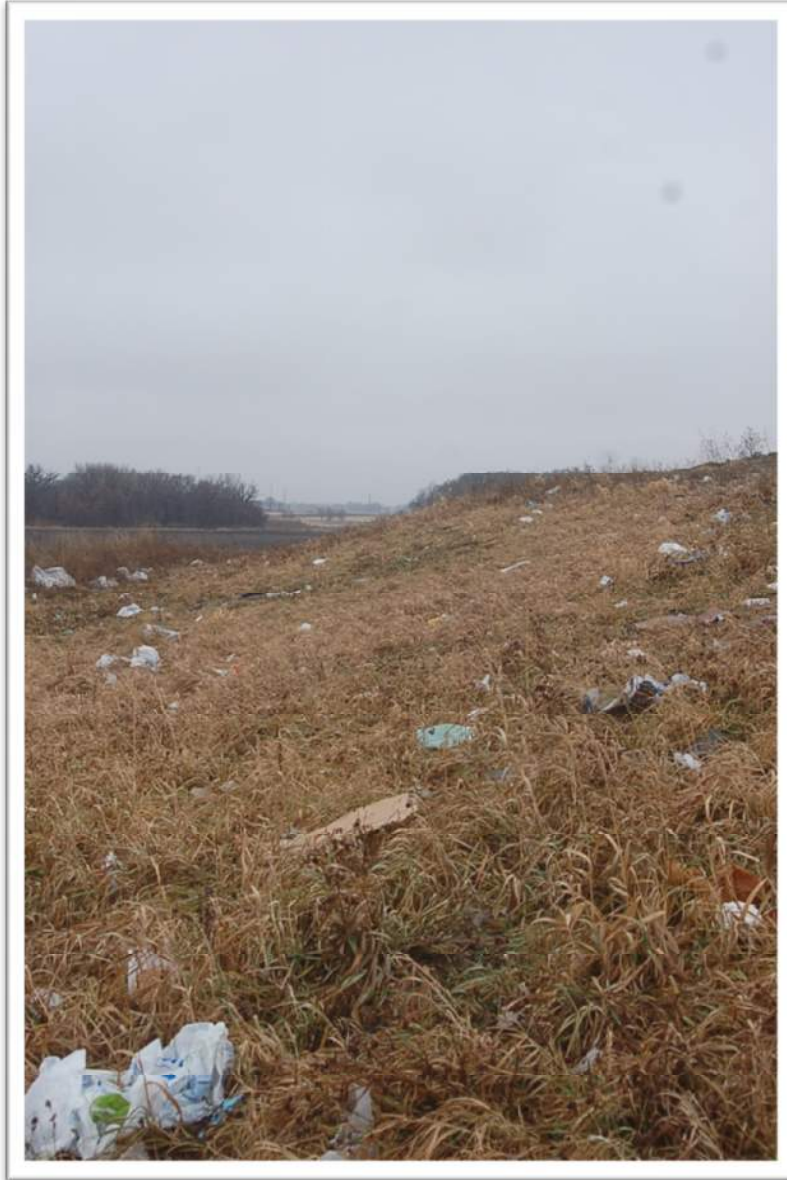
14. North End of East Slope
Facing South
Top of Slope

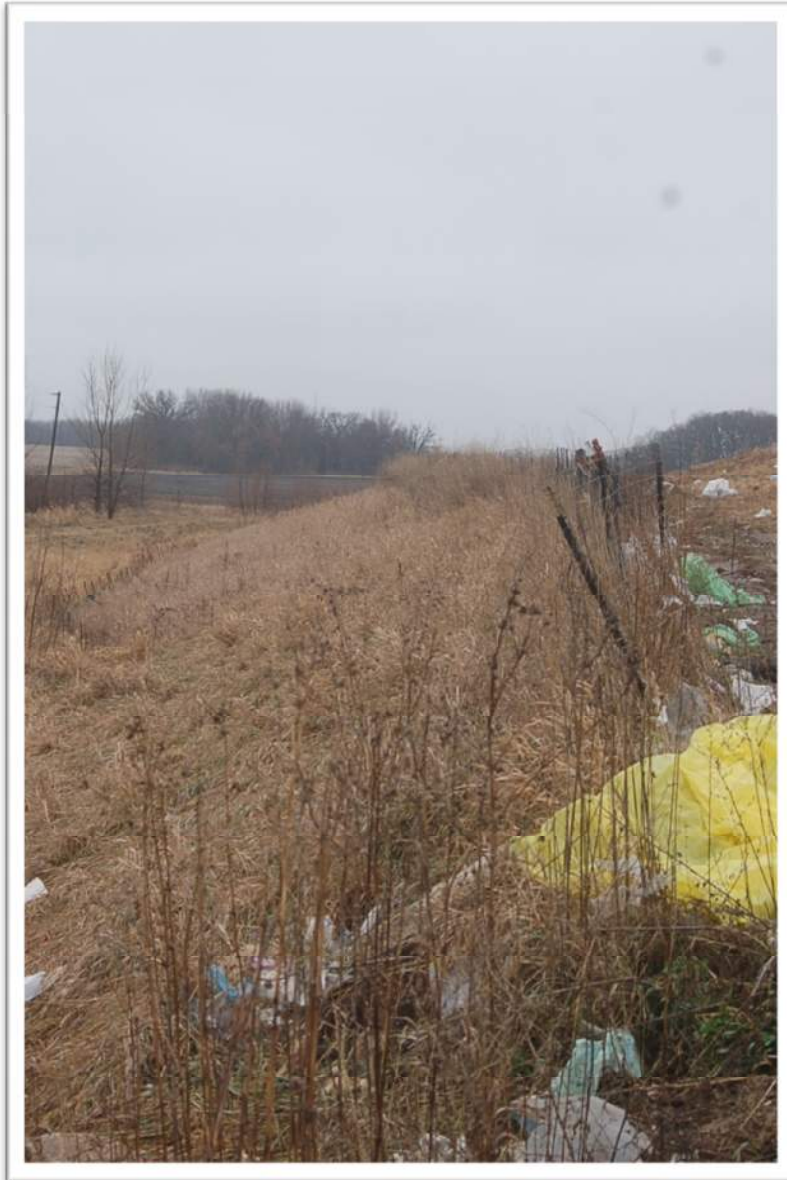
15. Mid Section of East Slope
Facing South
Bottom of Slope

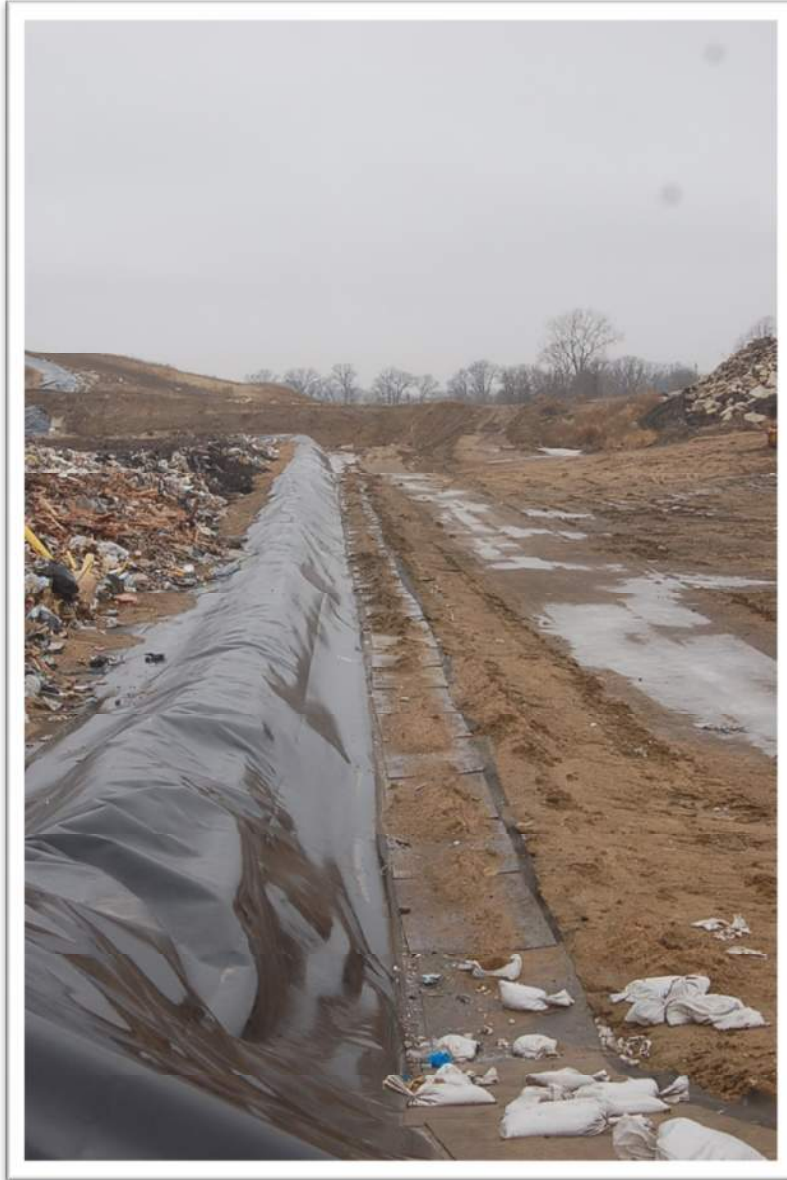
16. East Side of Site
Facing West
Lined Outer Berm

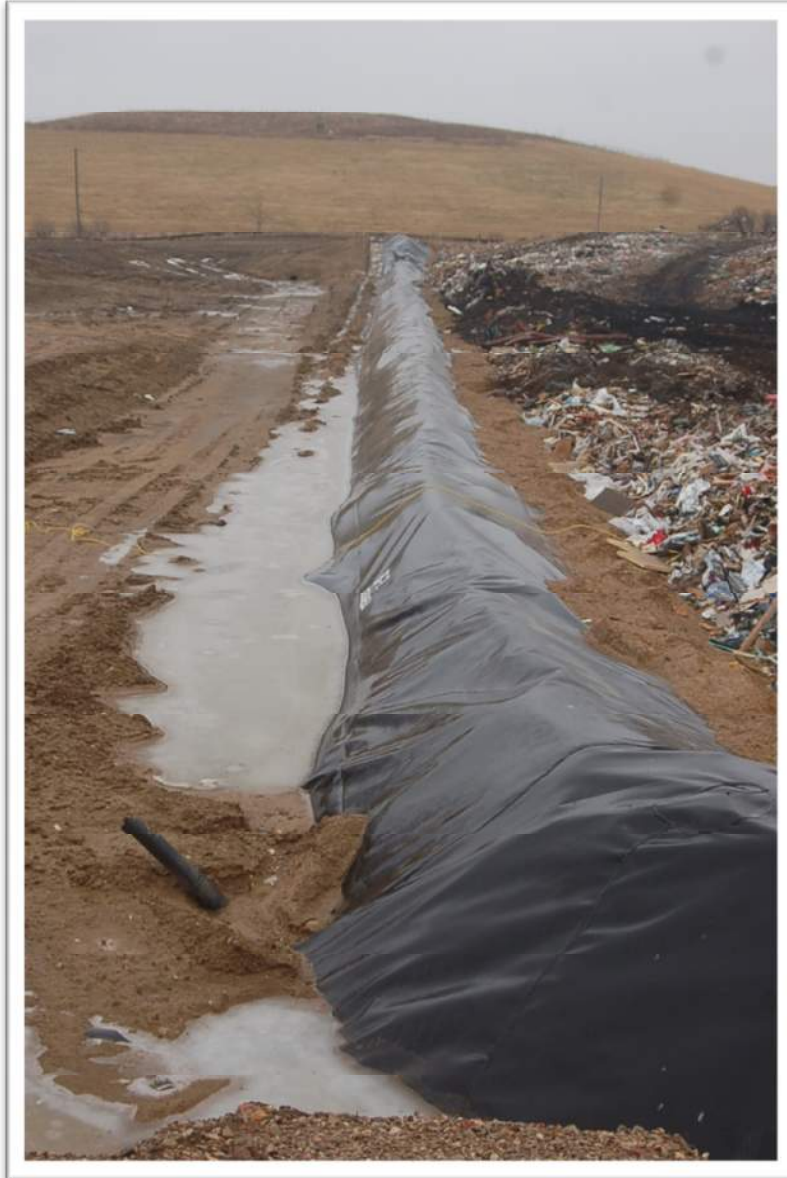
17. Near Middle of Site
Facing East
Lined Outer Berm

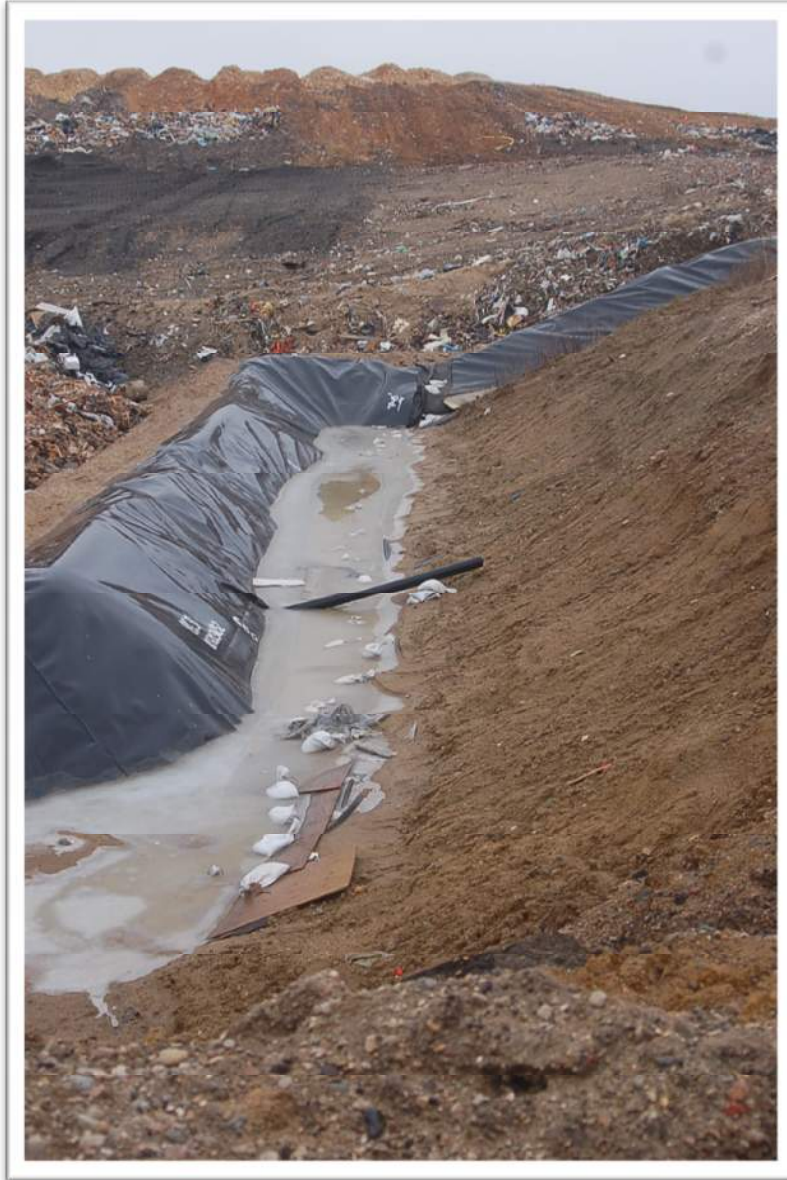
18. Near Middle of Site
Facing South
Lined Outer Berm

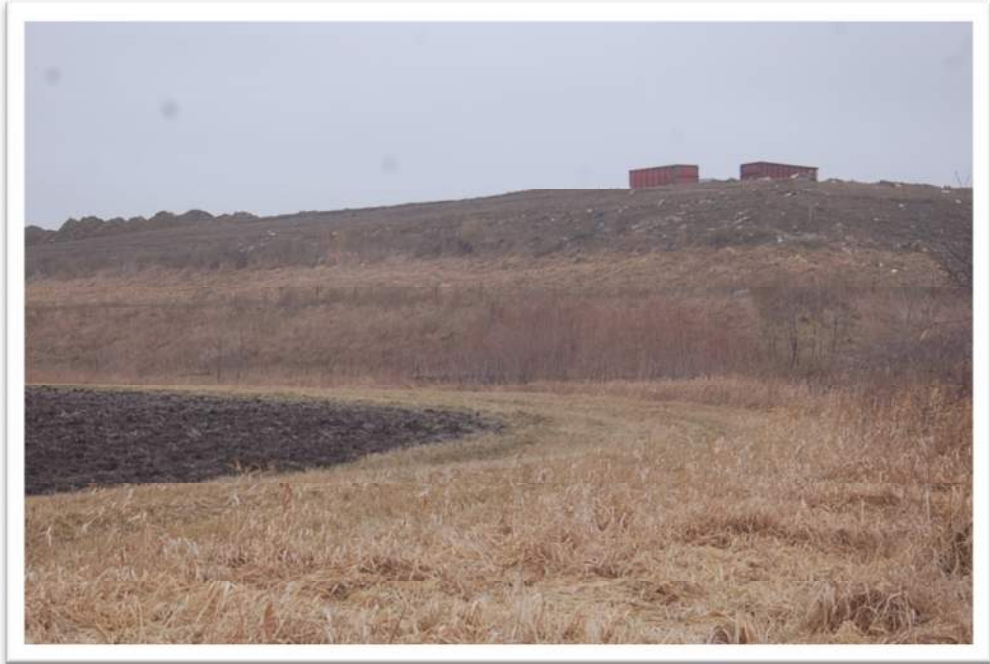
19) South East of Site
Facing Northwest

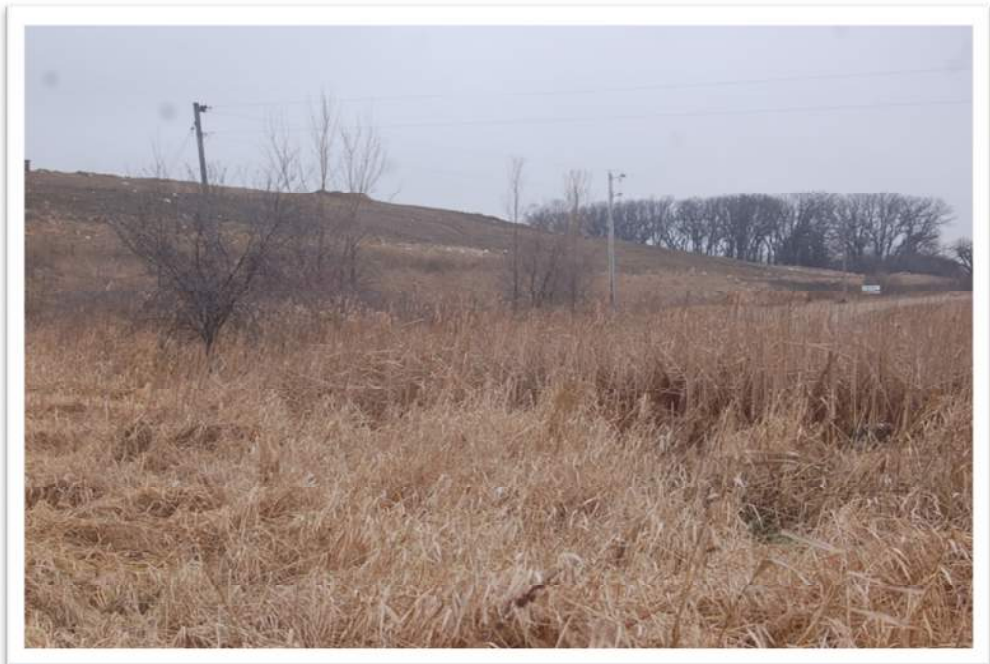
20) South East of Site
Facing North
