Technical Memo

Subject: 2017 Annual Inspection SKB Lansing - Report of CCR Landfill Inspection
Wenck Project # B3053-0057

SKB (Austin) Environmental, LLC owns and operates the SKB Lansing Landfill, a Class III facility operating under MPCA Solid Waste Permit SW-514, originally issued in 1996.

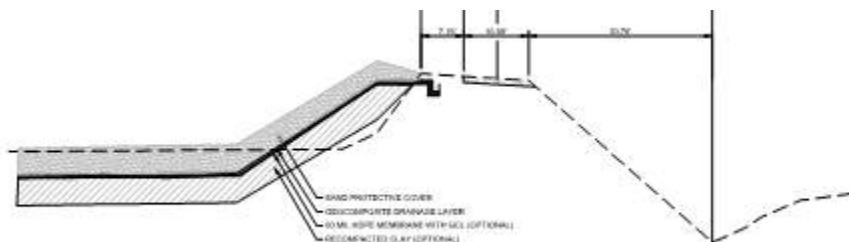
The landfill cell embankments were constructed using on-site and import controlled fill materials, and compacted in lifts. A typical perimeter section, taken from the Cell 2, Phase 2 Construction Documentation Report, prepared by CRA in November, 2012 is shown below.

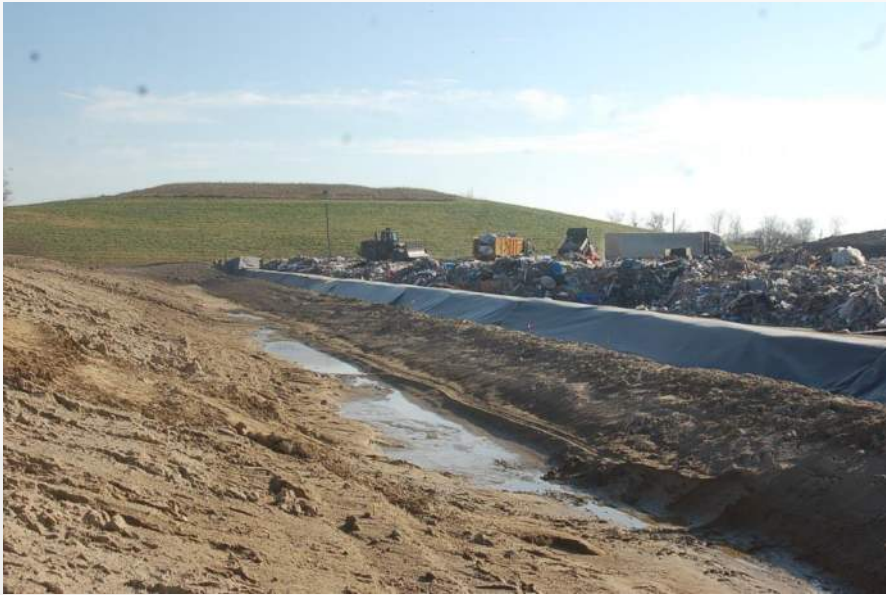
Photo 1 - Phase 3 North Temp Berm

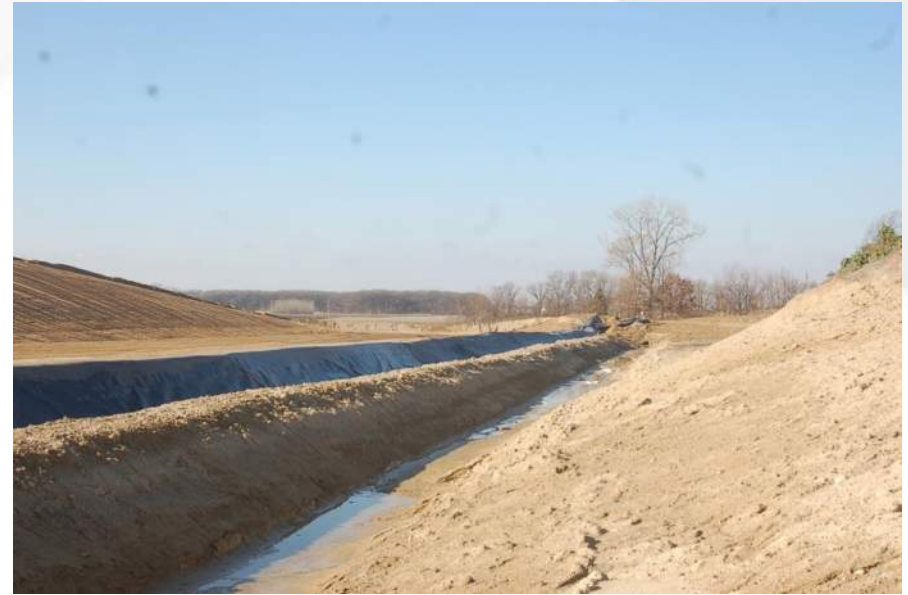
Photo 2 - Phase 3 North Temp Berm

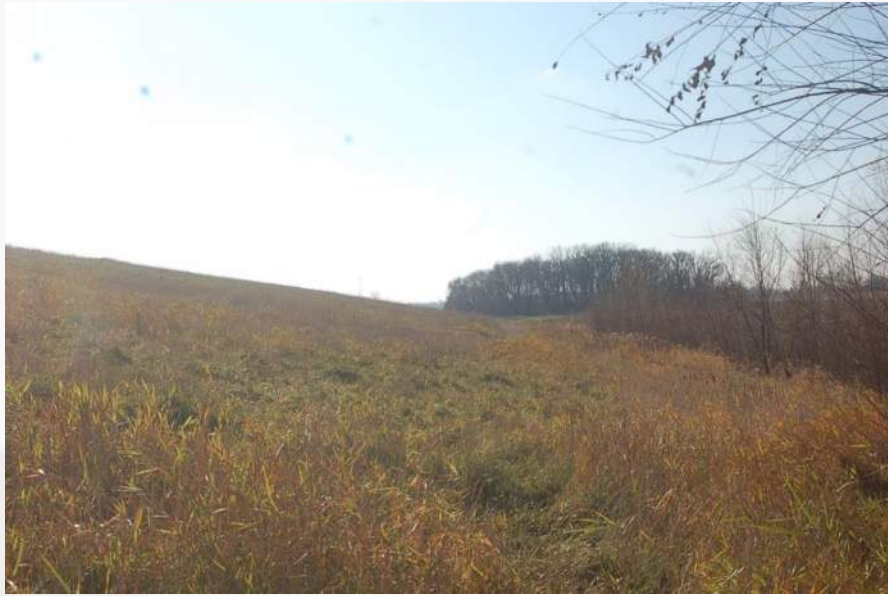
Photo 3 - Phase 1 West Closed Face

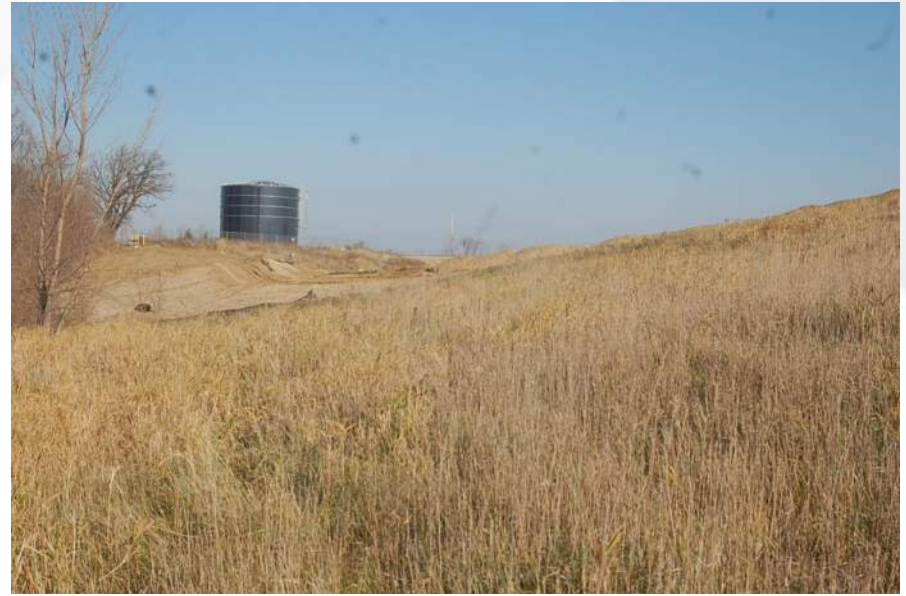
Photo 4 - Phase 1 West Closed Face

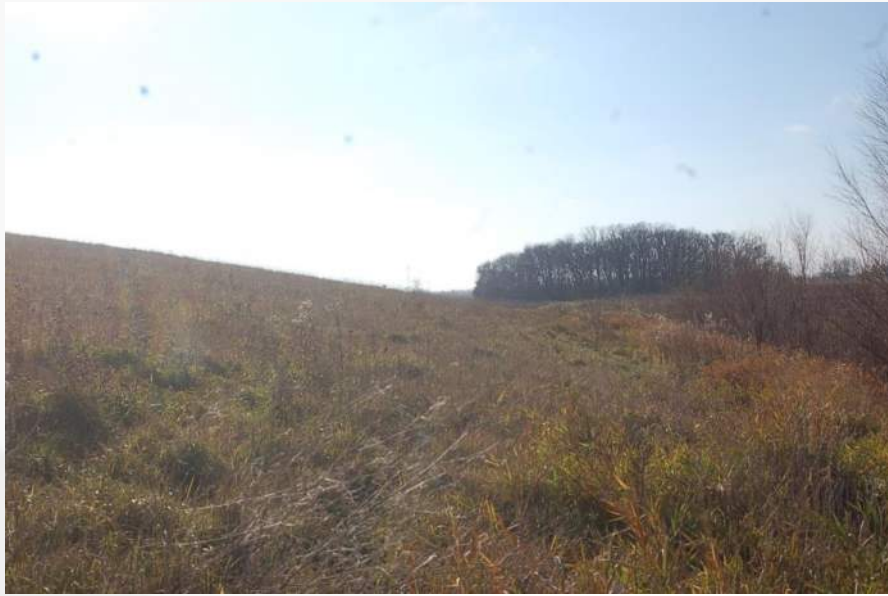
Photo 5 - Phase 1 West Closed Face

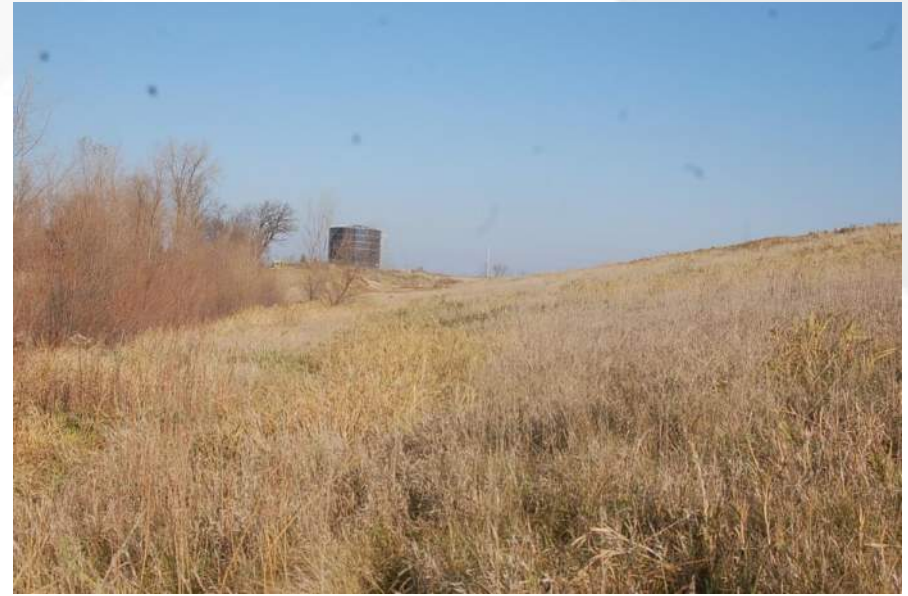
Photo 6 - Phase 1 West Closed Face

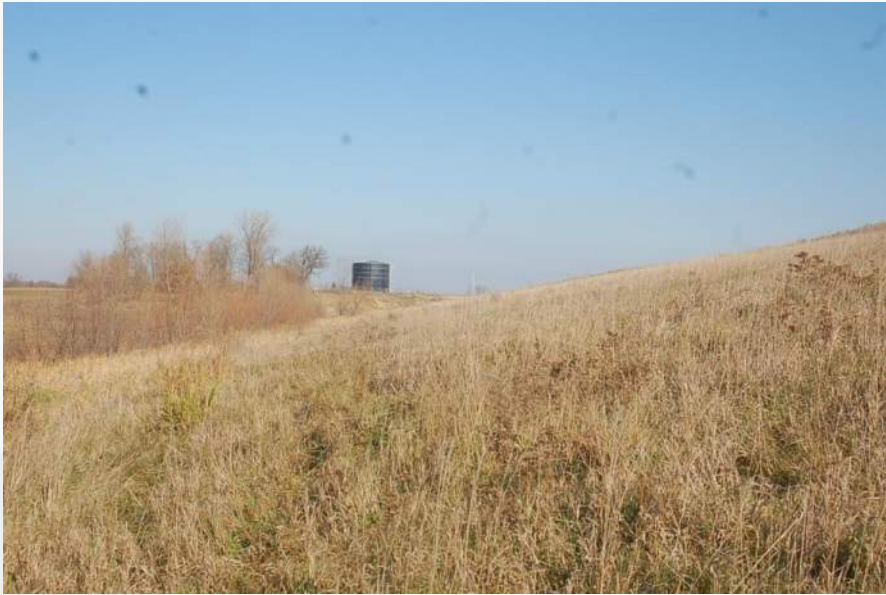
Photo 7 - Phase 1 West Closed Face

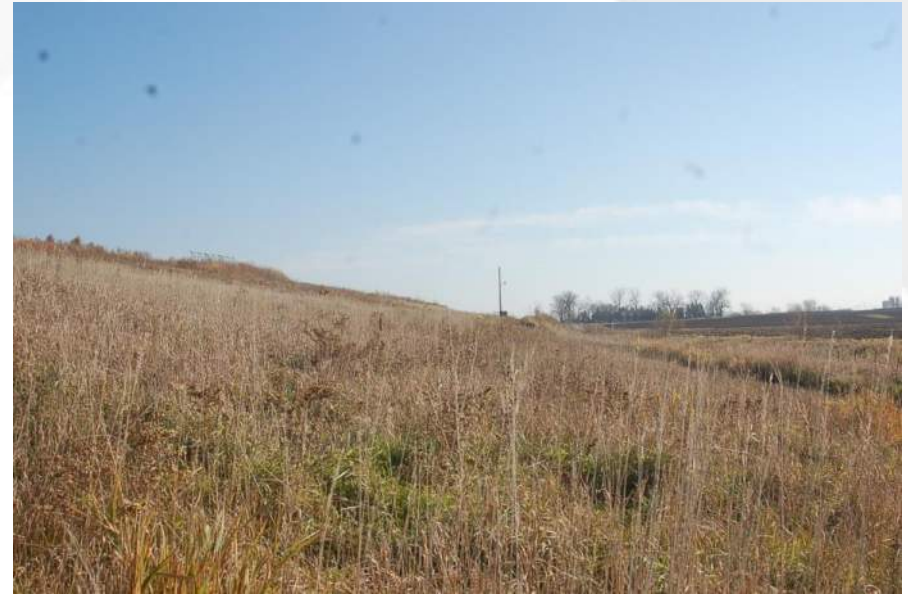
Photo 8 - Phase 1 South Closed Face

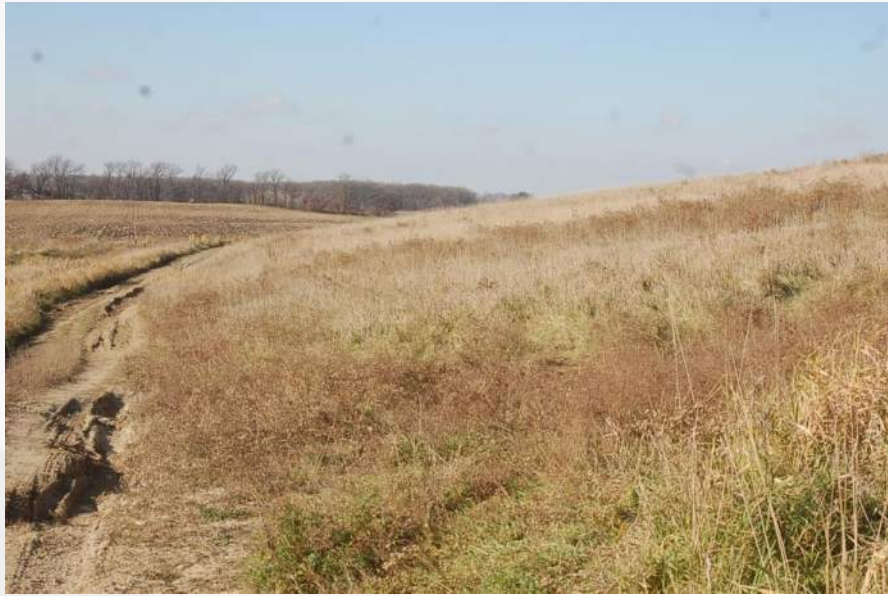
Photo 9 - Phase 1 South Closed Face

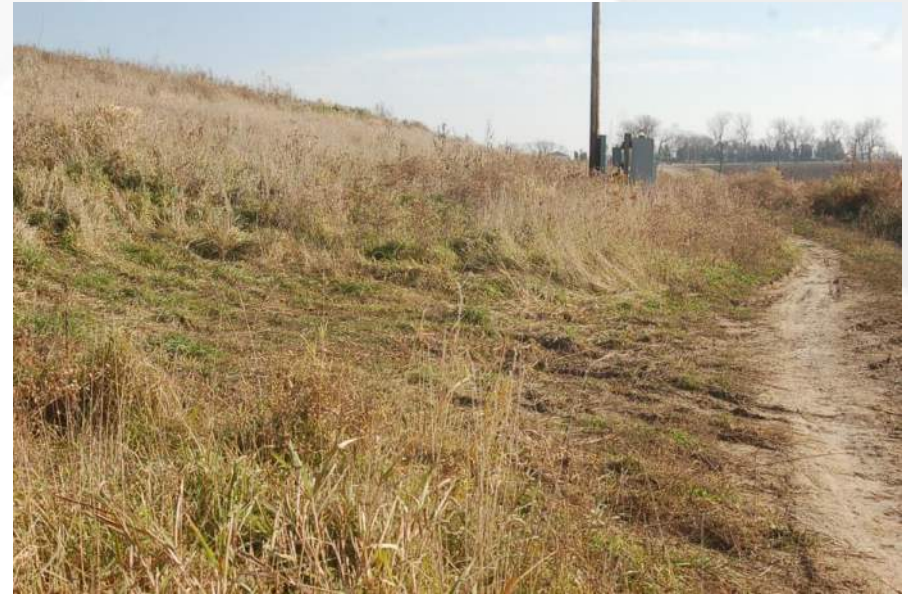
Photo 10 - Phase 1 South Closed Face

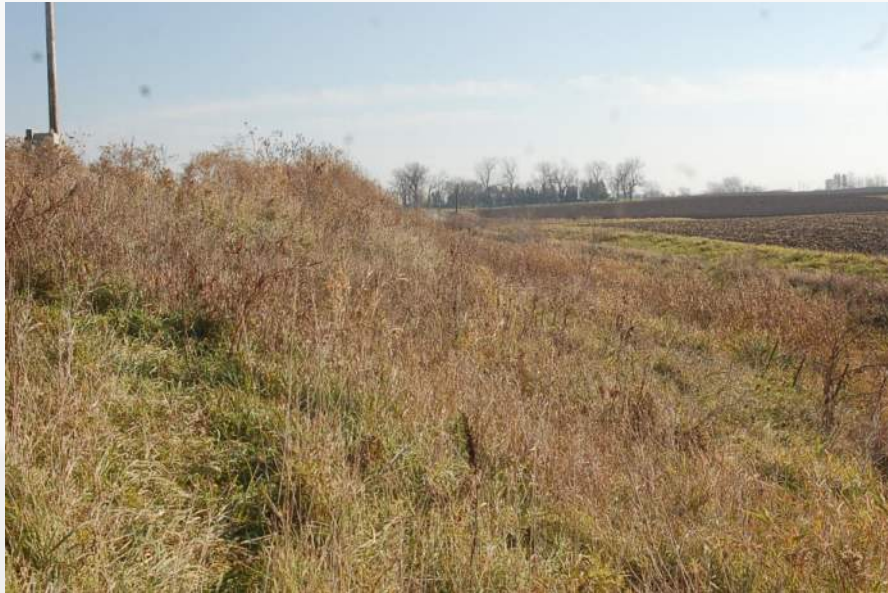
Photo 11 - Phase 1 South Exterior Slope

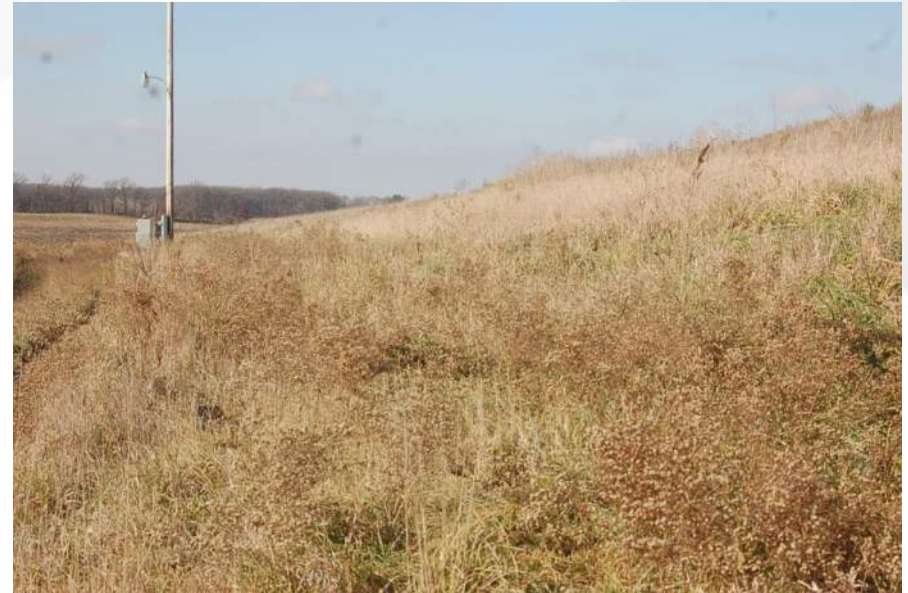
Photo 12 - Phase 2 South Waste Face

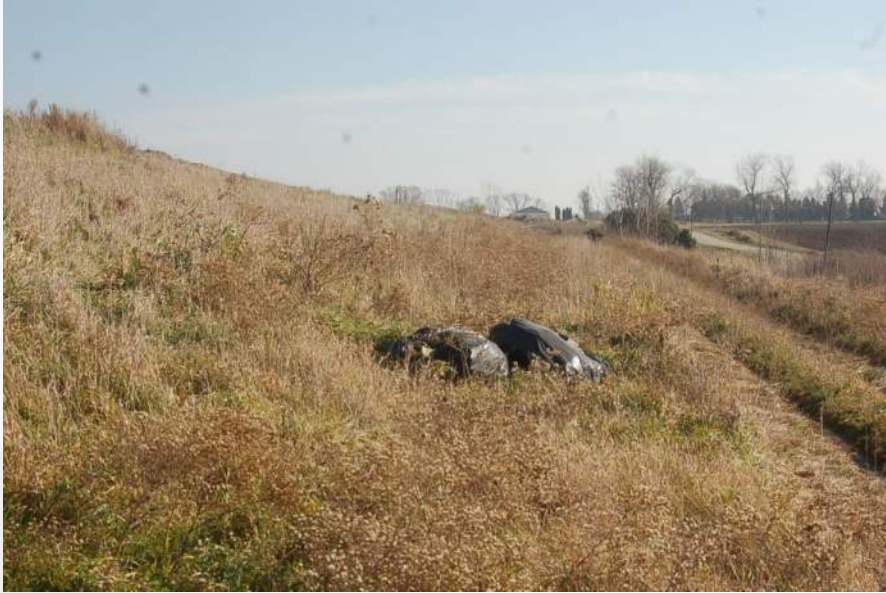
Photo 13 - Phase 2 South Waste Face

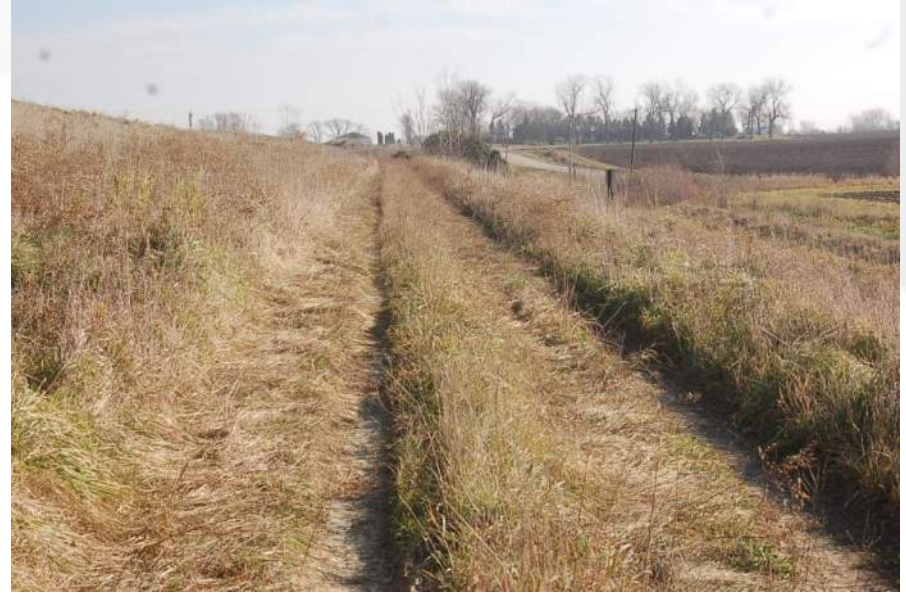
Photo 14 - Phase 2 Top South Berm

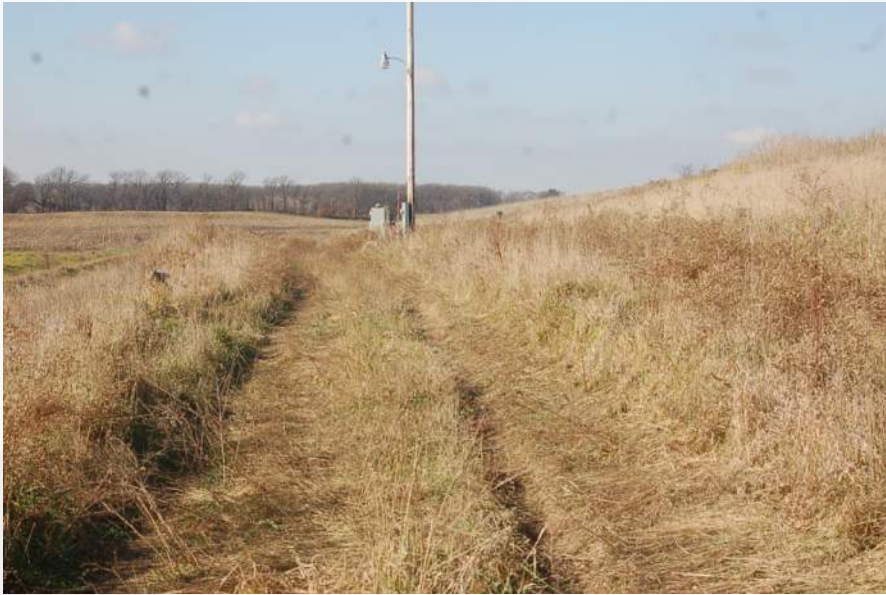
Photo 15 - Phase 2 Top South Berm

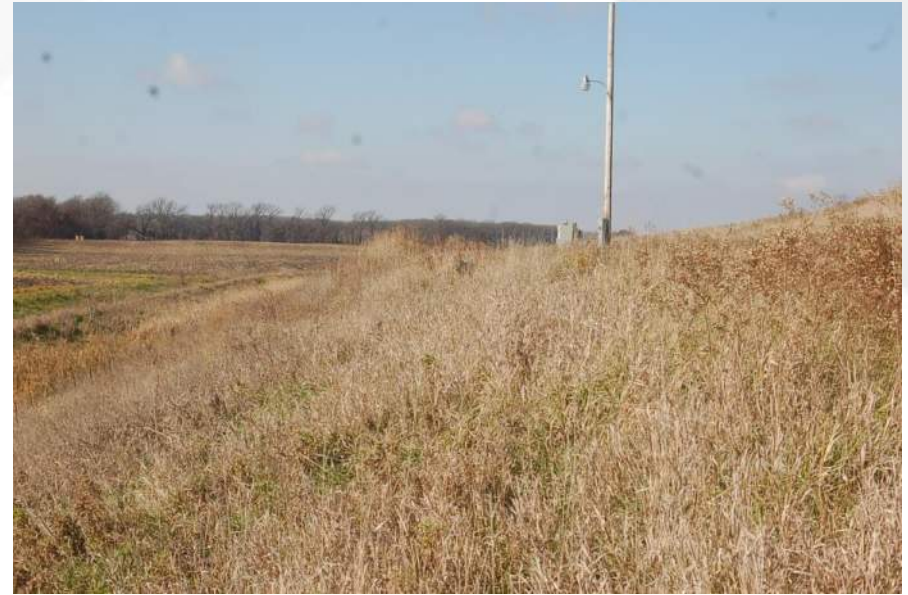
Photo 16 - Phase 2 South Exterior Slope

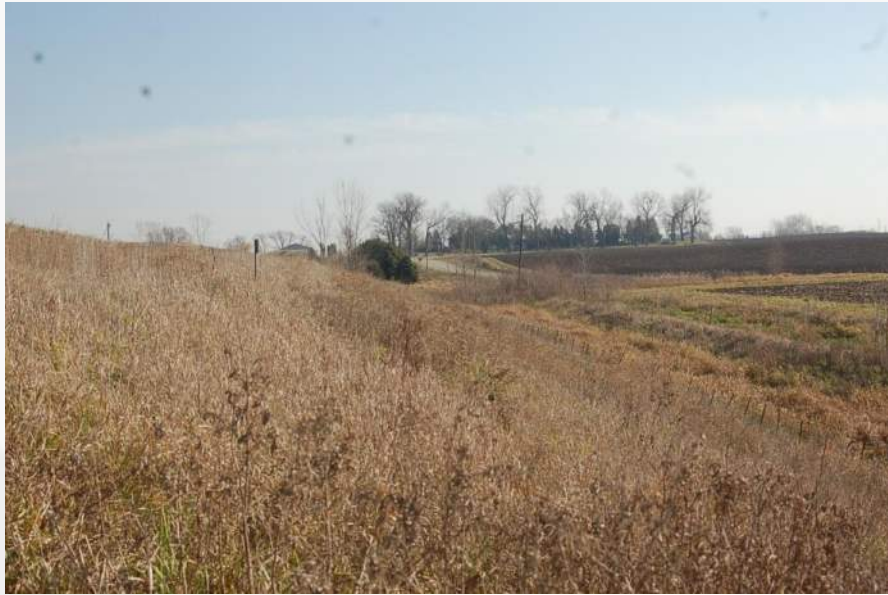
Photo 17 - Phase 2 South Exterior Slope

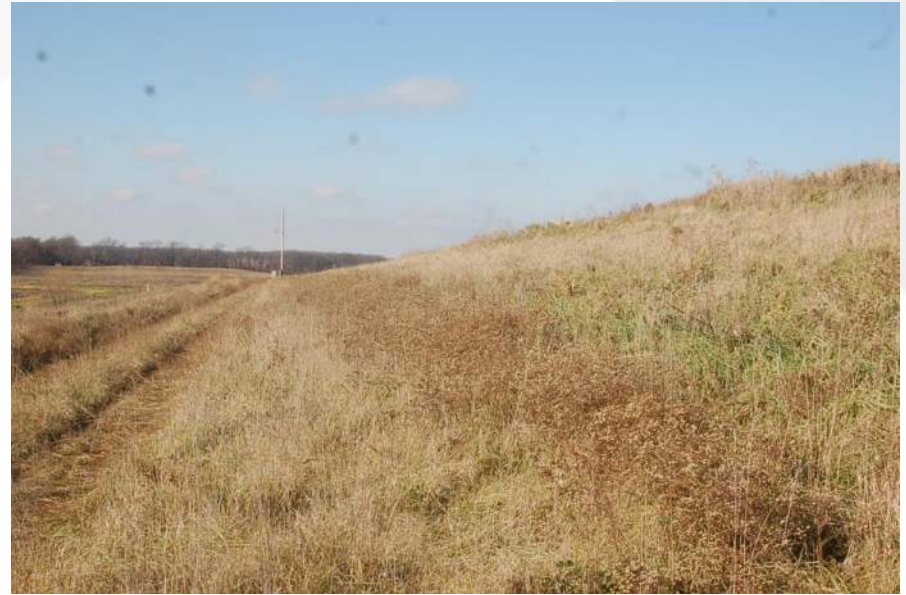
Photo 18 - Phase 2 South Waste Face

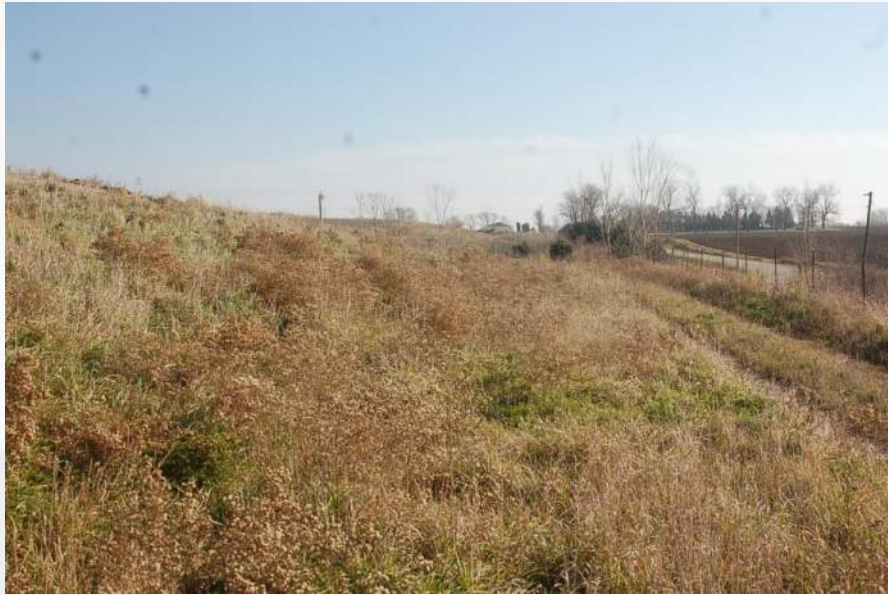
Photo 19 - Phase 2 South Waste Face

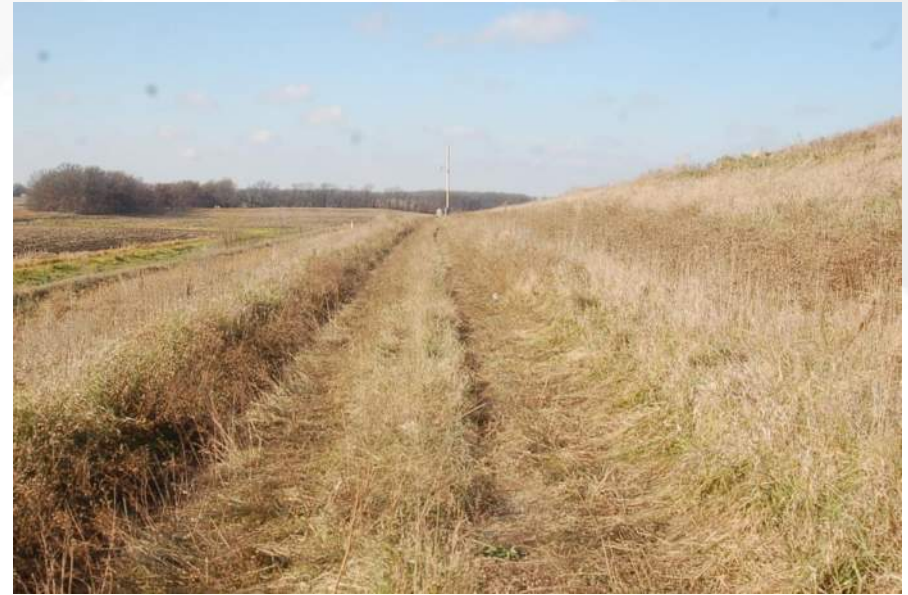
Photo 20 - Phase 2 Top South Berm

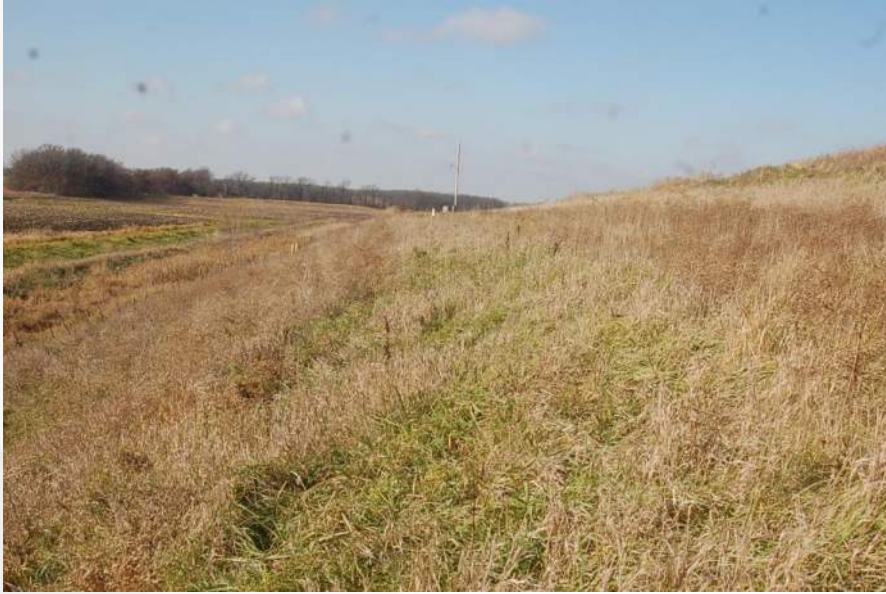
Photo 21 - Phase 2 South Exterior Slope

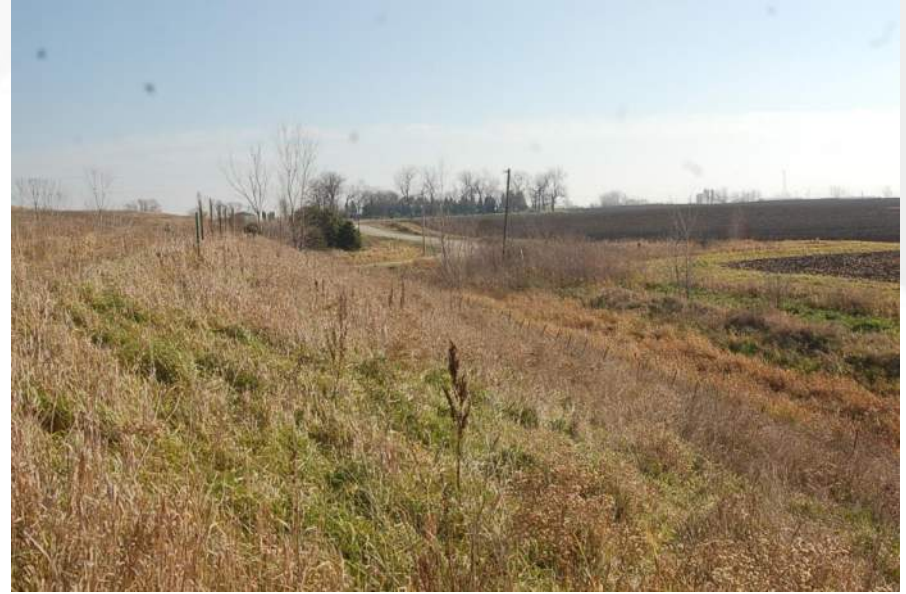
Photo 22 - Phase 2 South Exterior Slope

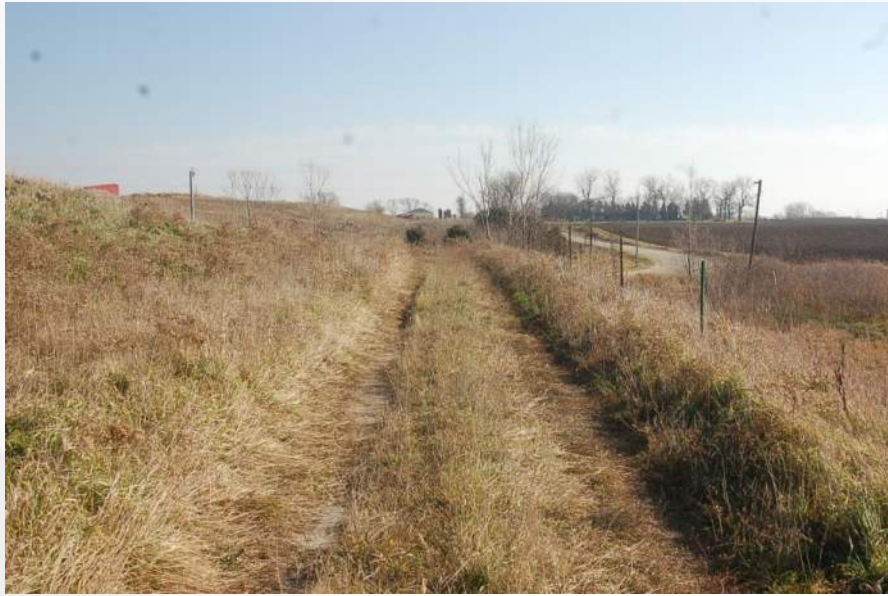
Photo 23 - Phase 2 Top South Berm

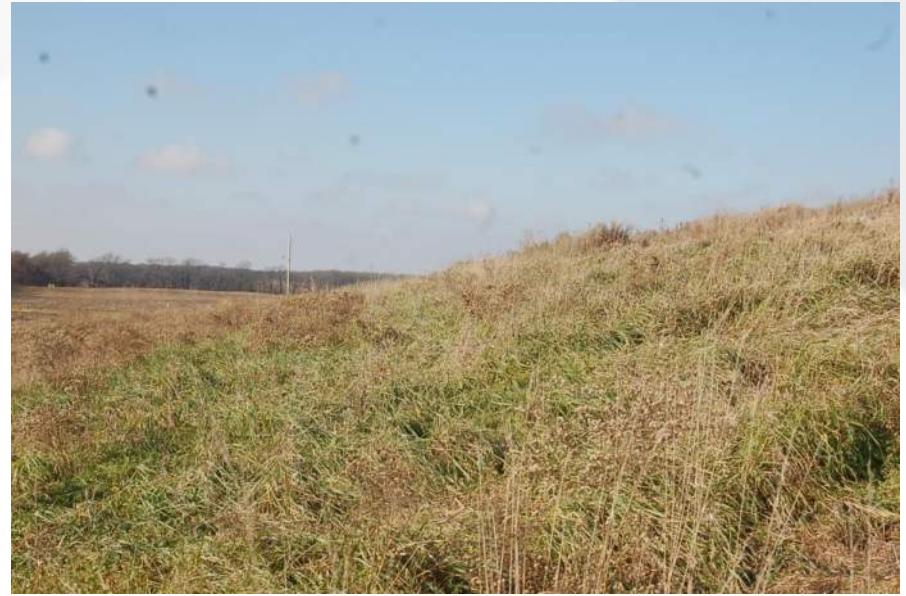
Photo 24 - Phase 2 South Waste Face

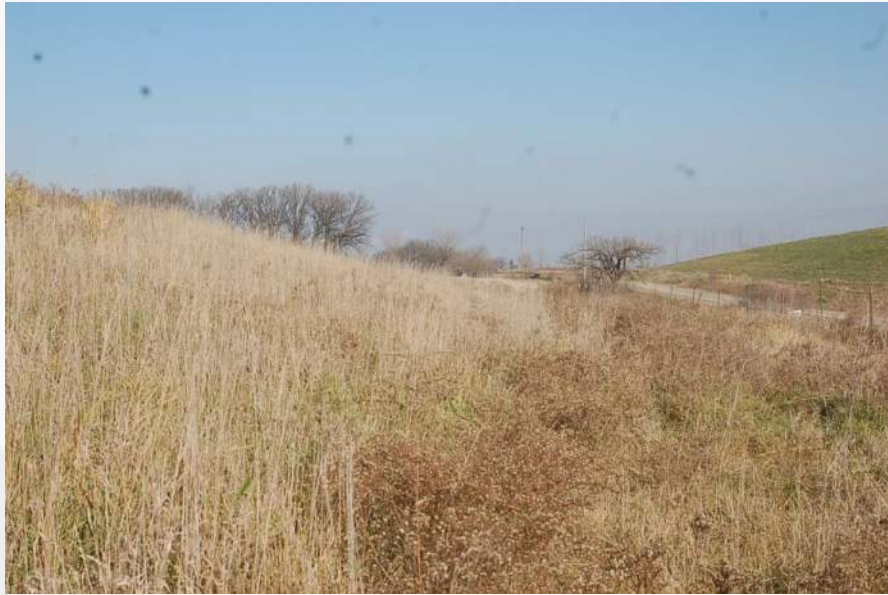
Photo 25 - Phase 2 East Waste Face

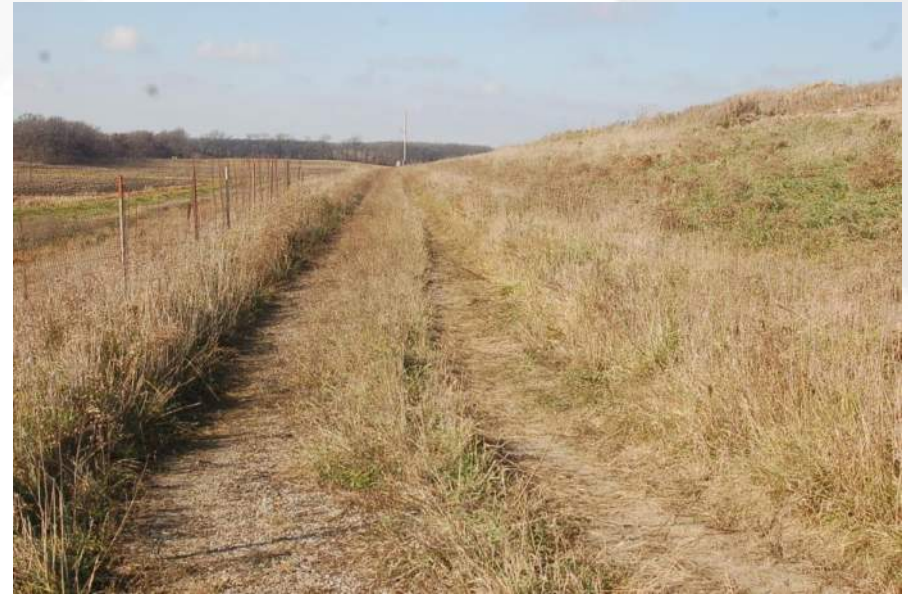
Photo 26 - Phase 2 Top South Berm

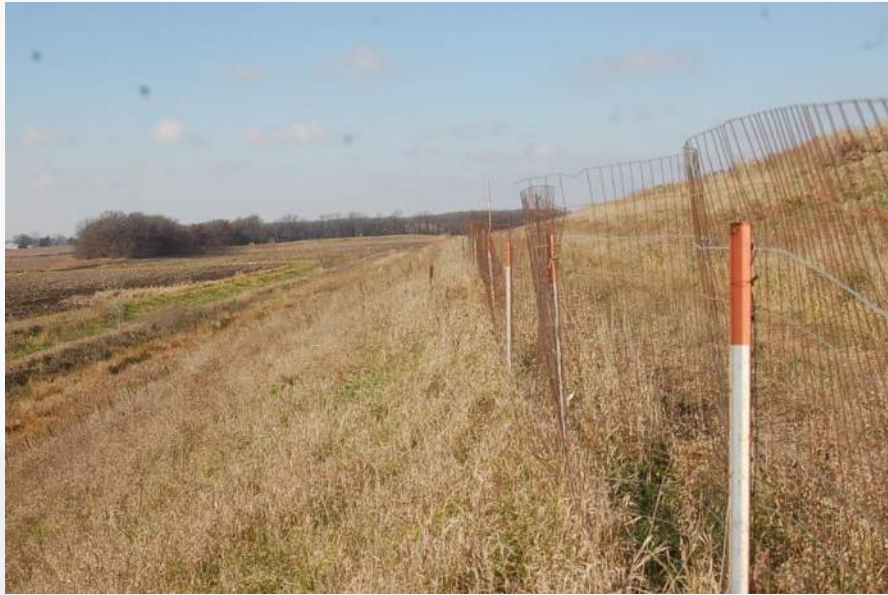
Photo 27 - Phase 2 South Exterior Slope

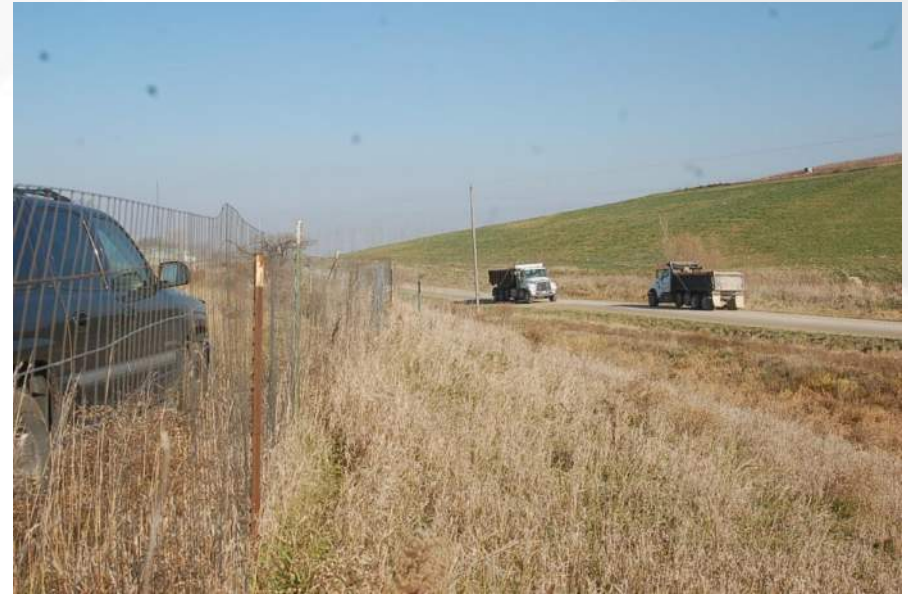
Photo 28 - Phase 2 East Exterior Slope

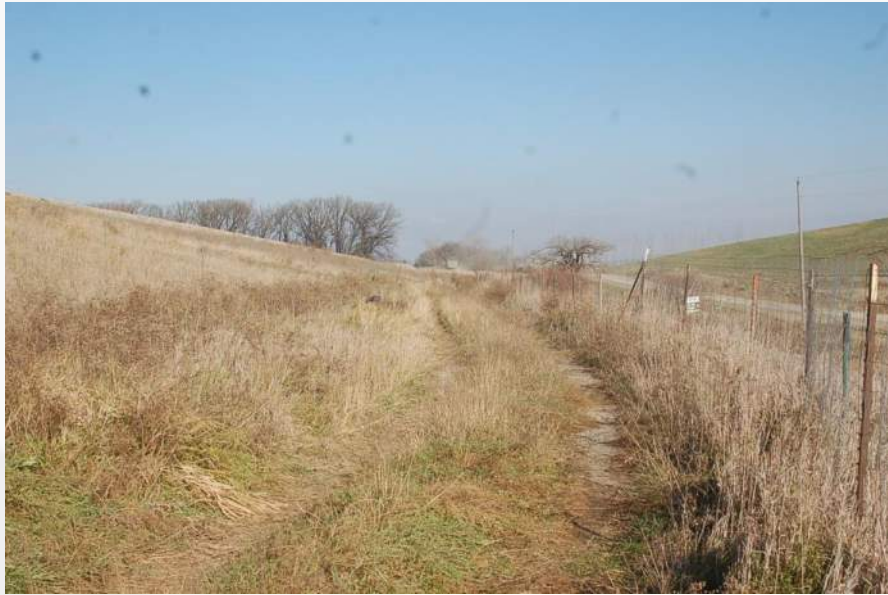
Photo 29 - Phase 2 Top East Berm

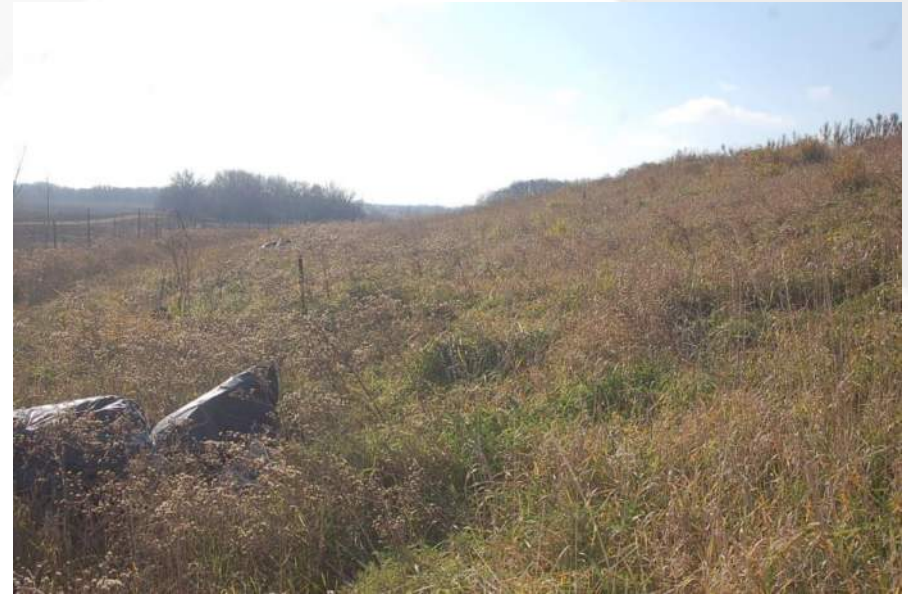
Photo 30 - Phase 2 East Waste Face

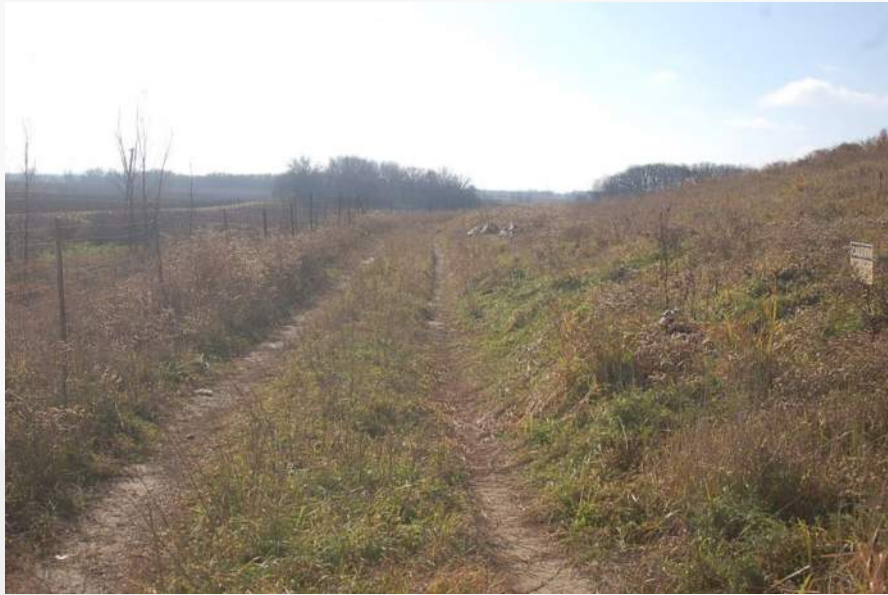
Photo 31 - Phase 2 Top East Berm

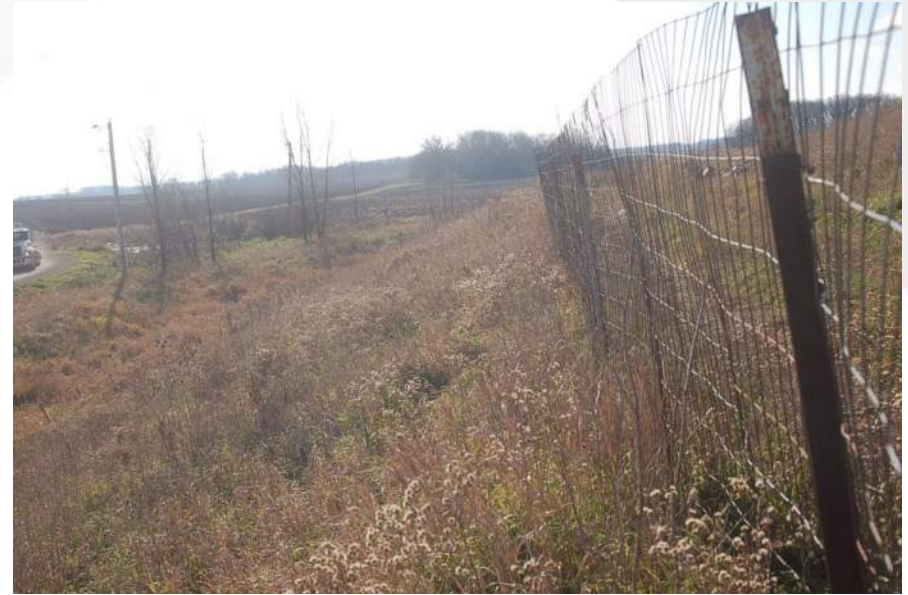
Photo 32 - Phase 2 East Exterior Slope

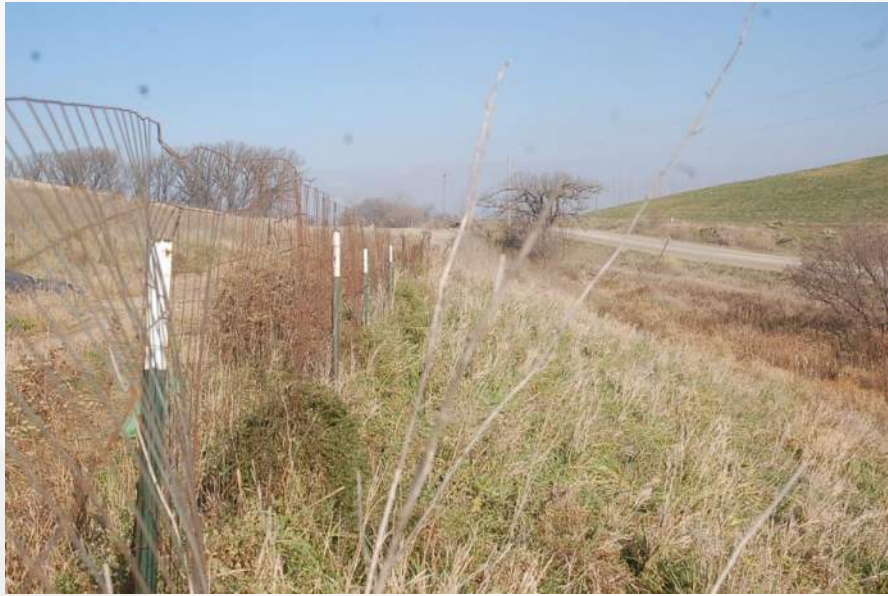
Photo 33 - Phase 2 East Exterior Slope

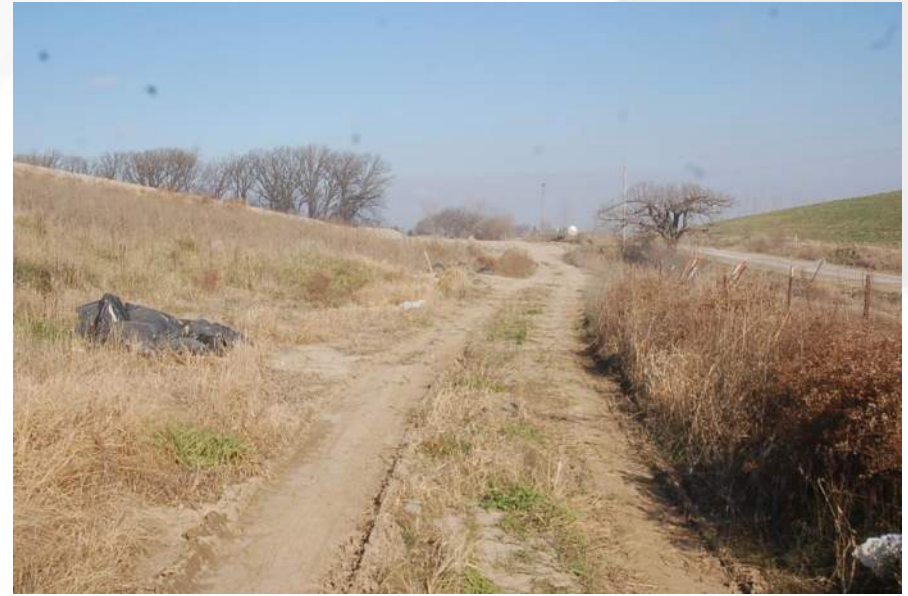
Photo 34 - Phase 2 Top East Berm

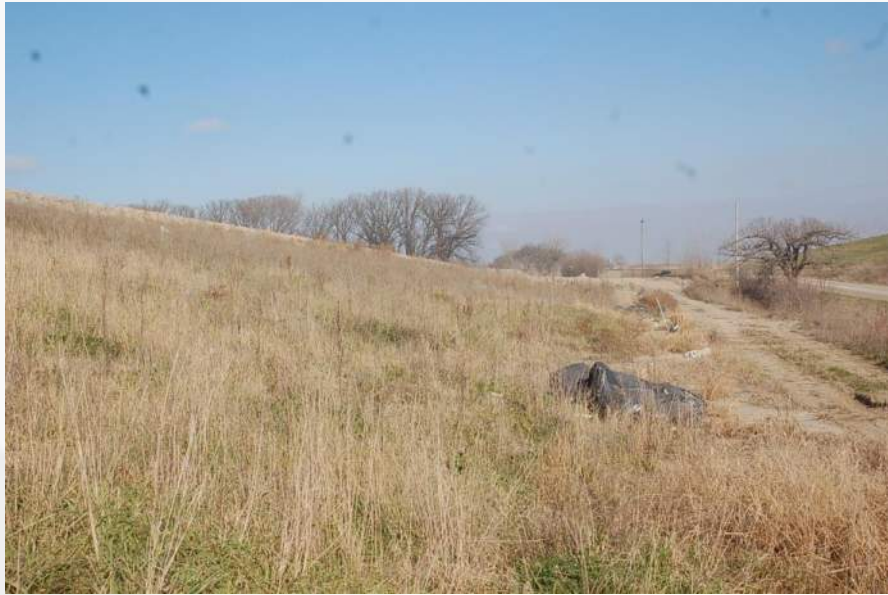
Photo 35 - Phase 2 East Waste Face

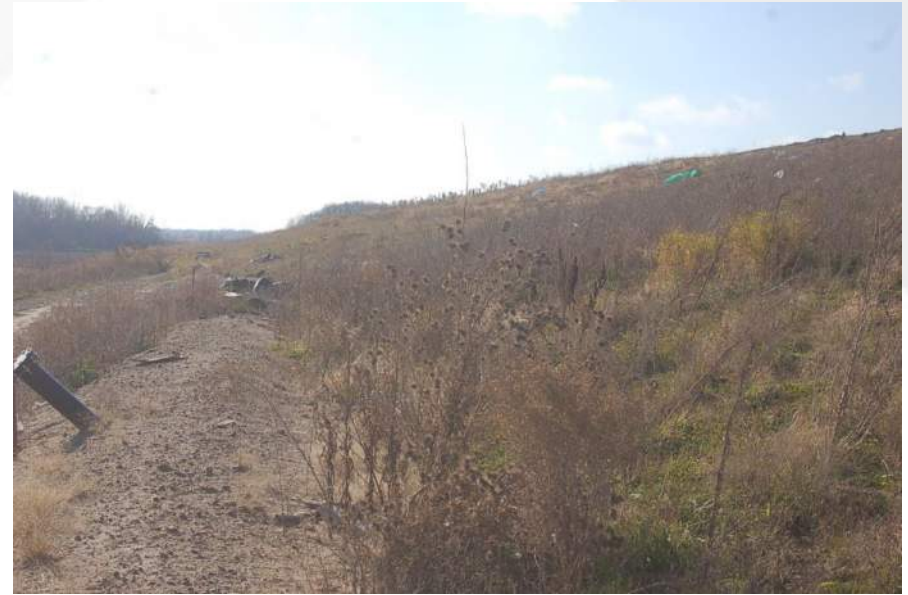
Photo 36 - Phase 2 East Waste Face

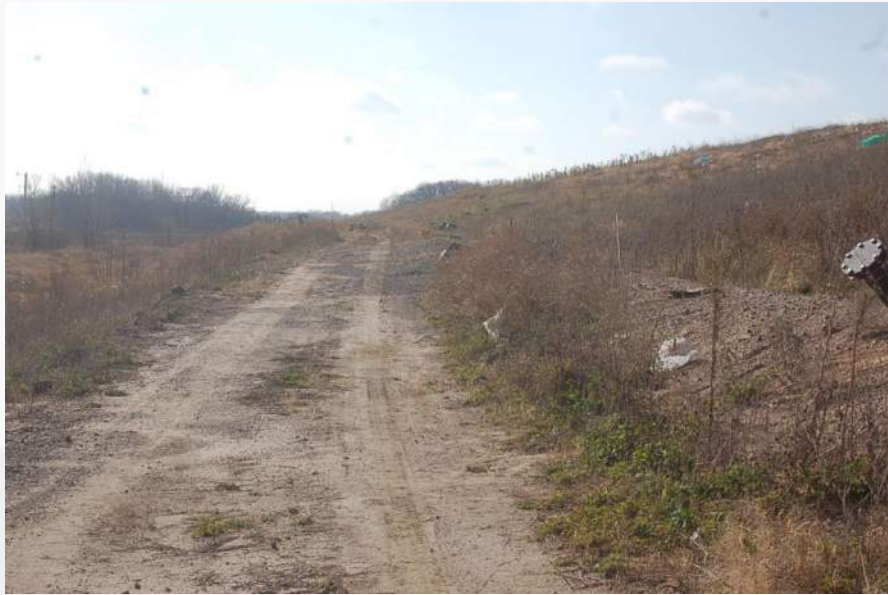
Photo 37 - Phase 2 Top East Berm

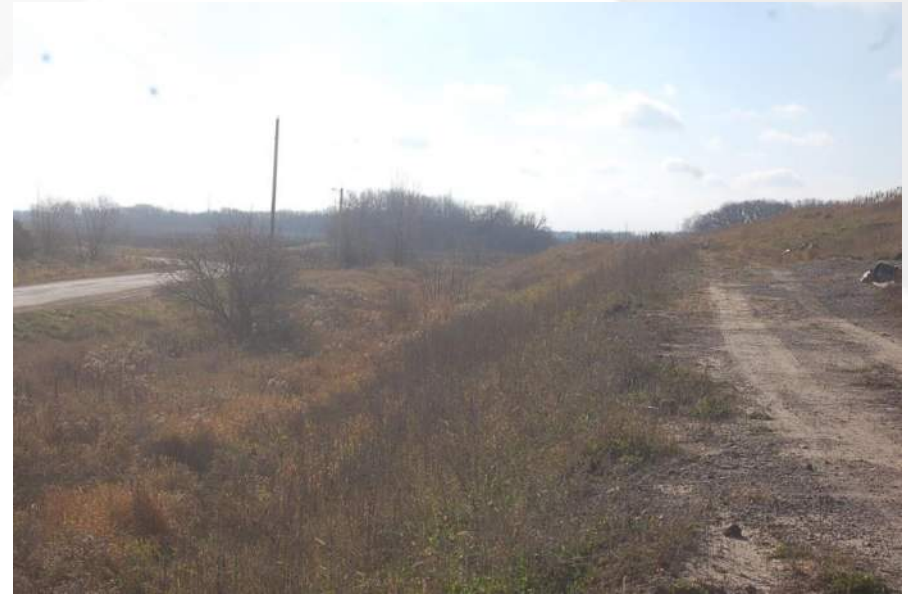
Photo 38 - Phase 2 East Exterior Slope

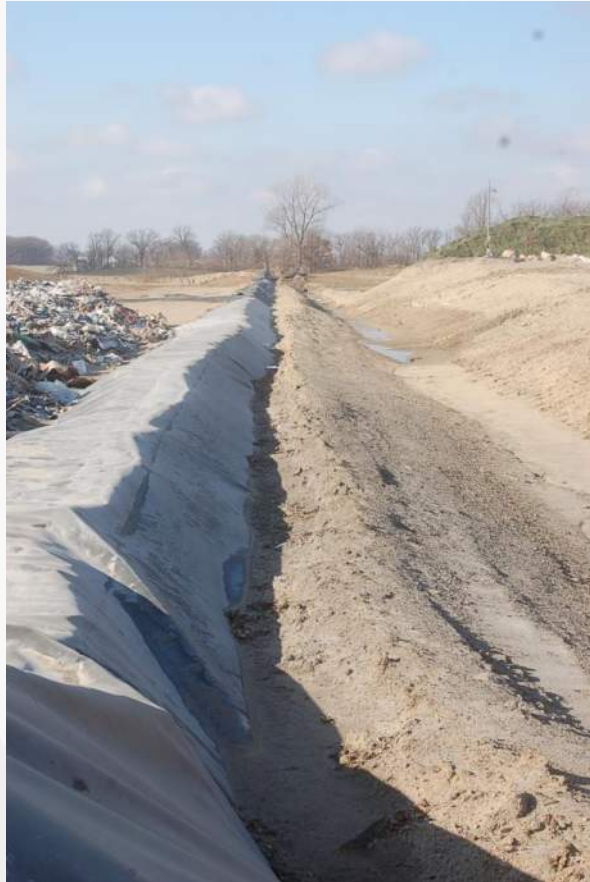
**Photo 39 - Phase 3 North
Temp Berm**
