Technical Memo

Subject: 2017 Annual Inspection SKB Lansing - Report of CCR Landfill Inspection
Wenck Project # B3053-0057

SKB (Austin) Environmental, LLC owns and operates the SKB Lansing Landfill, a Class III facility operating under MPCA Solid Waste Permit SW-514, originally issued in 1996.

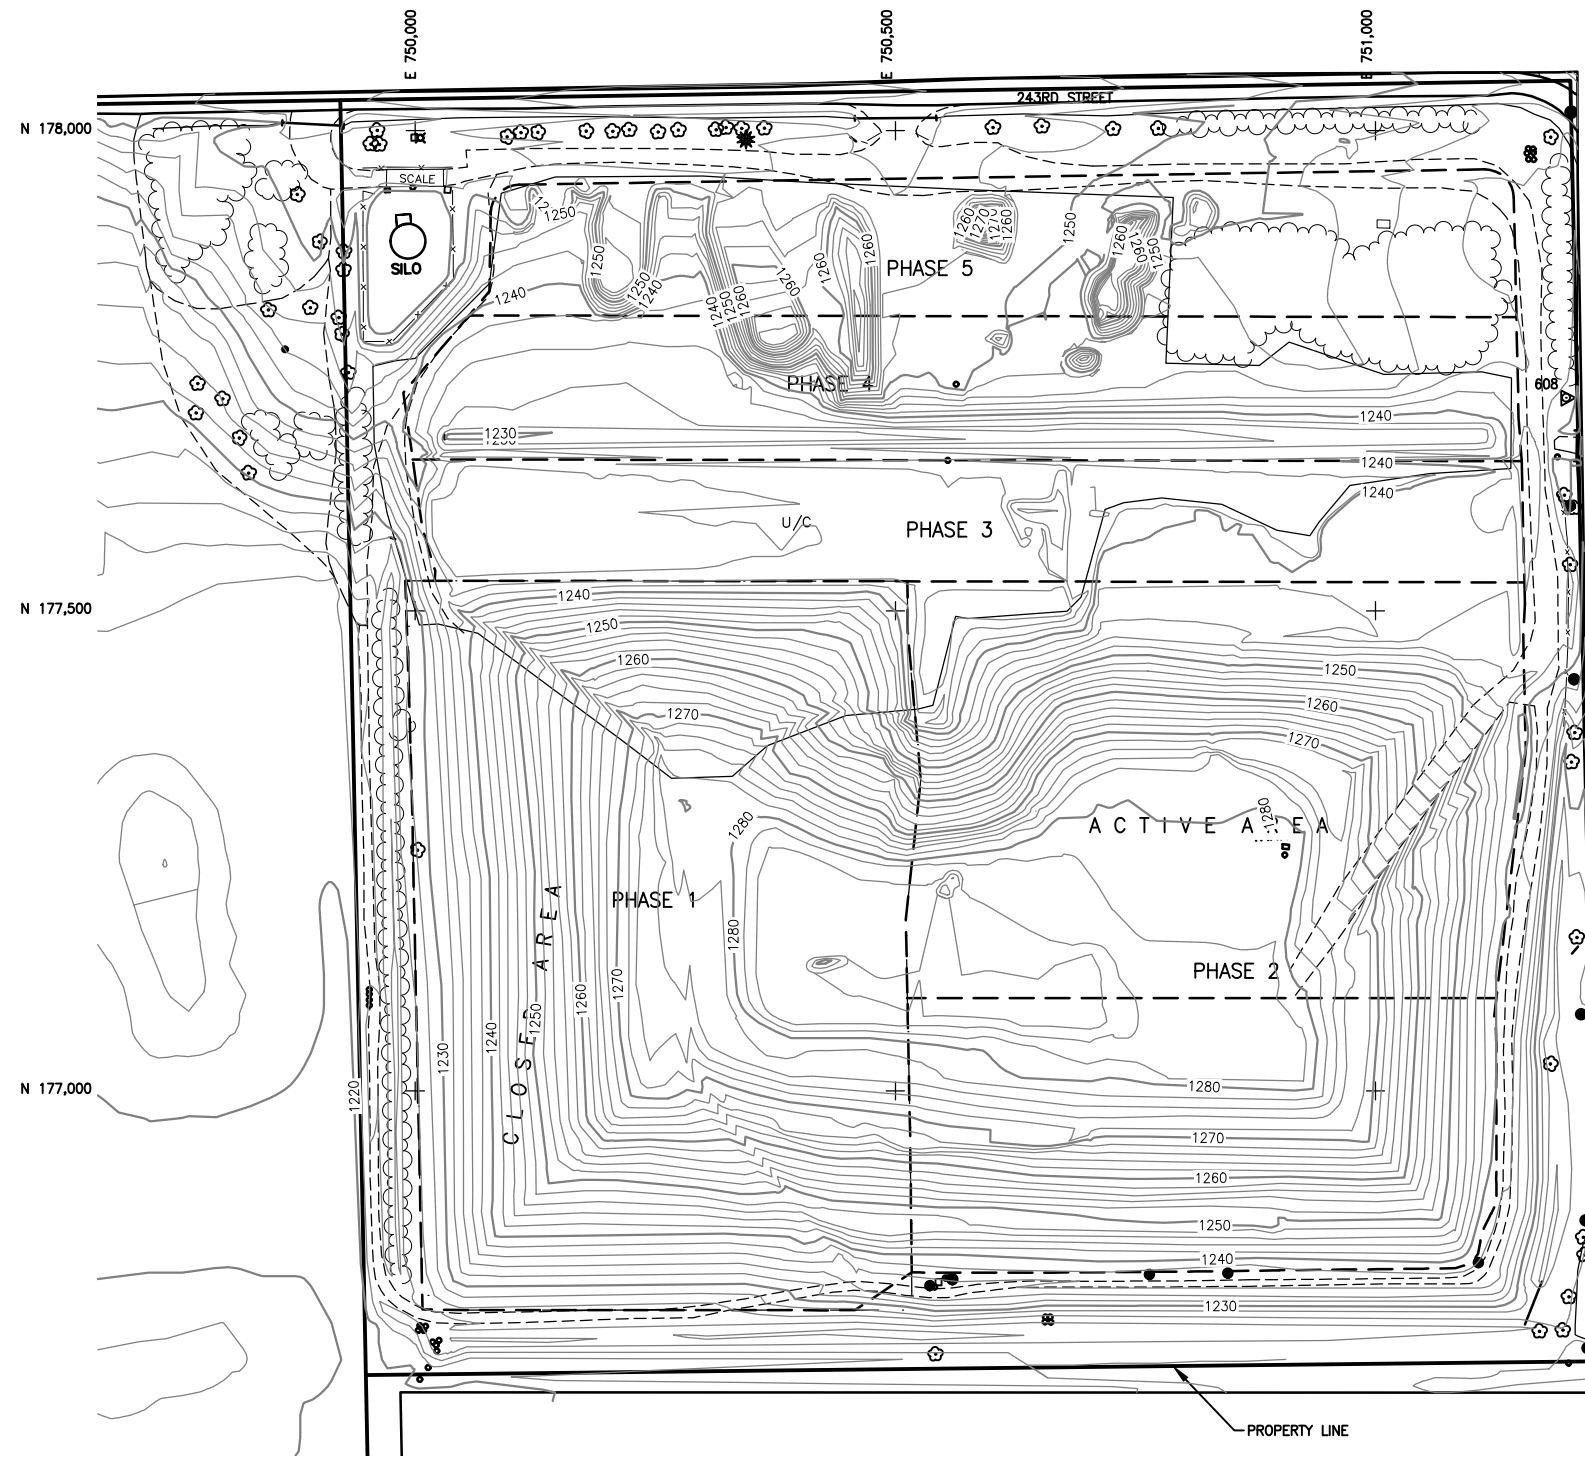
SHEET TITLE			
NOVEMBER 2016 TOPOGRAPHY			
DWN BY	CHK'D	APP'D	DWG DATE
JVB	DMP	DMP	DEC. 2016
PROJECT NO.		SCALE	
3052-0057		AS NOTED	
SHEET NO.		REV NO.	
FIGURE 3

There were no apparent changes from the geometry of the impoundment when compared to the permit drawings or the past construction documentation reports. Also, the recent aerial survey done in November, 2016 shows that the topography of the embankments has stayed straight and true. This is shown on Figure 3.
