Technical Memo

Date: January 9, 2018

Subject: 2018 Annual Inspection SKB Lansing - Report of CCR Landfill Inspection
Wenck Project # B3053-0094

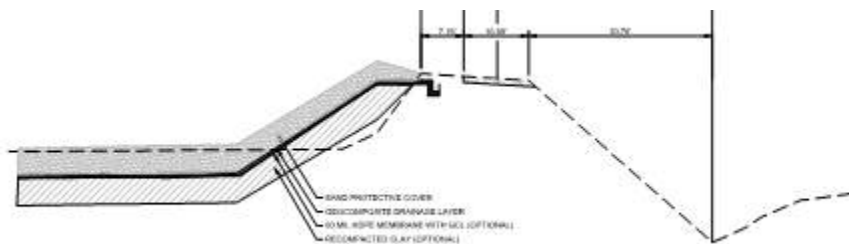
The landfill cell embankments were constructed using on-site and import controlled fill materials, and compacted in lifts. A typical perimeter section, taken from the Cell 2, Phase 2 Construction Documentation Report, prepared by CRA in November, 2012 is shown below.

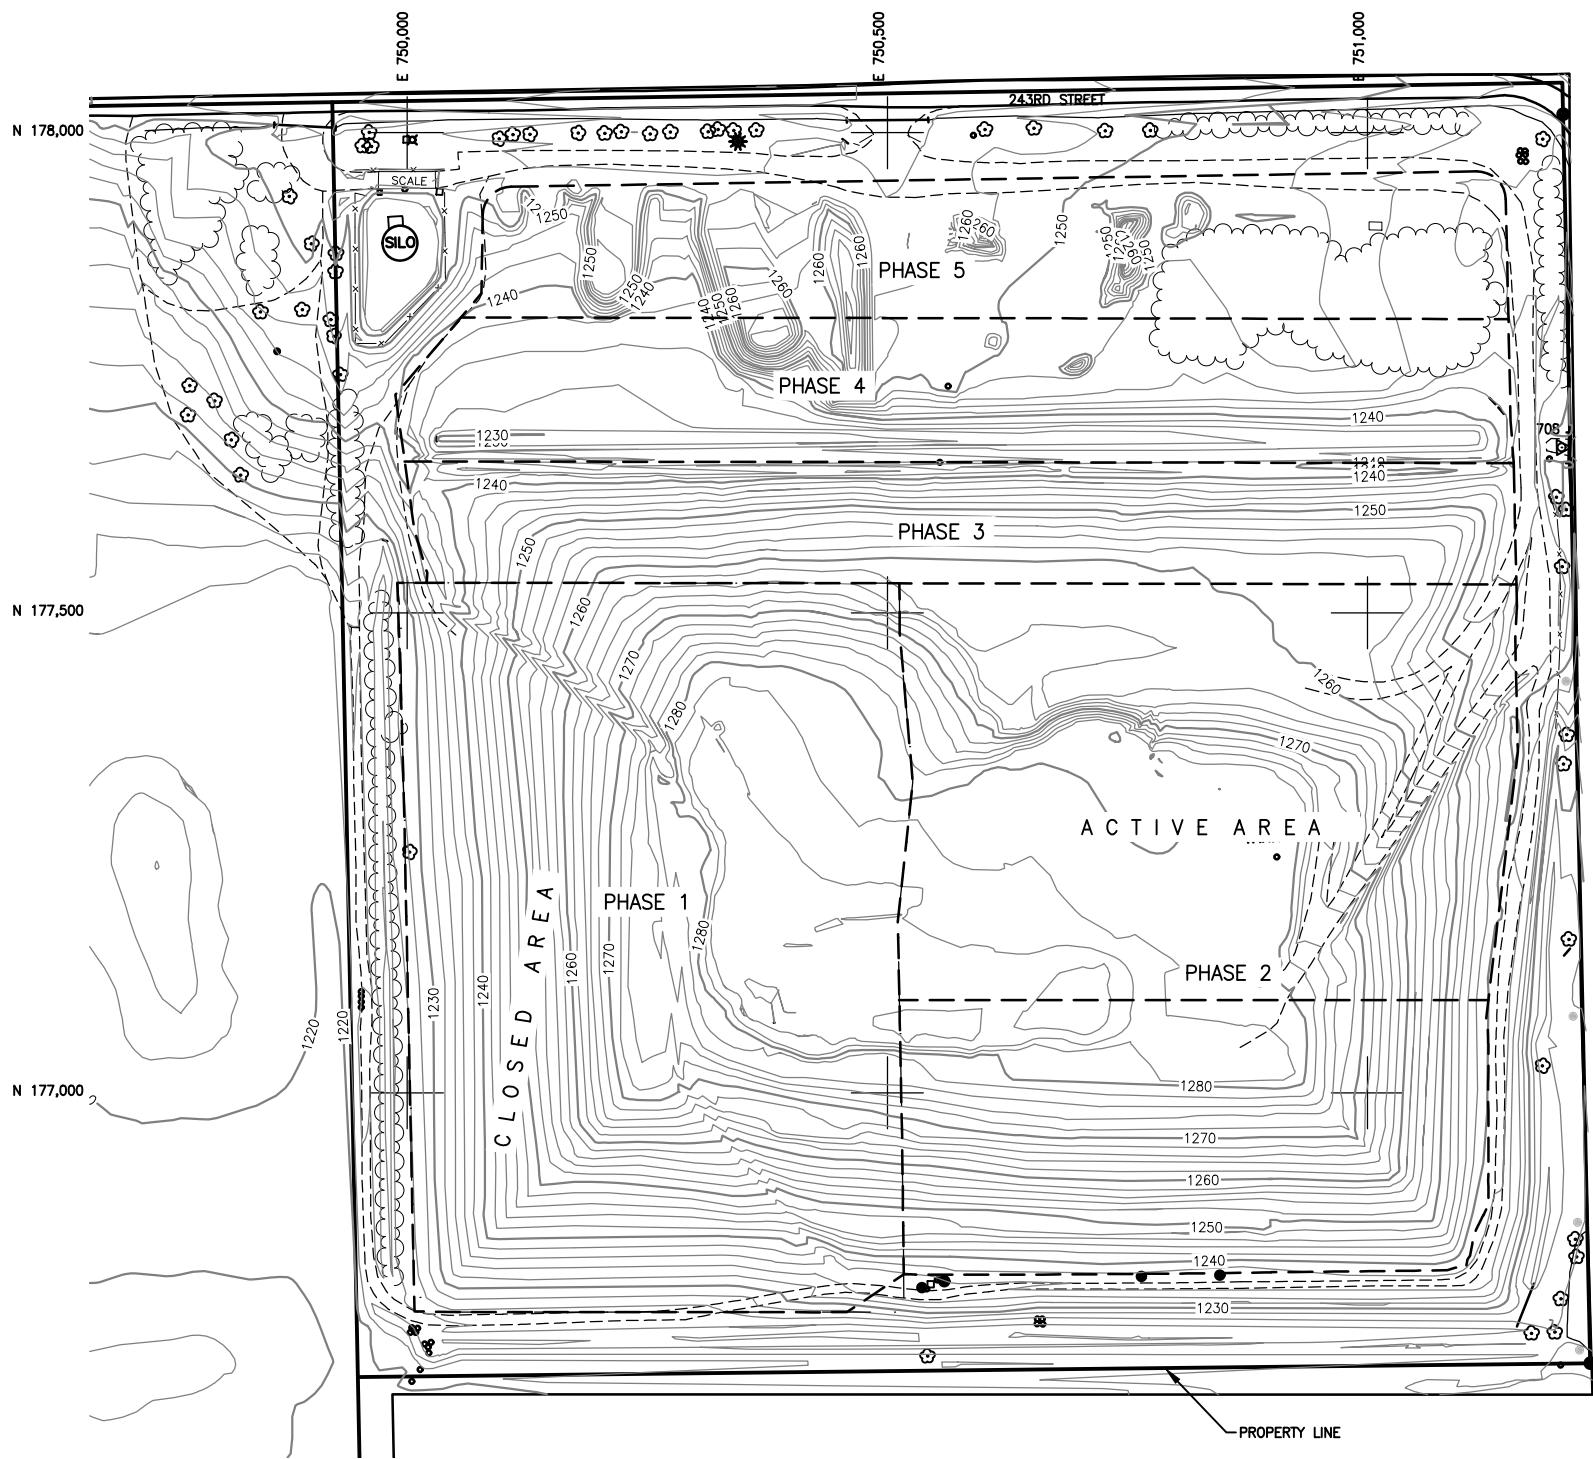
SHEET TITLE		NOVEMBER 2017 TOPOGRAPHY	
DWN BY	CHK'D	APP'D	DWG DATE
JVB	DMP	DMP	DEC. 2017
PROJECT NO.		SCALE	
3052-0094		AS NOTED	
SHEET NO.		REV. NO.	
FIGURE 3		0

There were no apparent changes from the geometry of the impoundment when compared to the permit drawings or the past construction documentation reports. Also, the recent aerial survey done in November, 2017 shows that the topography of the embankments has stayed straight and true. This is shown on Figure 3.
