Technical Memo

To: Geoff Strack, P.E., Waste Connections
From: Brad Sullivan, P.E., Wenck Associates, Inc.
Date: January 9, 2019
Subject: WCI Austin Landfill, LLC – 2018 Annual CCR Inspection
Wenck Project # B3053-0139

PROJECT TITLE
2018 CCR INSPECTION REPORT

WCI AUSTIN LANDFILL, LLC
 AUSTIN, MINNESOTA

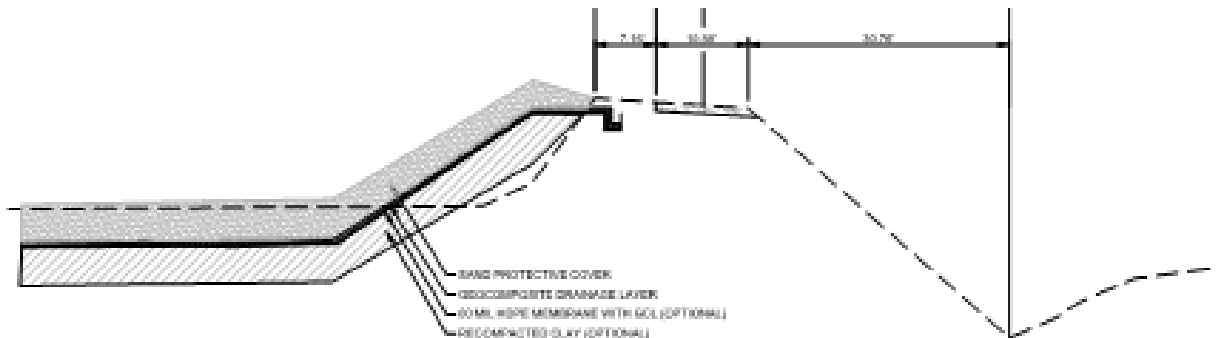
Typical Landfill Berm Detail

In general, the facility's landfill cell embankments were constructed using on-site and imported borrow materials. A typical perimeter section, taken from the Cell 2, Phase 2 Construction Documentation Report, prepared by CRA in November, 2012 is shown below.

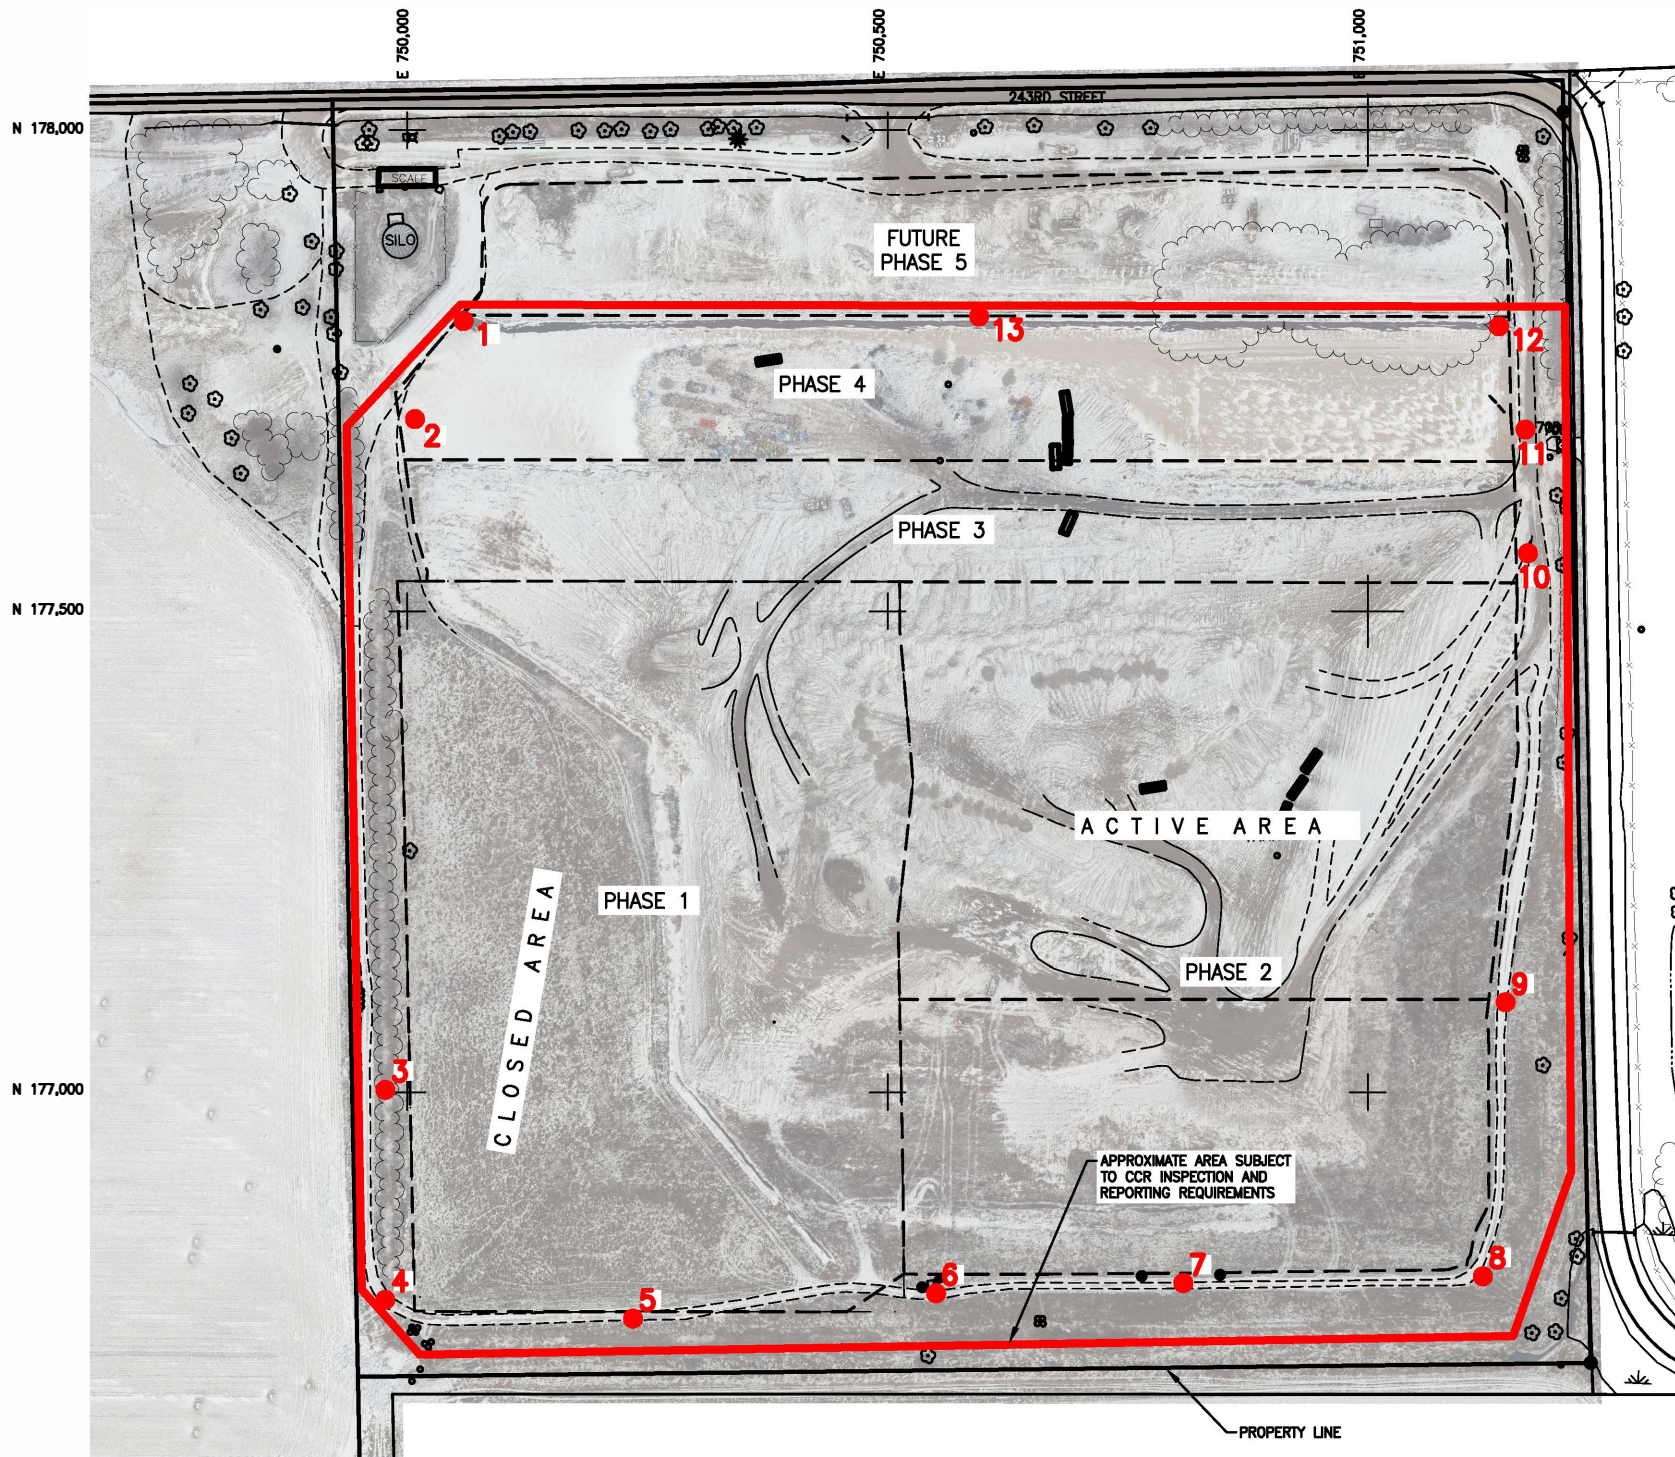
SHEET TITLE				
PHOTO LOCATIONS				
DWN BY	CHK'D	APP'D	DWG DATE	JAN. 2019
JVB	DMP	DMP	SCALE	AS NOTED
PROJECT NO.	SHEET NO.	REV NO.		
3053-0139	FIGURE 1	0

Photos were taken during the inspection. Figure 1 presents the photo locations, and Attachment 1 contains a photo log and the photos taken.

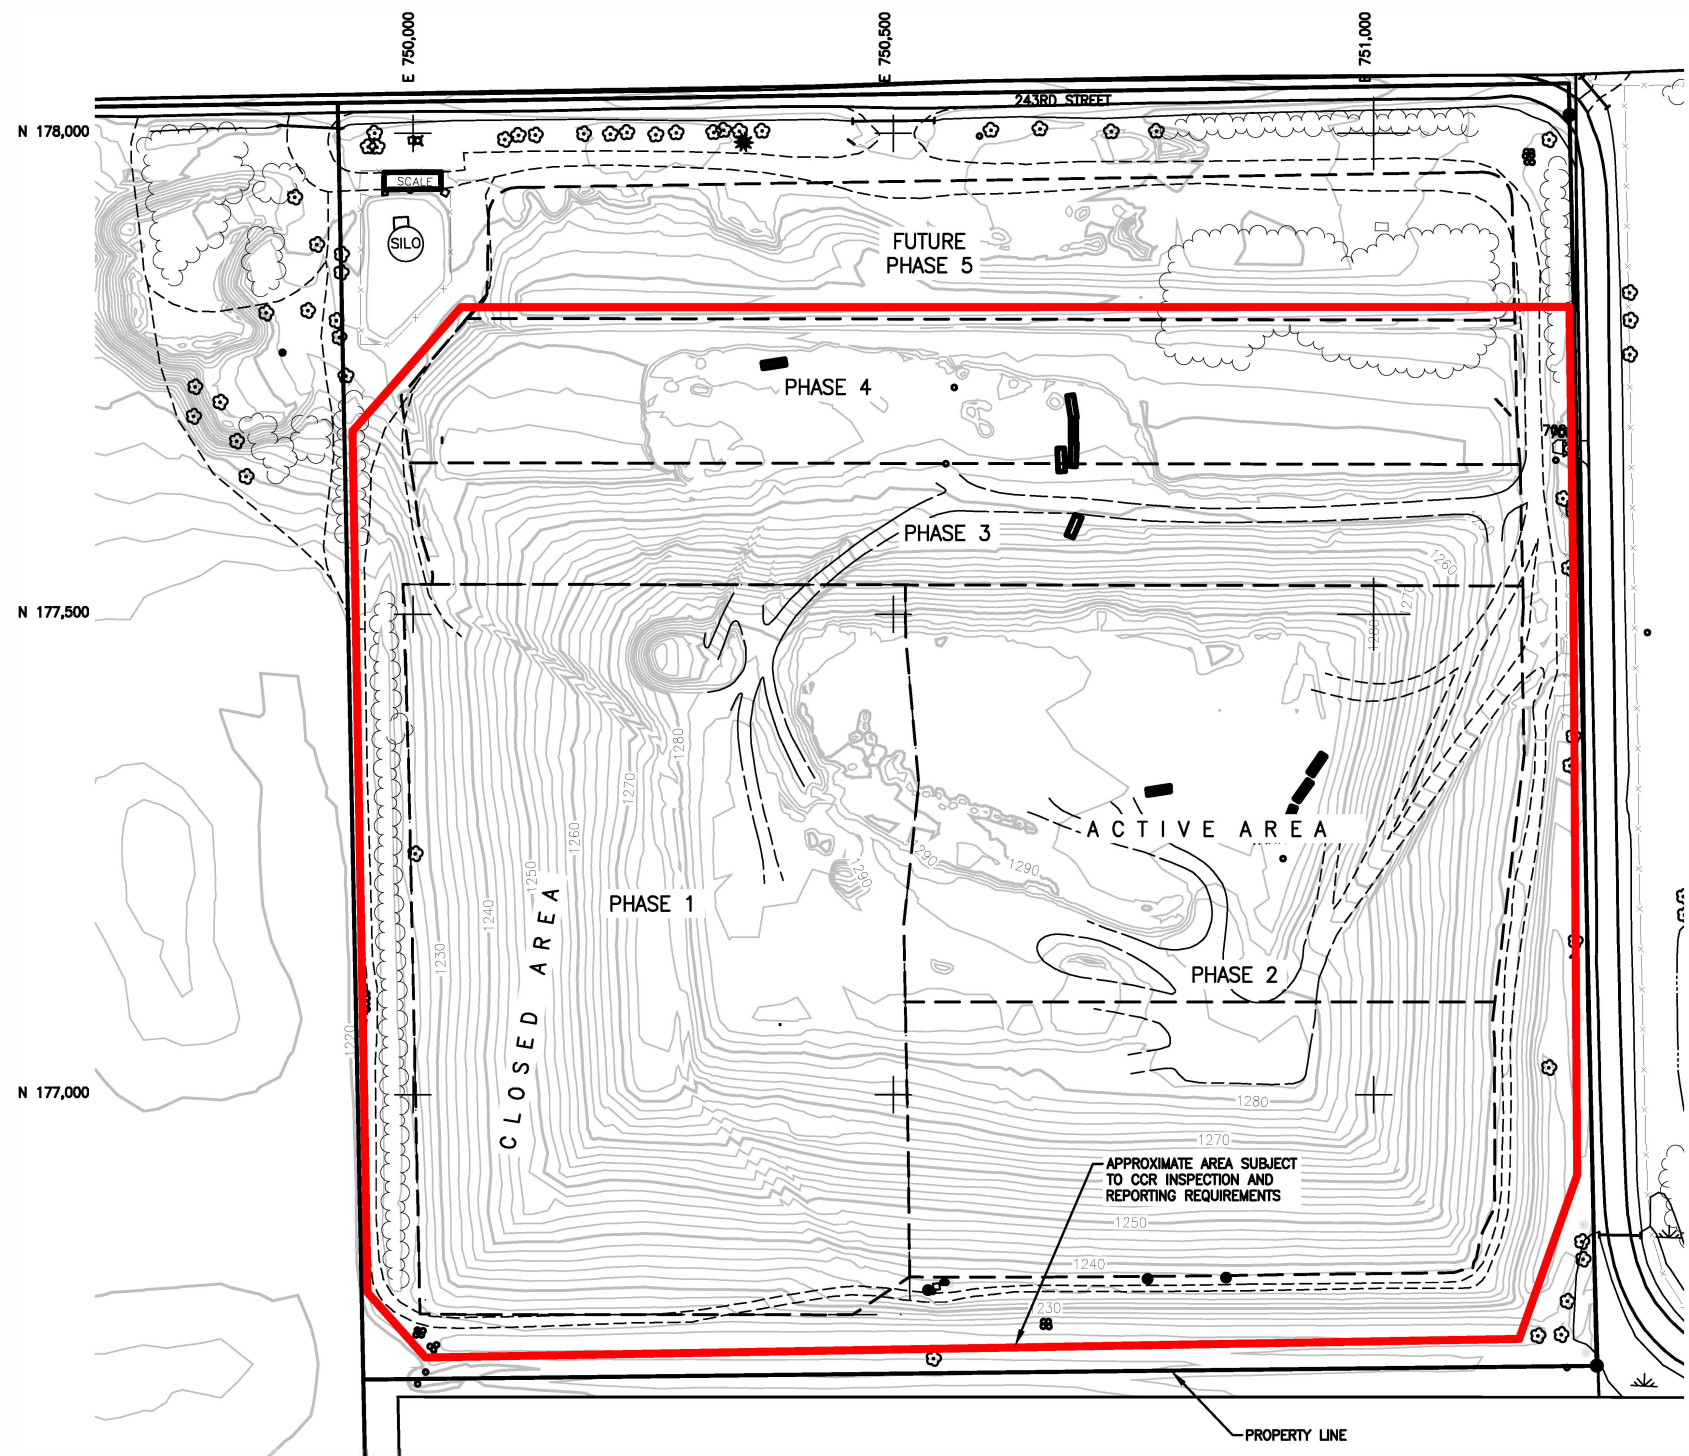
SHEET TITLE			
SITE MAP			
DWN BY	CHK'D	APP'D	DWG DATE
JVB	DMP	DMP	JAN. 2018
PROJECT NO.		SCALE	
3053-0139		AS NOTED	
SHEET NO.		REV NO.	
FIGURE 2		0

The annual aerial photogrammetry survey was performed on November 12, which the estimated in-place volume is based on. A comparison 2018 and 2017 aerial survey confirm that the embankment and slope topography is substantially unchanged with no significant movement. The 2018 aerial survey is included as Figure 2.

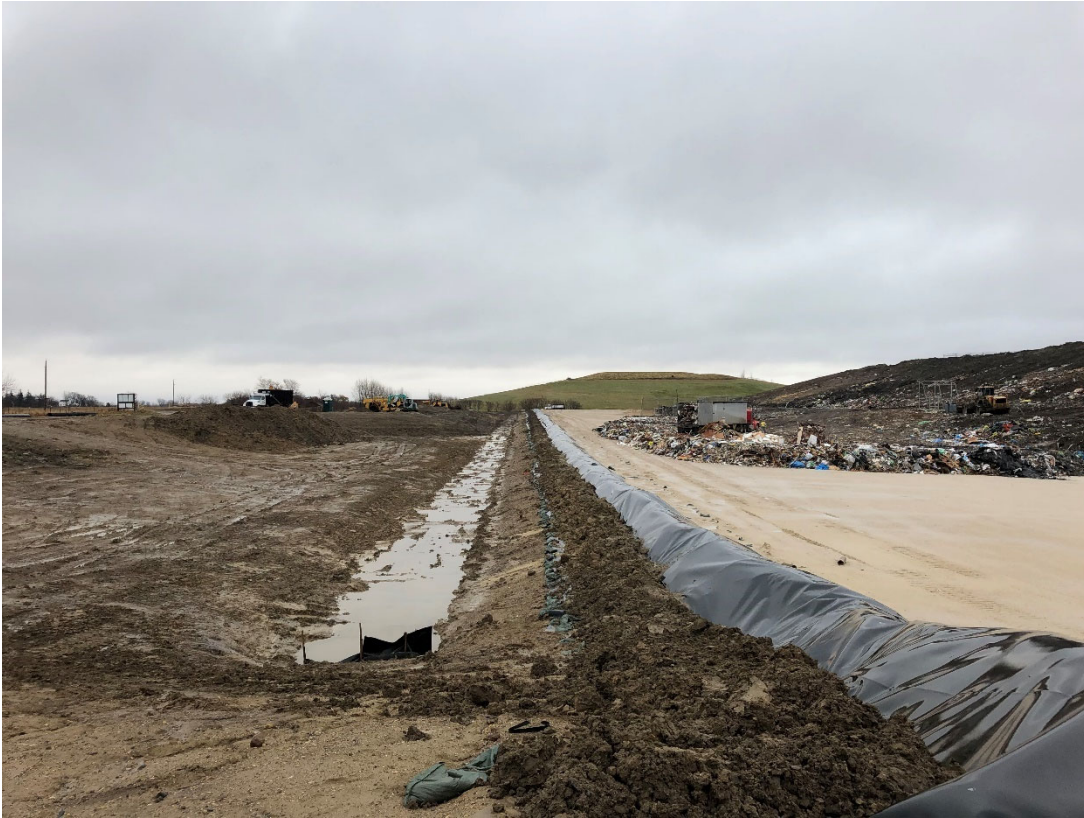
Photo 1: Location 1 – Looking East, Phase 4 Northern Rain Flap

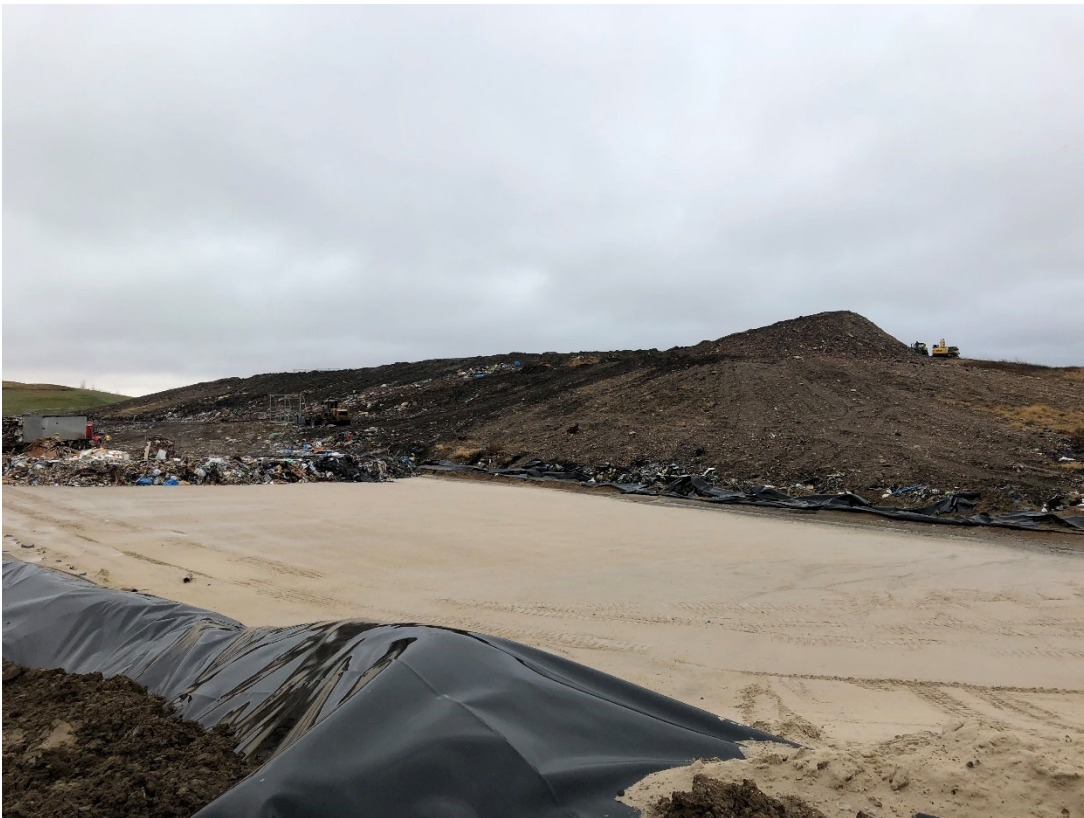
Photo 2: Location 1 – Looking Southeast, New Phase 4 Cell & Phase 3 Waste Slope

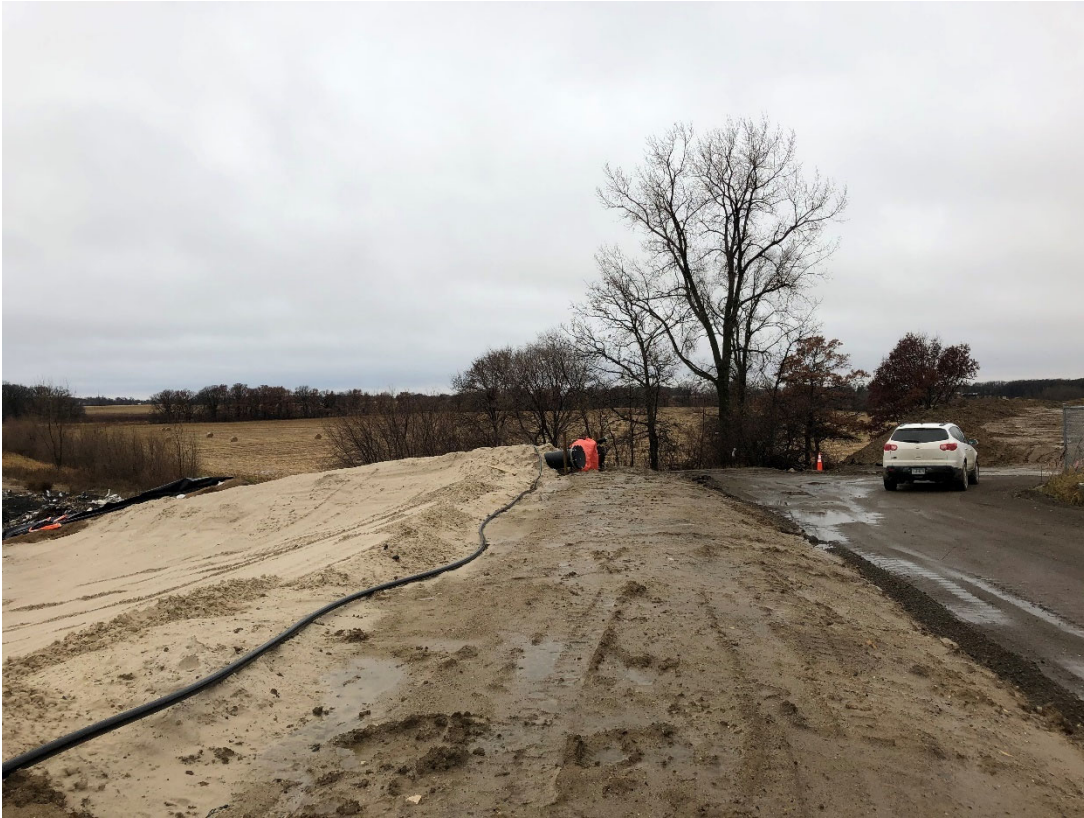
Photo 3: Location 1 – Looking Southwest, Phase 4 Anchor Trench

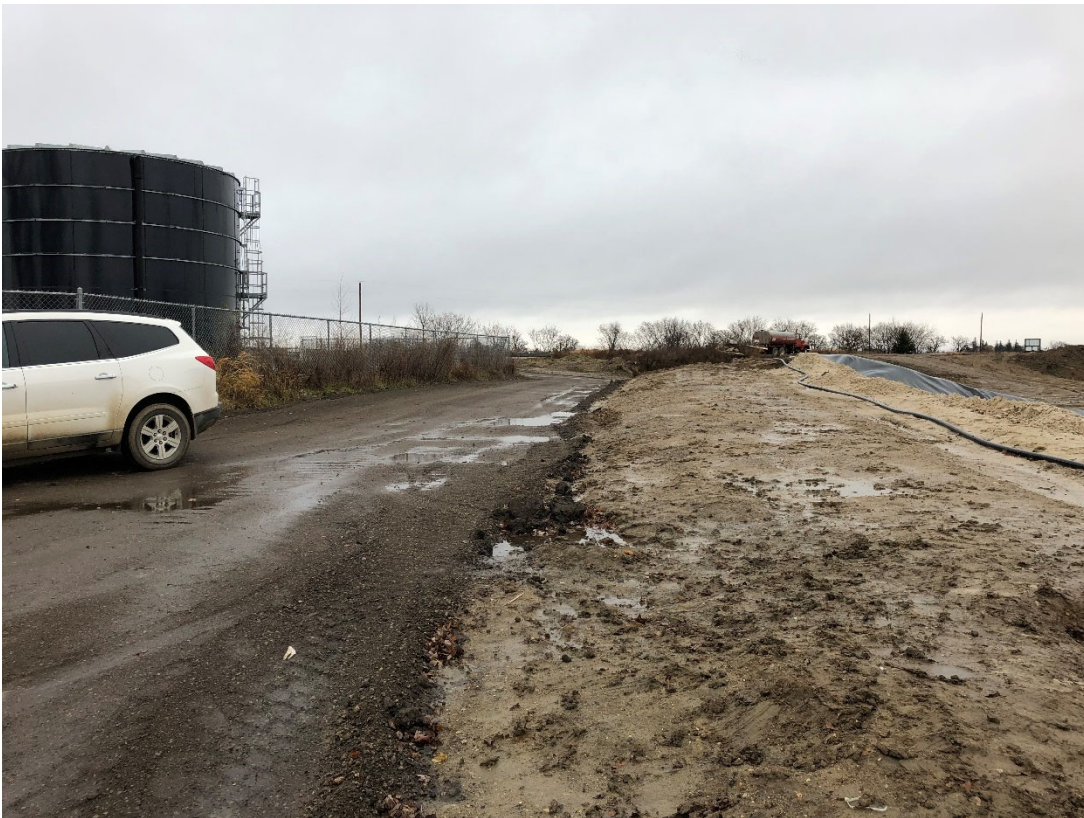
Photo 4: Location 2 – Looking Northeast, Phase 4 Anchor Trench

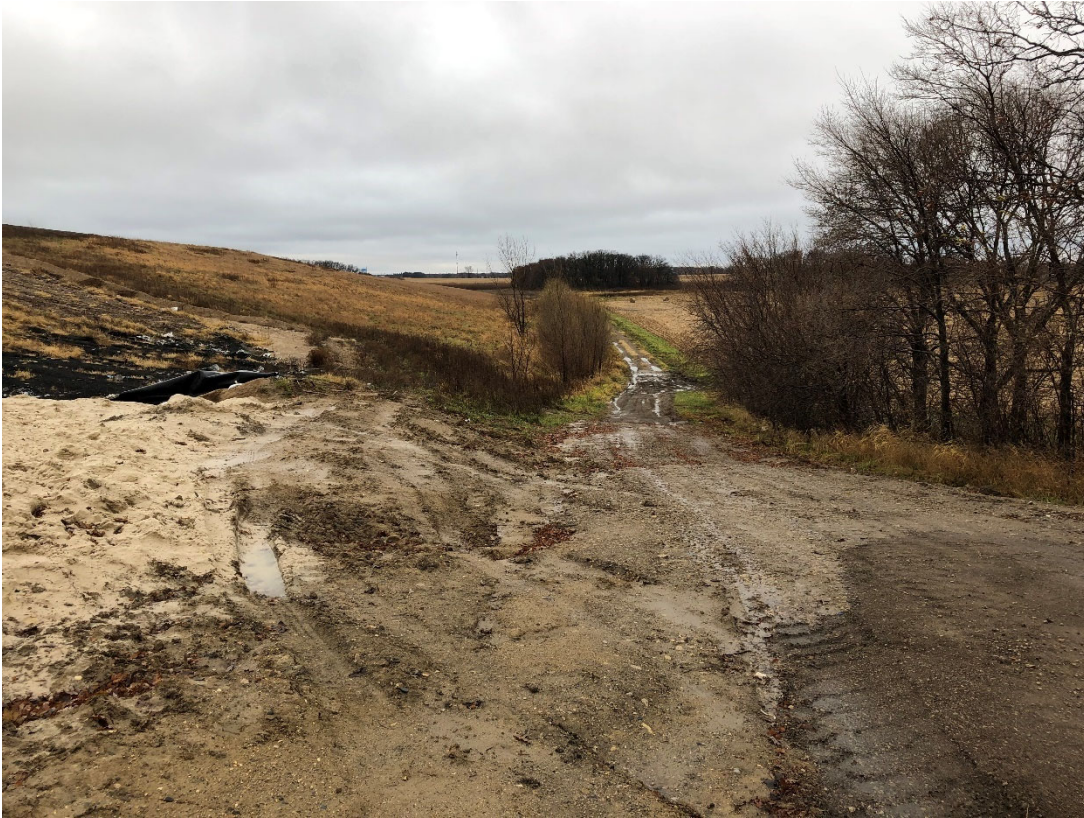
Photo 5: Location 2 – Looking South, Phase 3/1 Western Perimeter

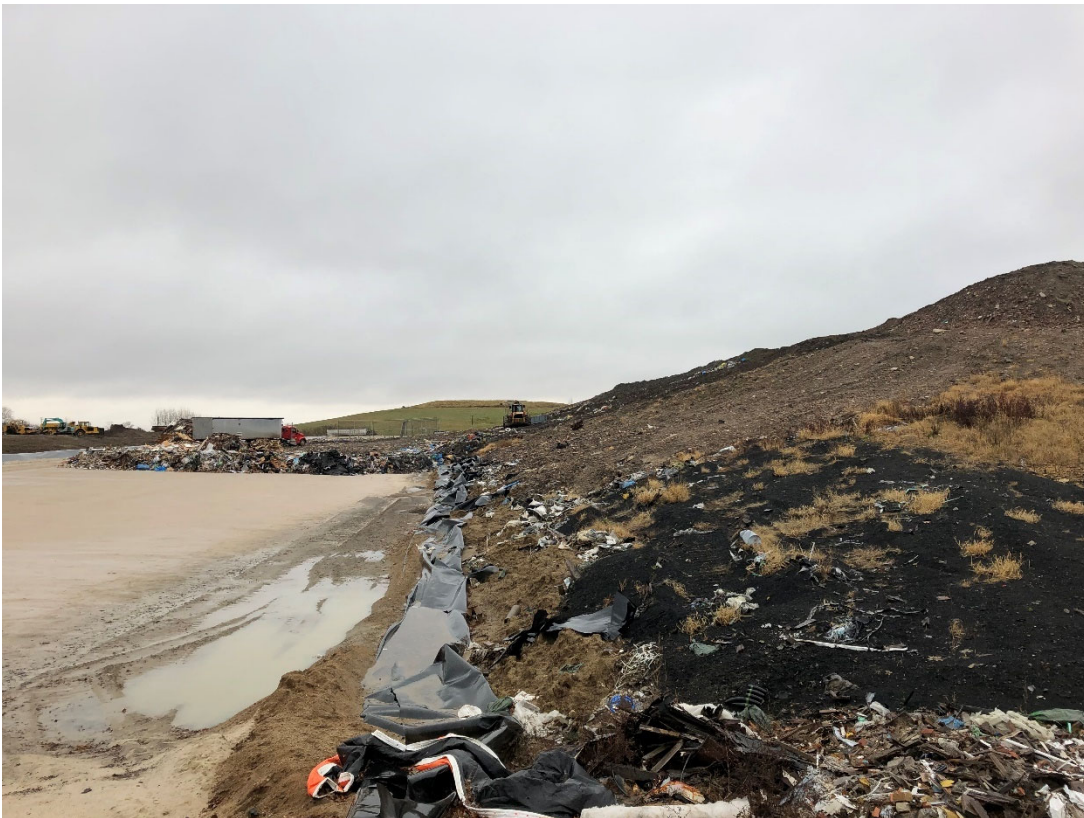
Photo 6: Location 2 – Looking East, Phase 4/3 Connection & Phase 3 Northern Interior Slope

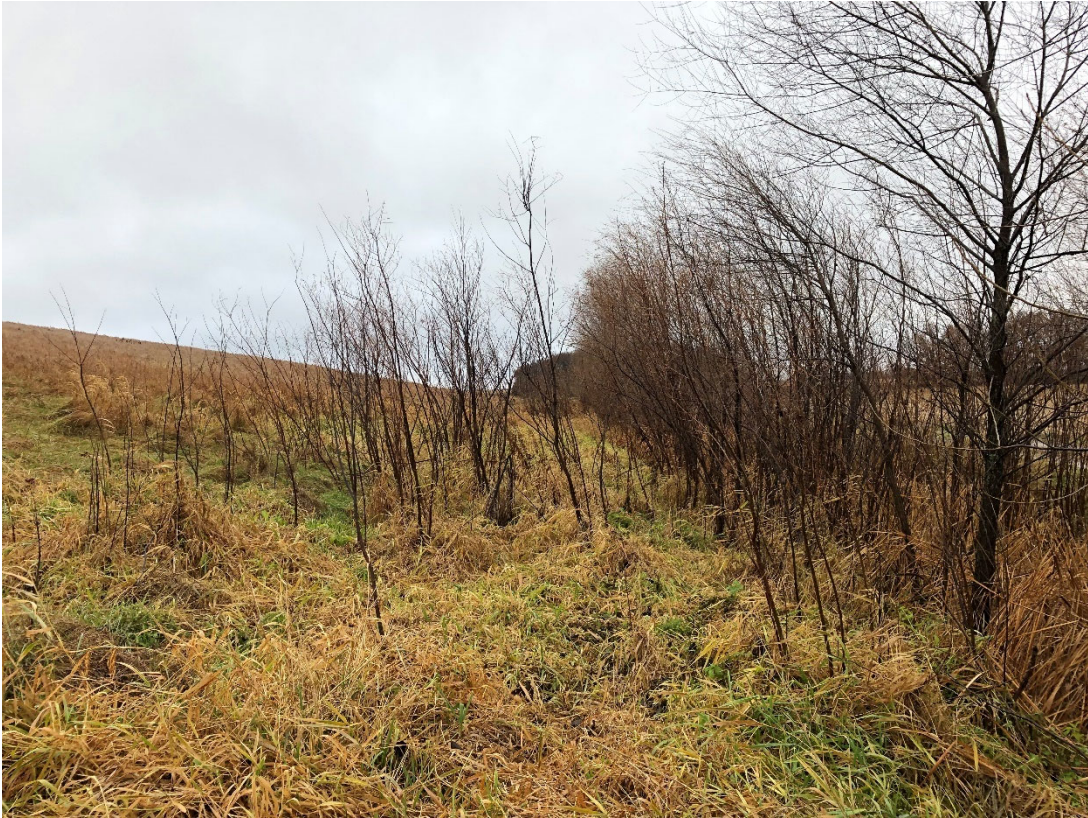
Photo 7: Location 3 – Looking South, Toe of Phase 1 Western Slope

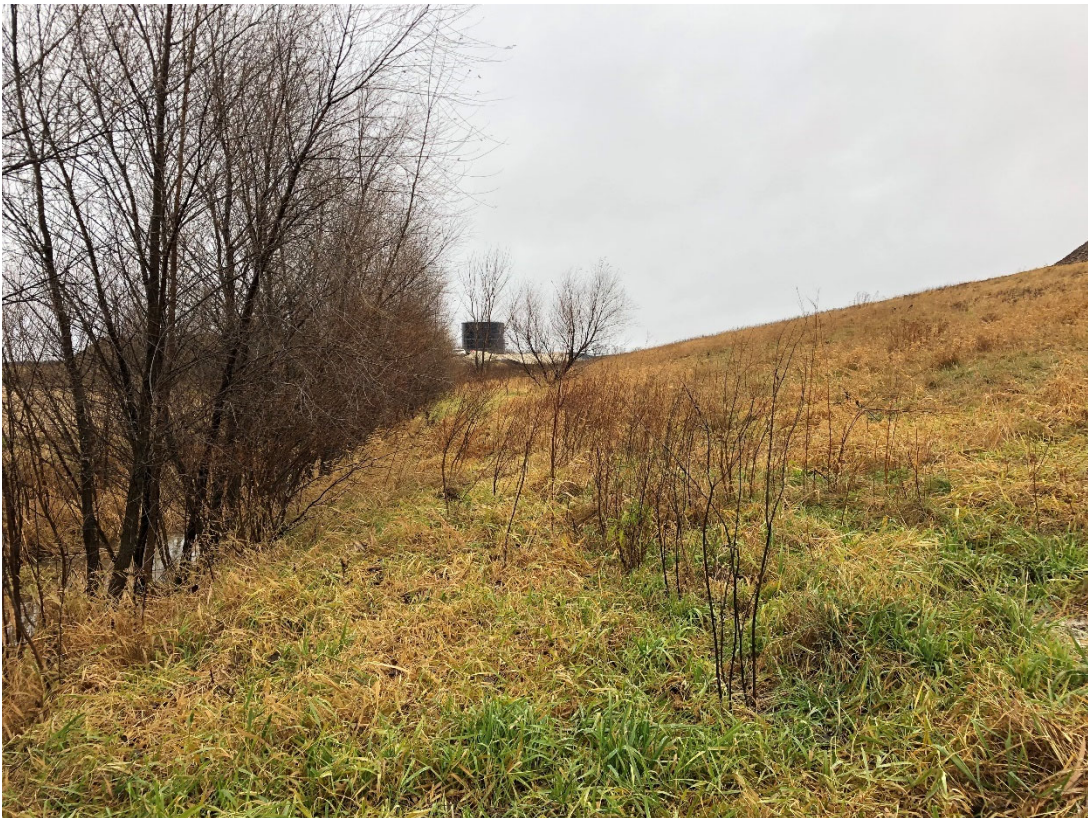
Photo 8: Location 3 – Looking North, Toe of Phase 1 Western Slope

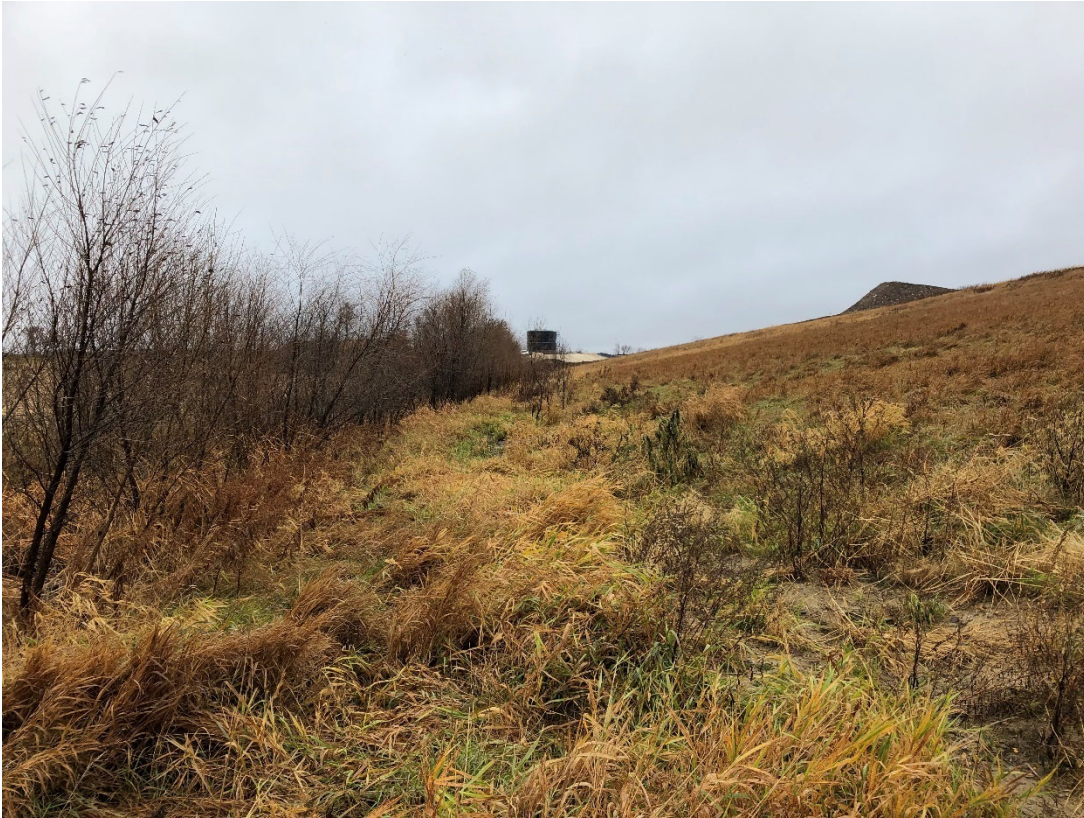
Photo 9: Location 4 – Looking North, Toe of Phase 1 Western Slope

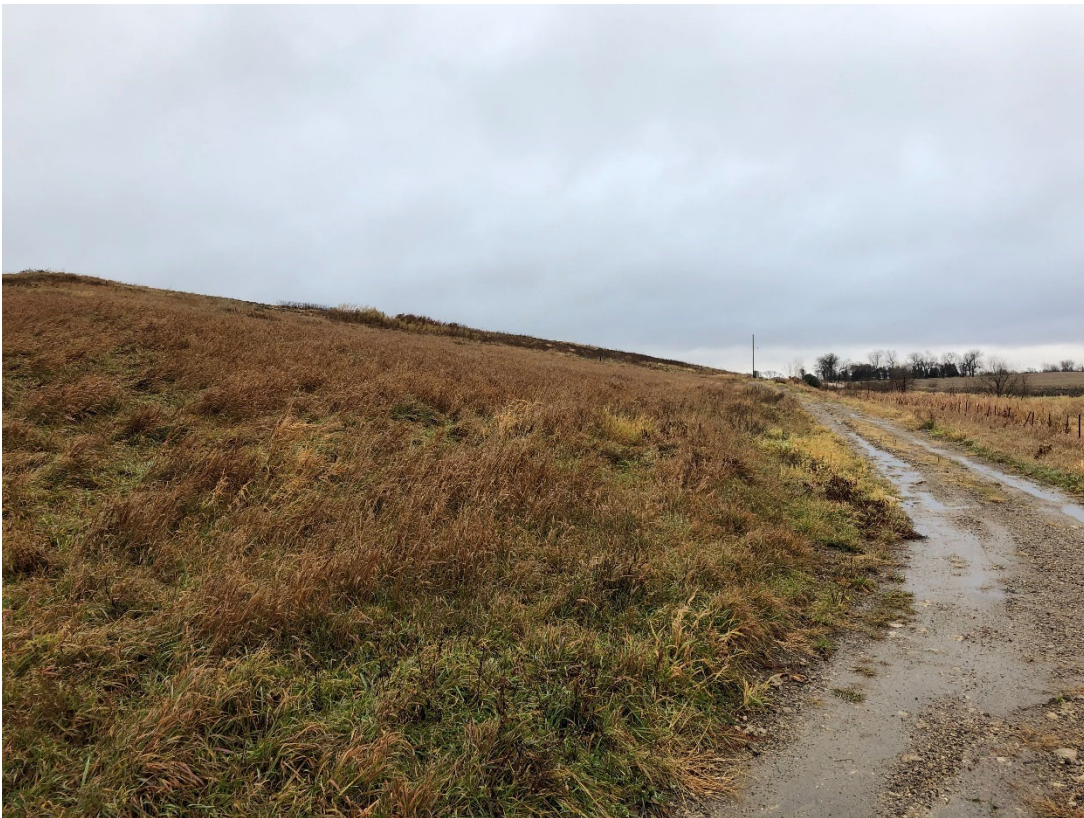
Photo 10: Location 4 – Looking East, Toe of Phase 1 Southern Slope

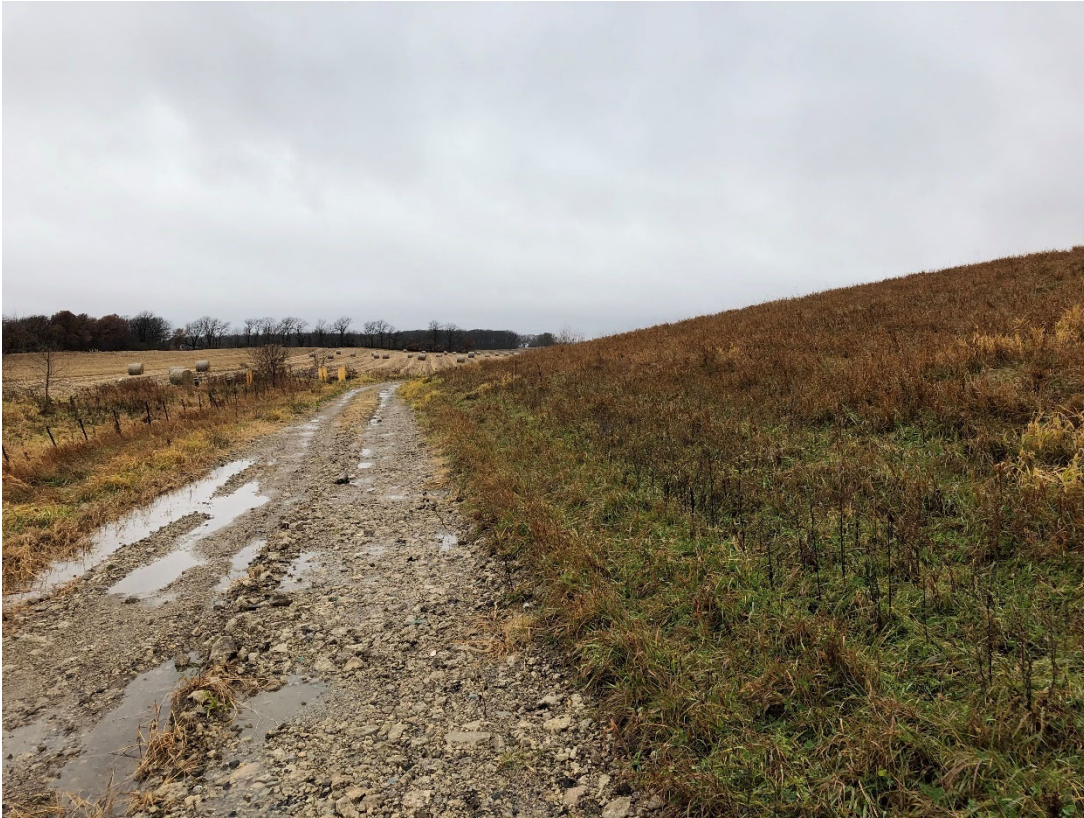
Photo 11: Location 5 – Looking West, Toe of Phase 1 Southern Slope

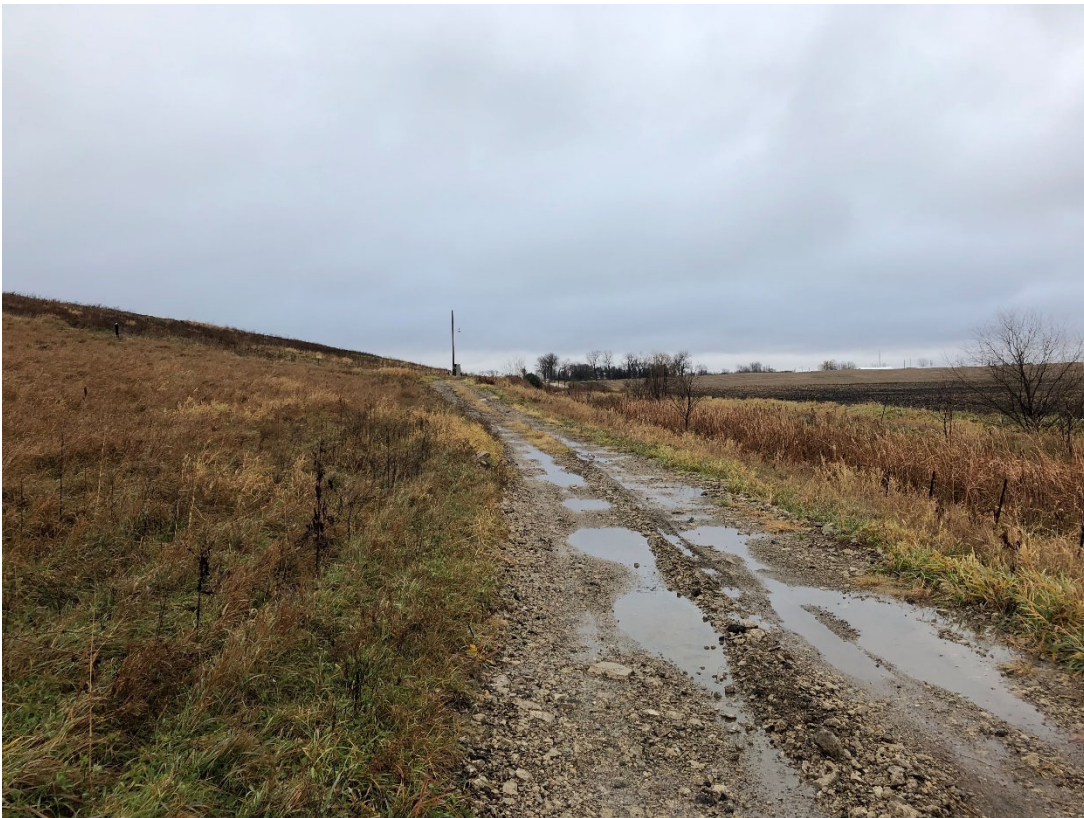
Photo 12: Location 5 – Looking East, Toe of Phase 1 Southern Slope

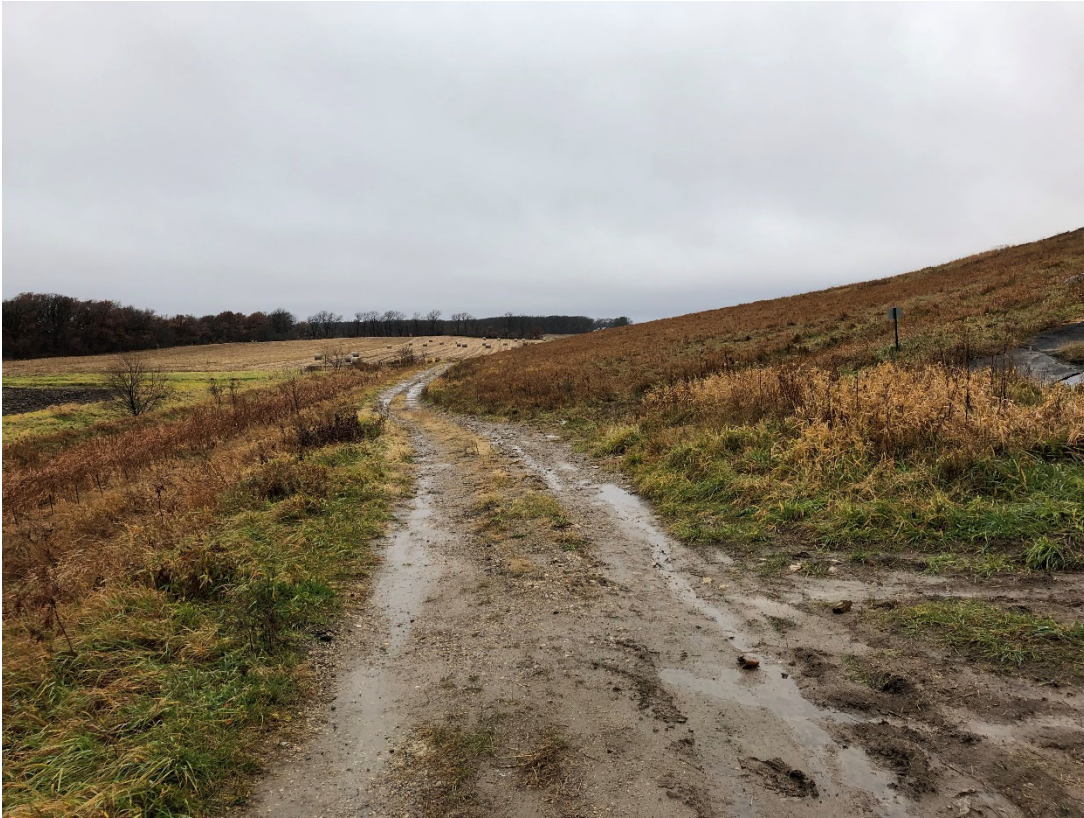
Photo 13: Location 6 – Looking West, Phase 1 Southern Slope

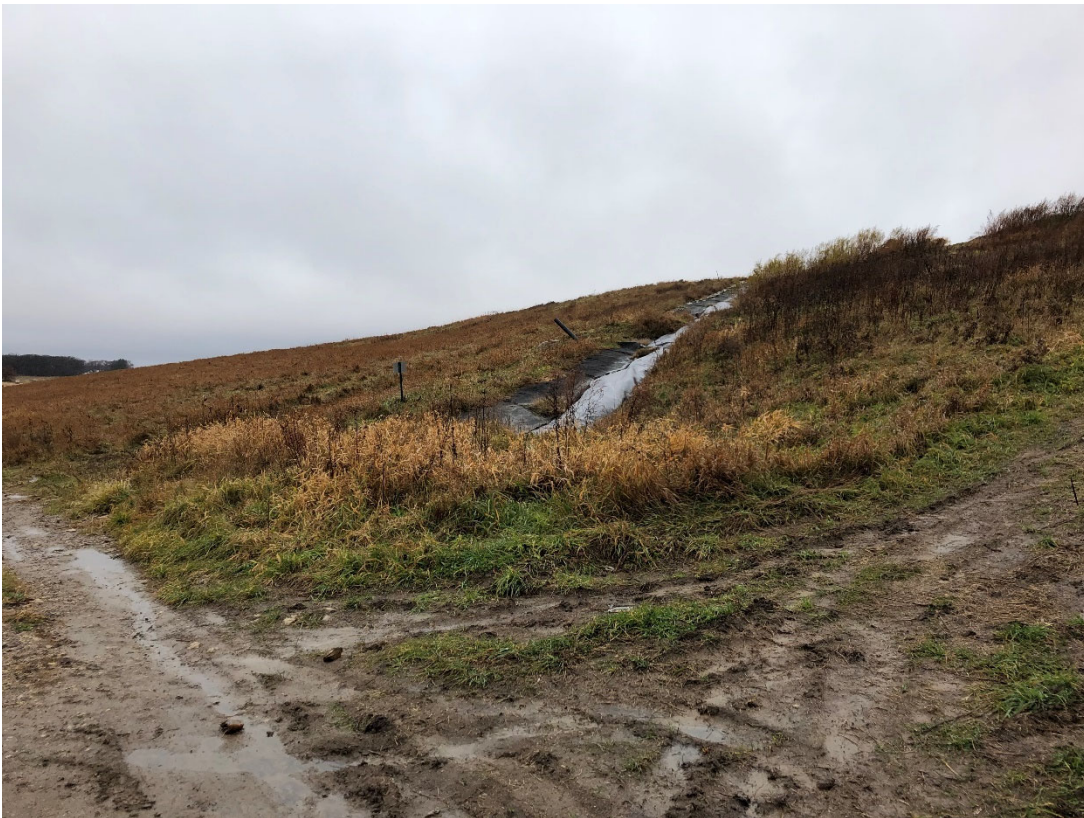
Photo 14: Location 6 – Looking West, Phase 1/2 Overlay Liner & Southern Slope

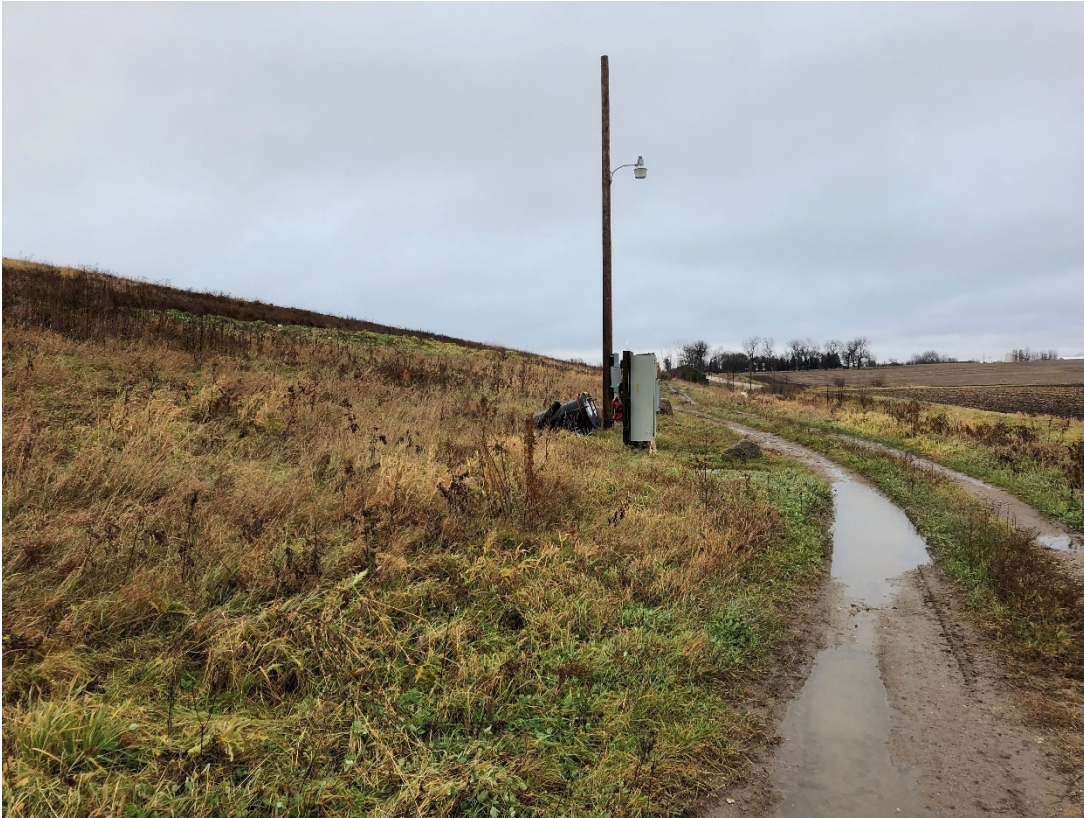
Photo 15: Location 6 – Looking East, Phase 2 Southern Slope

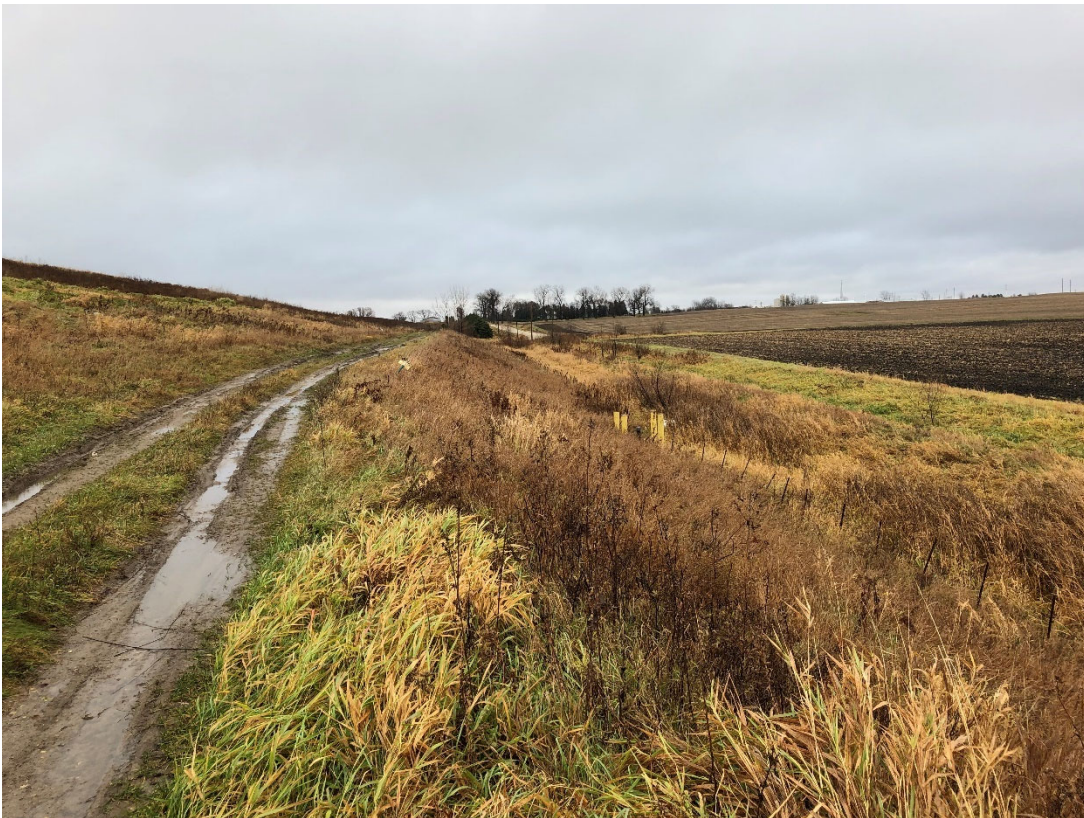
Photo 16: Location 6 – Looking East, Phase 2 Southern Berm

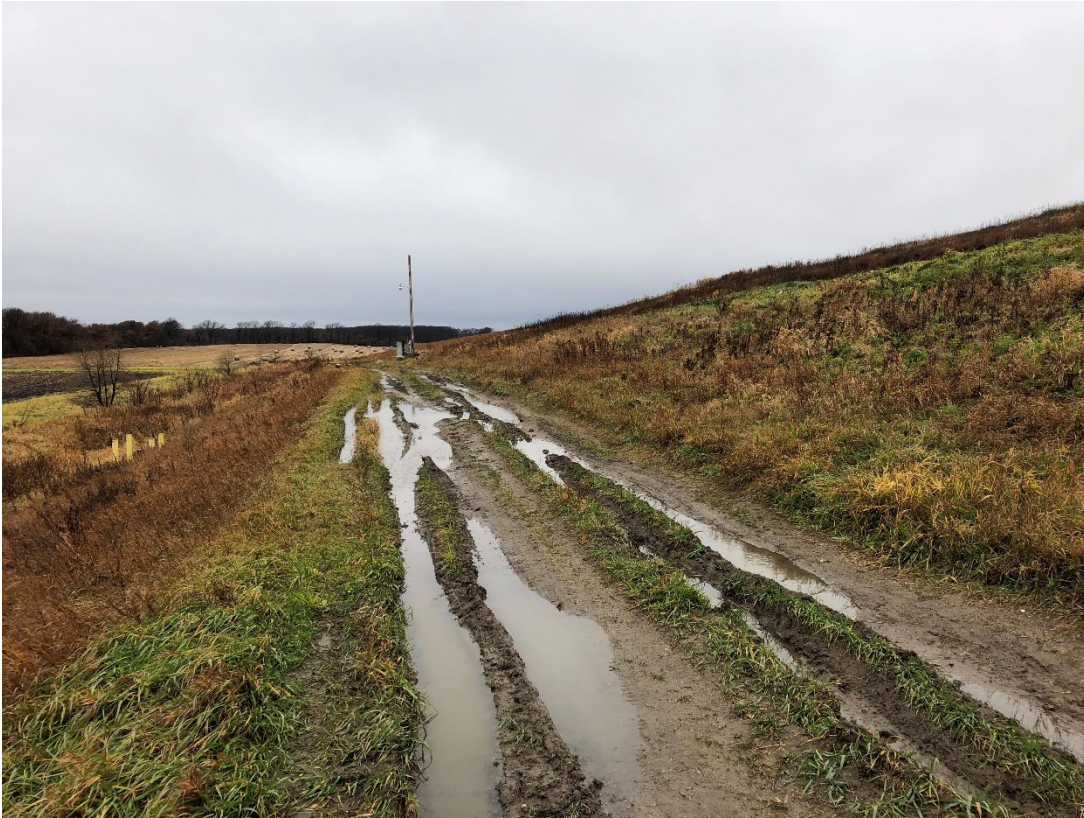
Photo 17: Location 7 – Looking West, Phase 2 Southern Perimeter Road and Slope

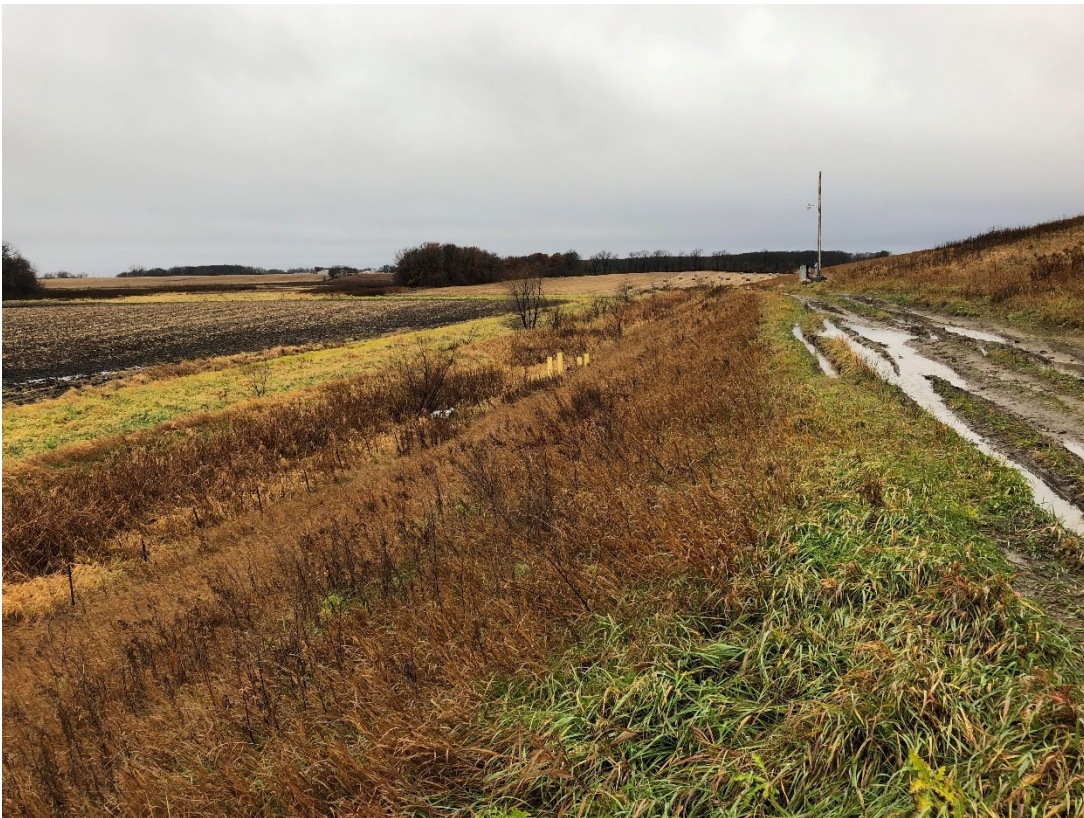
Photo 18: Location 7 – Looking West, Phase 2 Southern Berm

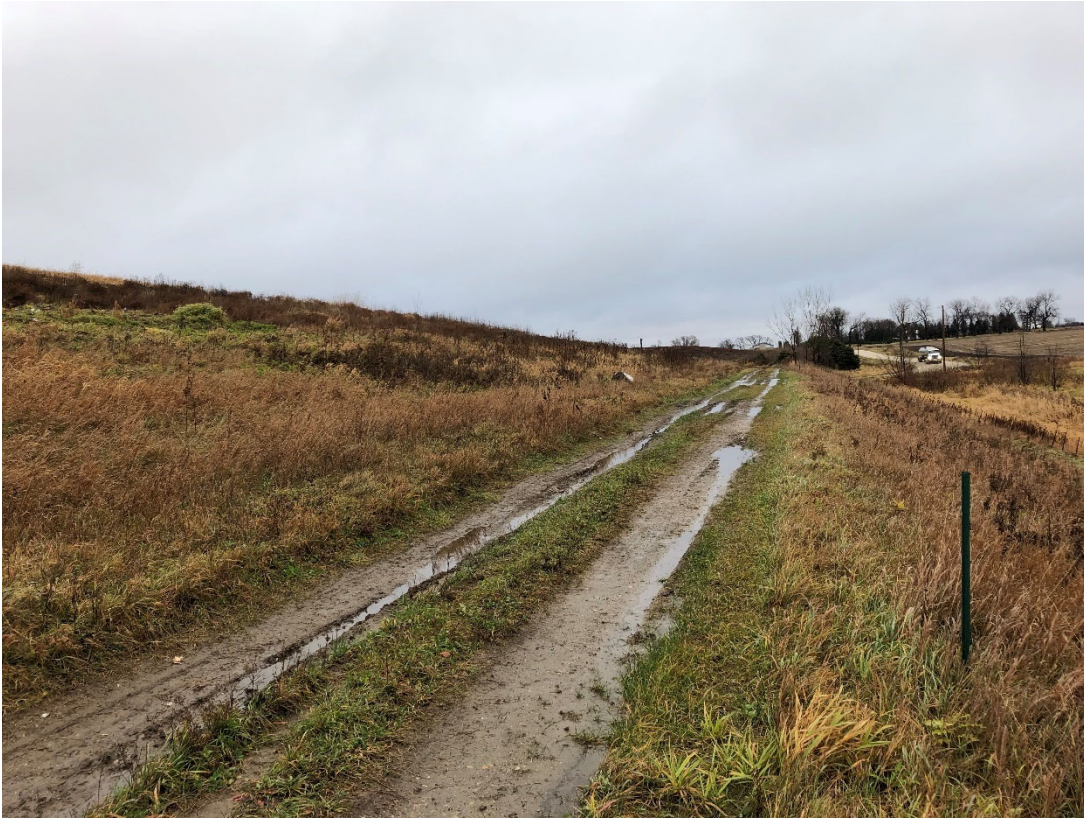
Photo 19: Location 7 – Looking East, Phase 2 Southern Perimeter Road and Slope
