Technical Memo

To: Geoff Strack, P.E., Waste Connections
From: Brad Sullivan, P.E., Wenck Associates, Inc.
Date: January 9, 2019
Subject: WCI Austin Landfill, LLC – 2018 Annual CCR Inspection
Wenck Project # B3053-0139

PROJECT TITLE
2018 CCR INSPECTION REPORT

WCI AUSTIN LANDFILL, LLC
 AUSTIN, MINNESOTA

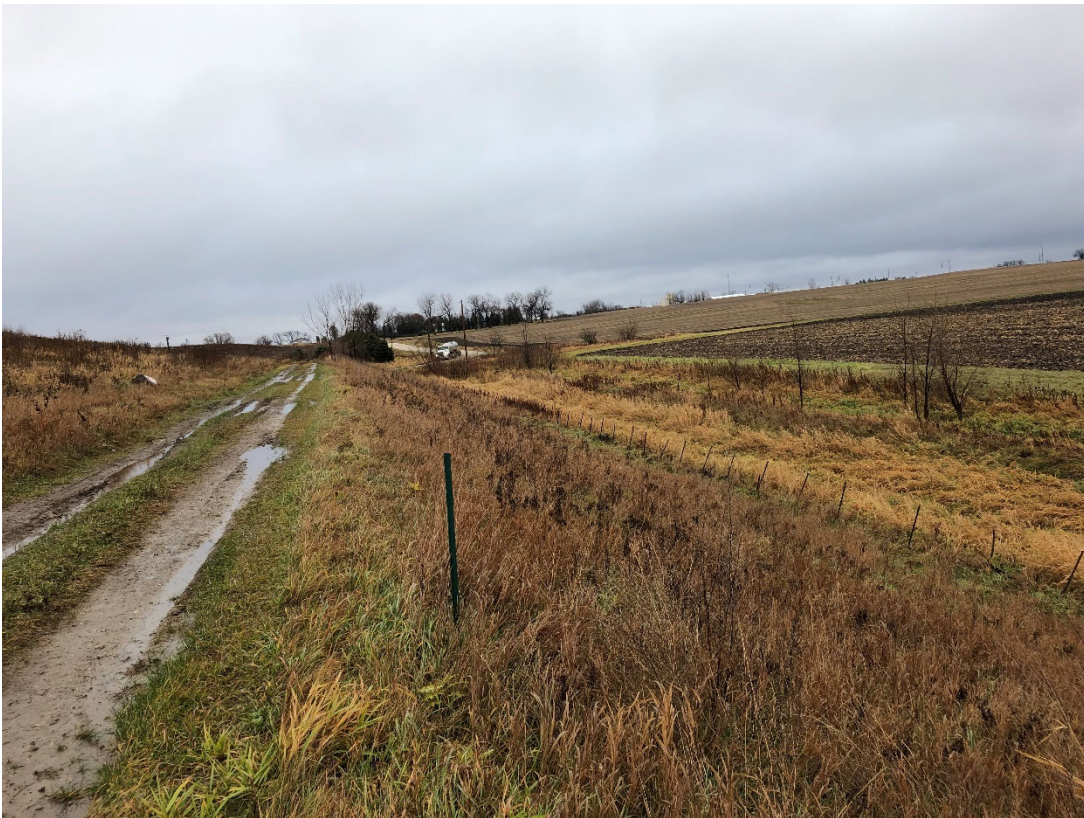
Photo 20: Location 7 – Looking East, Phase 2 Southern Berm

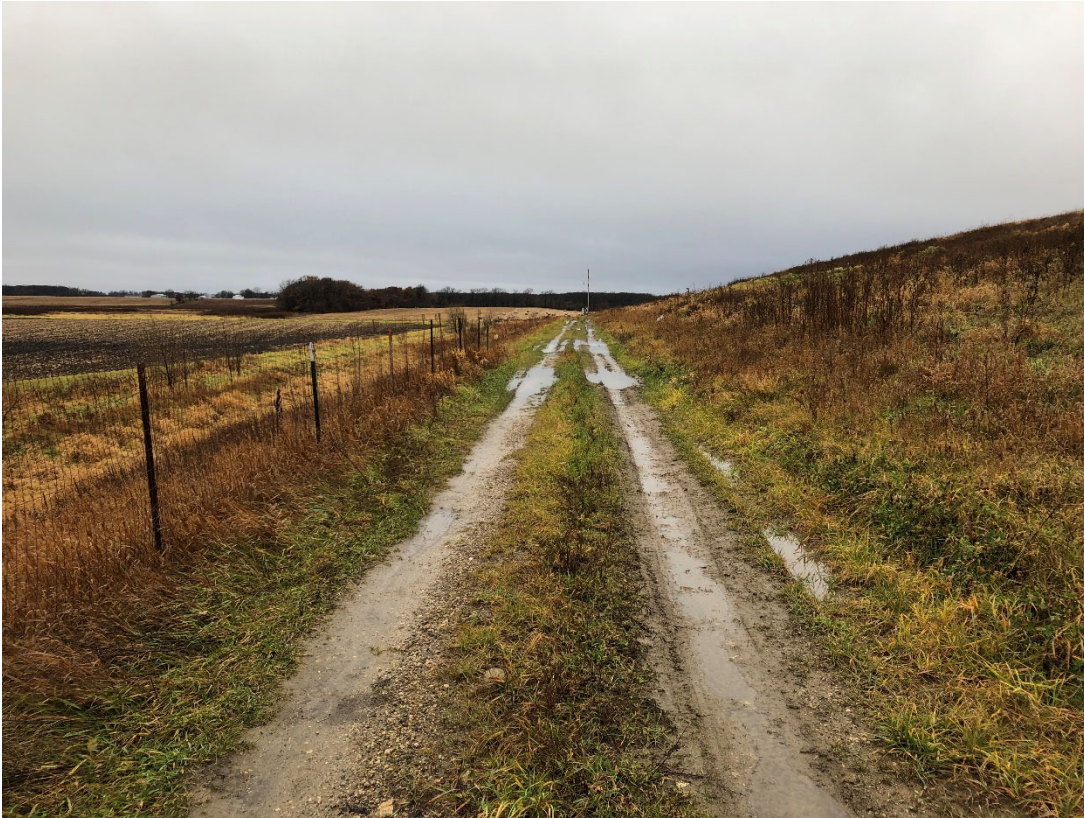
Photo 21: Location 8 – Looking West, Phase 2 Southern Perimeter Road and Slope

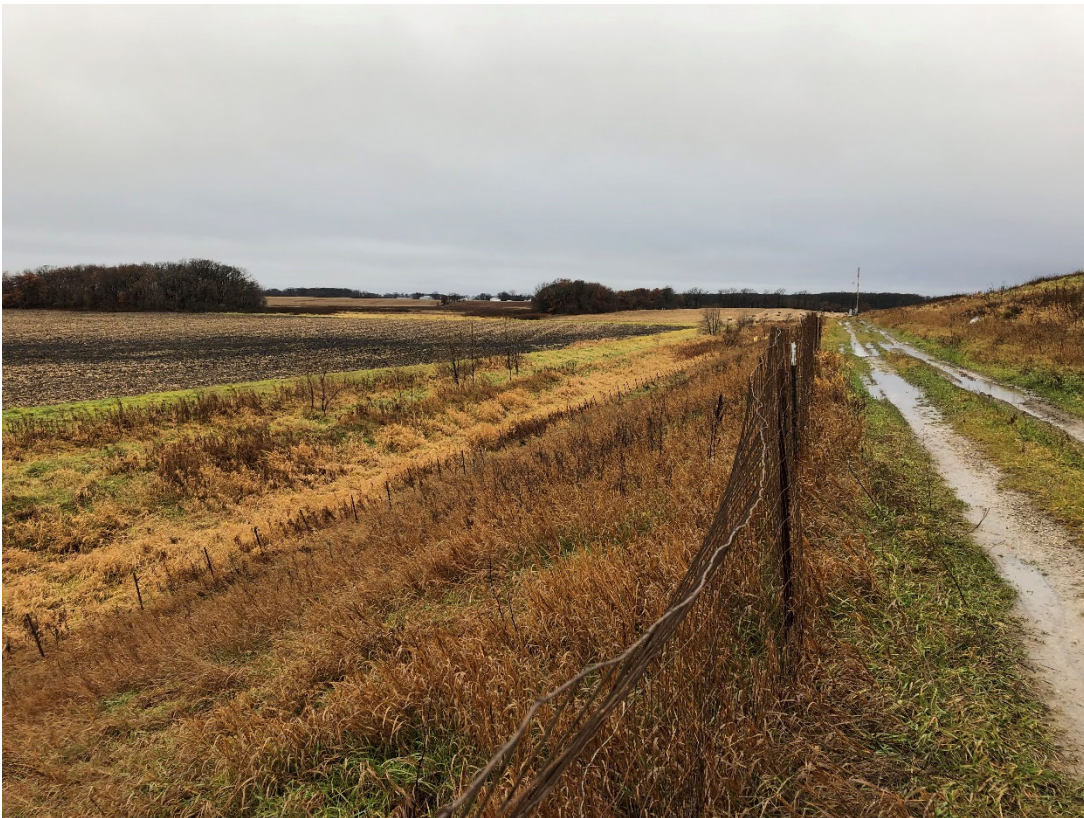
Photo 22: Location 8 – Looking West, Phase 2 Southern Berm

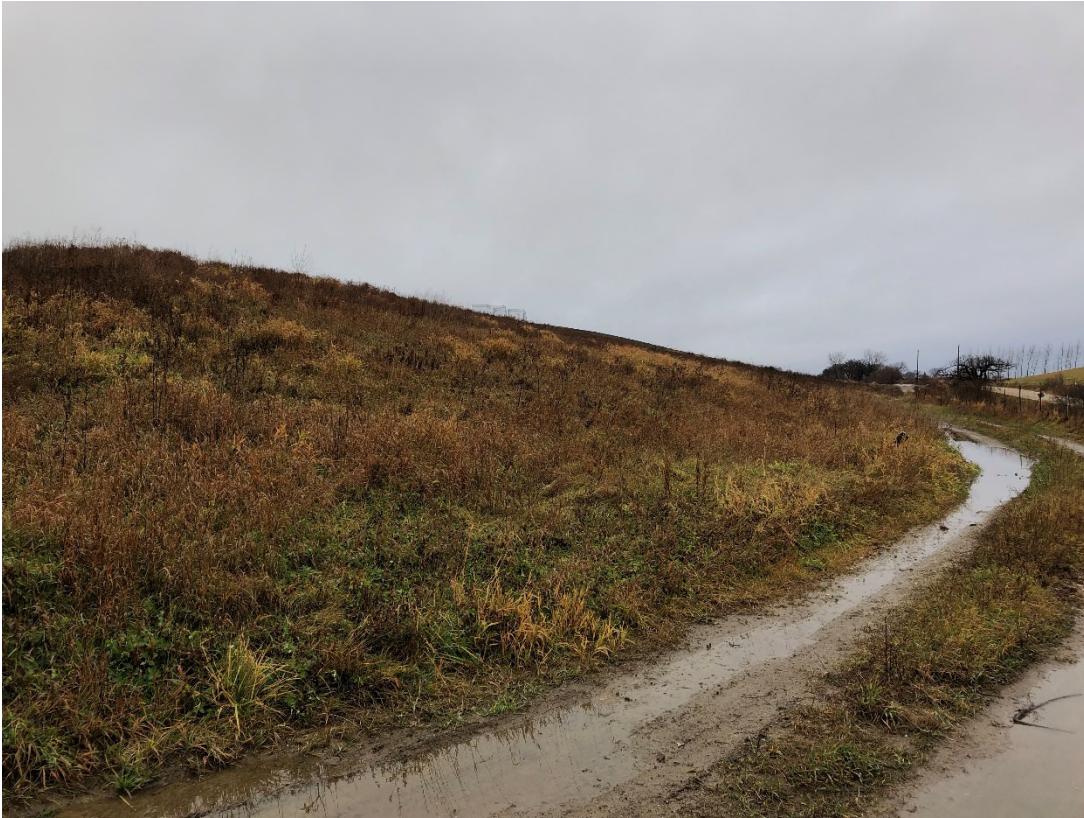
Photo 23: Location 8 – Looking North, Phase 2 Eastern Slope

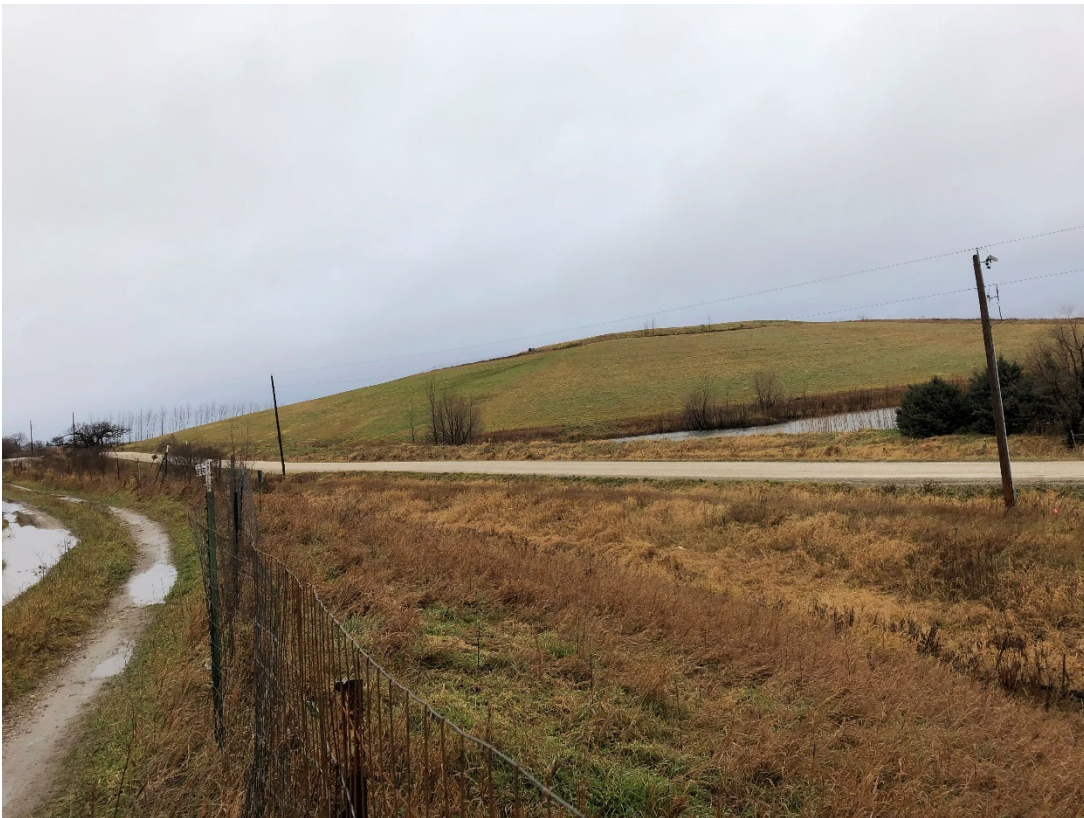
Photo 24: Location 8 – Looking North, Phase Eastern Berm

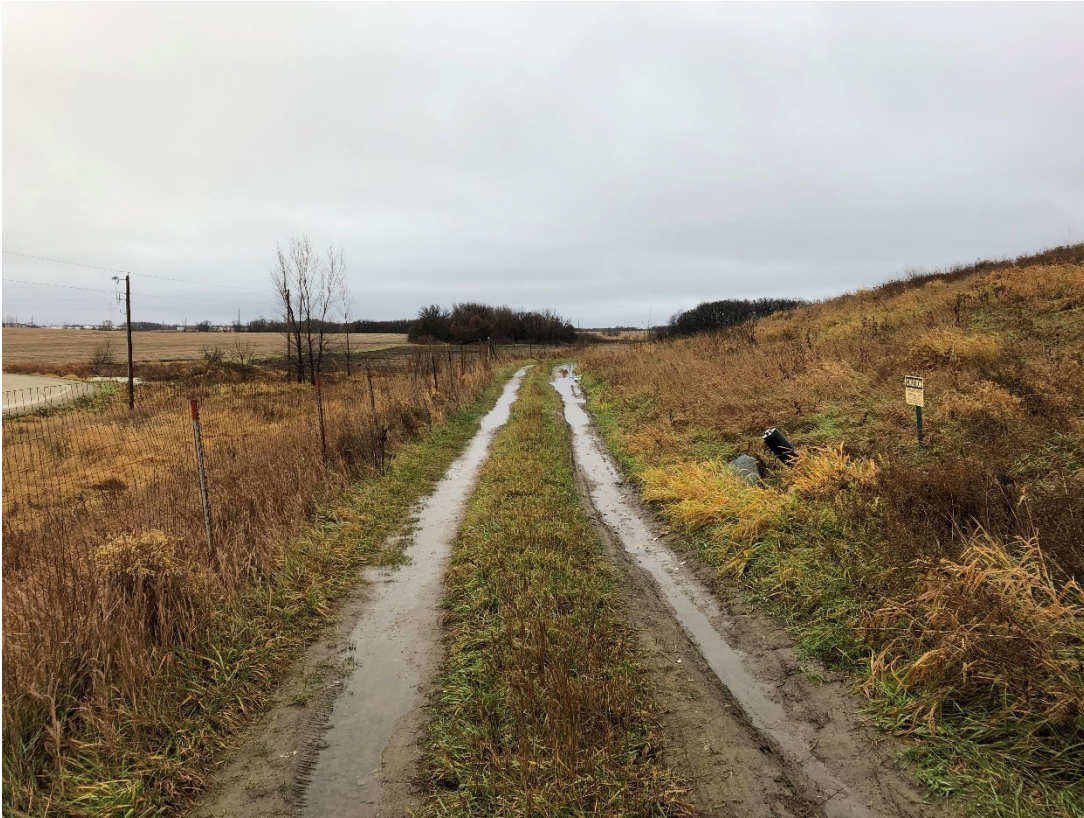
Photo 25: Location 9 – Looking South, Phase 2 Eastern Perimeter Road & Slope

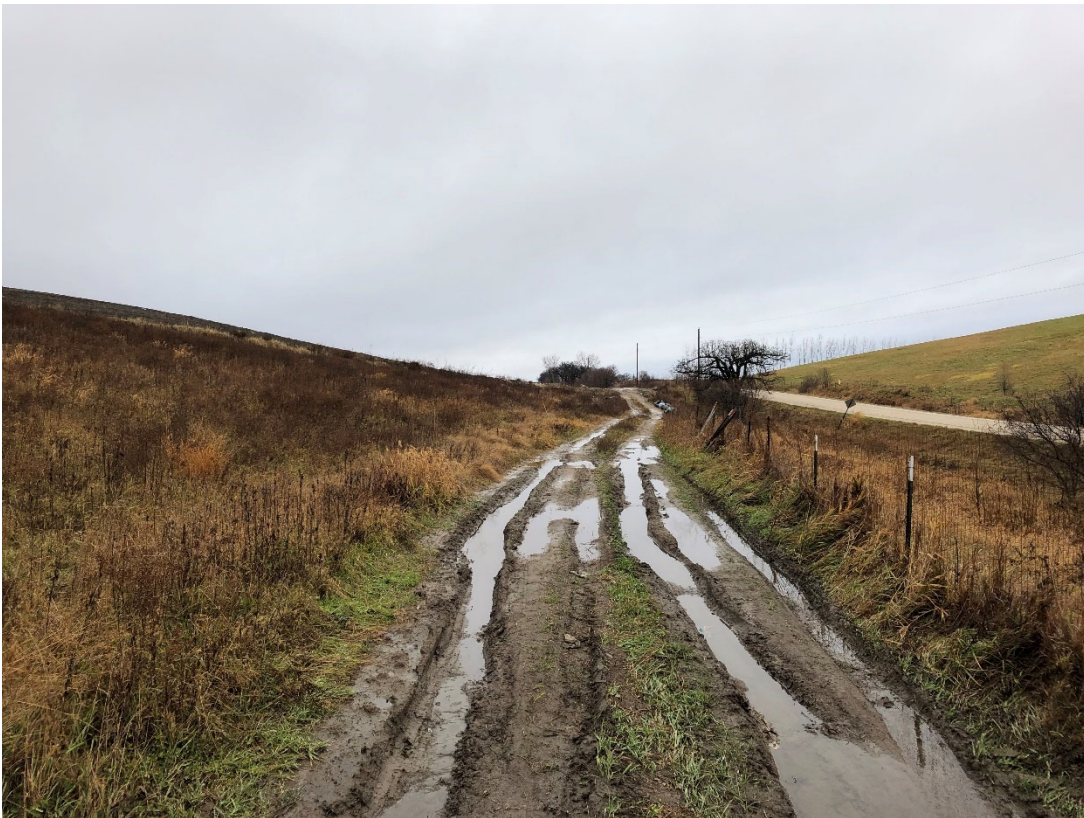
Photo 26: Location 9 – Looking North, Phase 2 Eastern Perimeter Road & Slope

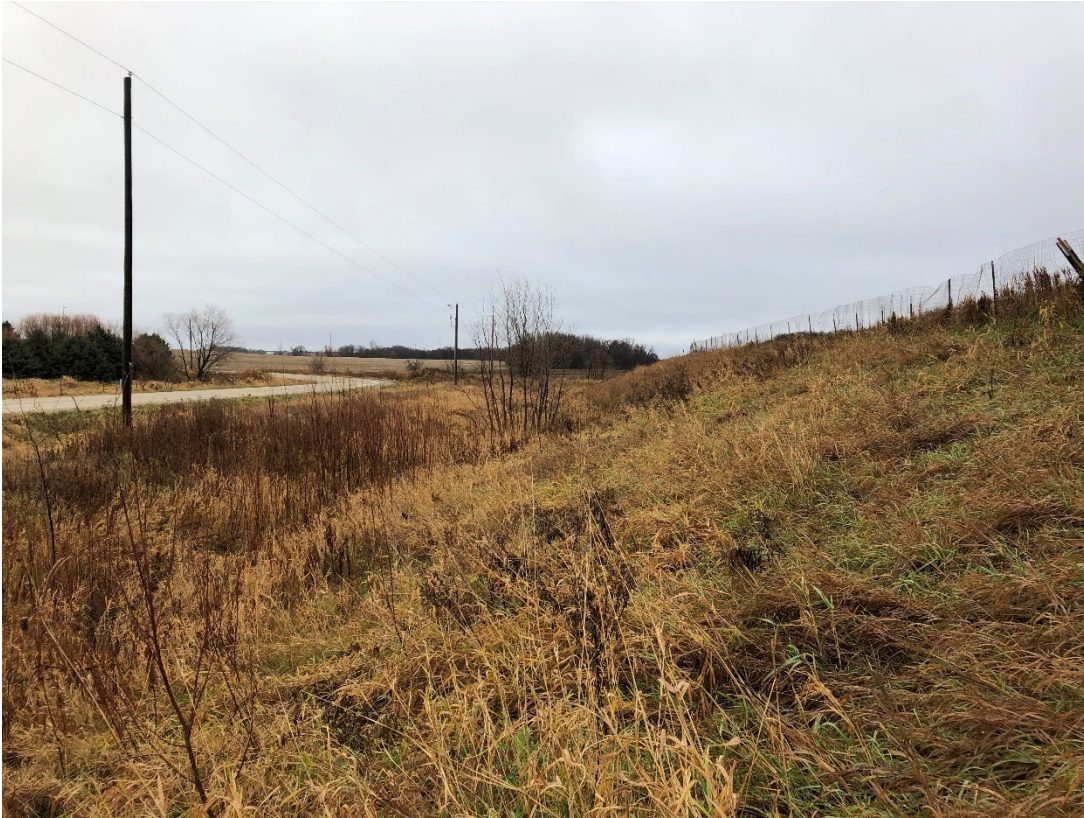
Photo 27: Location 9 – Looking South, Phase 2 Eastern Berm

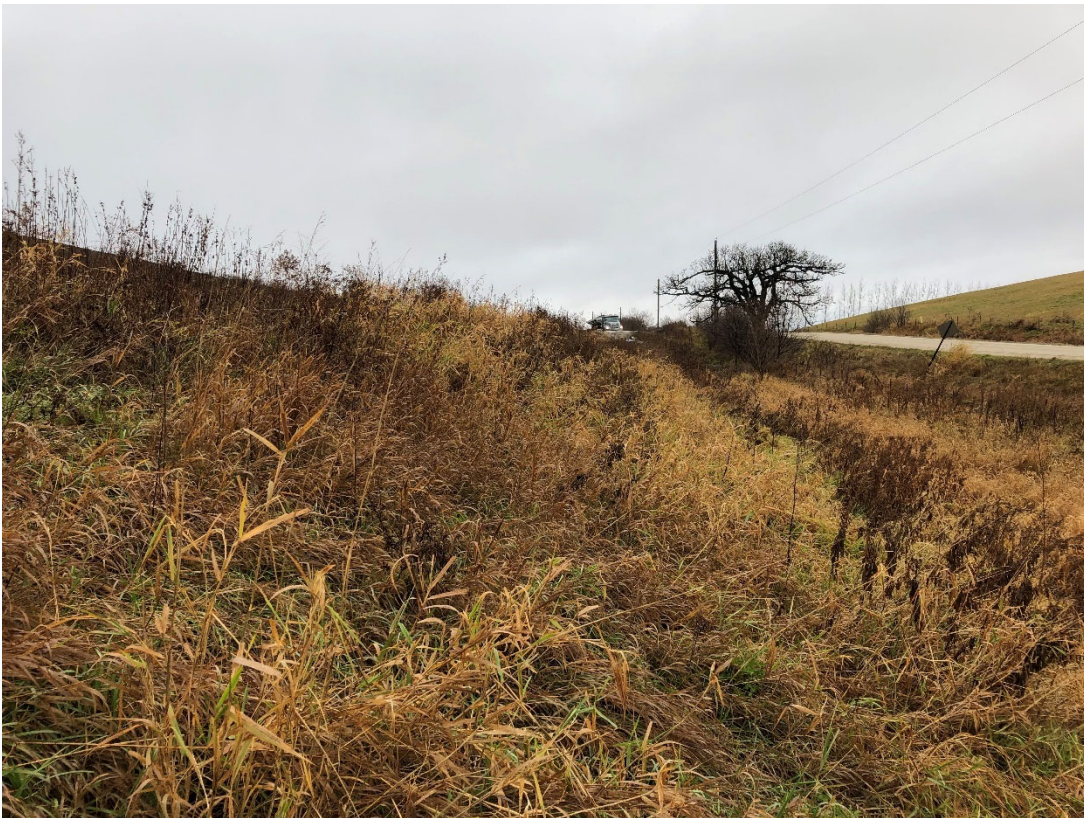
Photo 28: Location 9 – Looking North, Phase 2 Eastern Berm

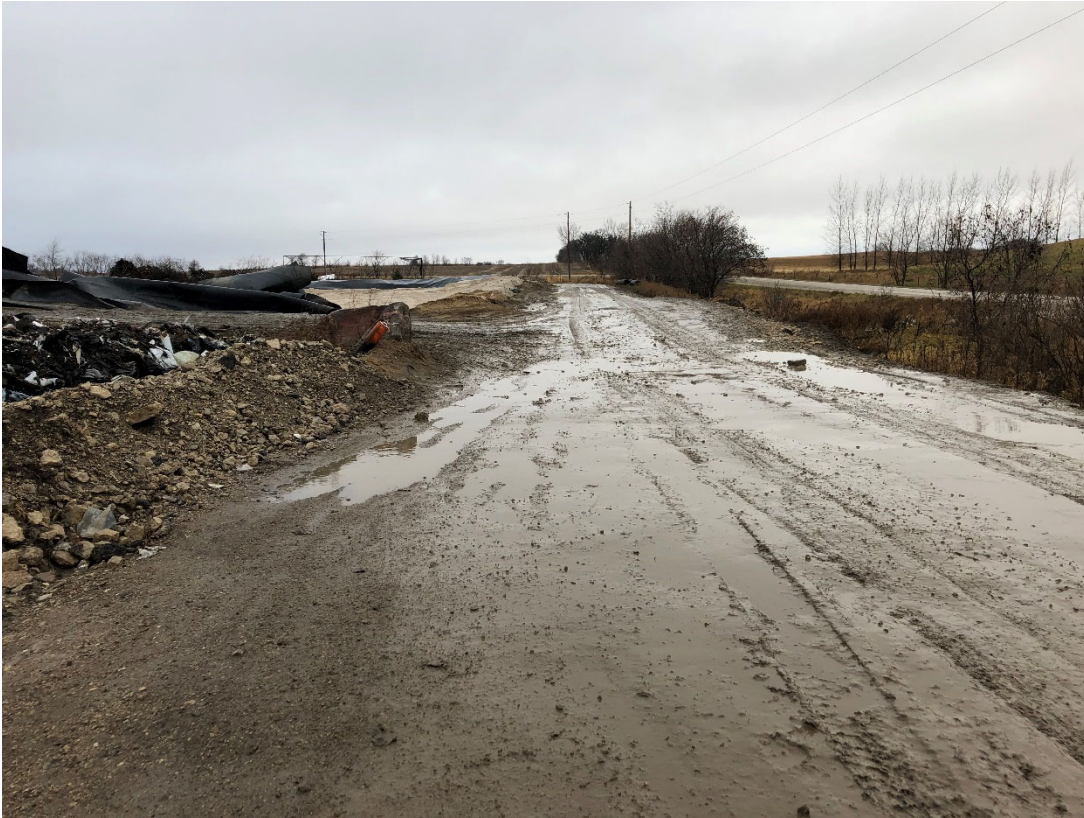
Photo 29: Location 10 – Looking North, Eastern Perimeter Road

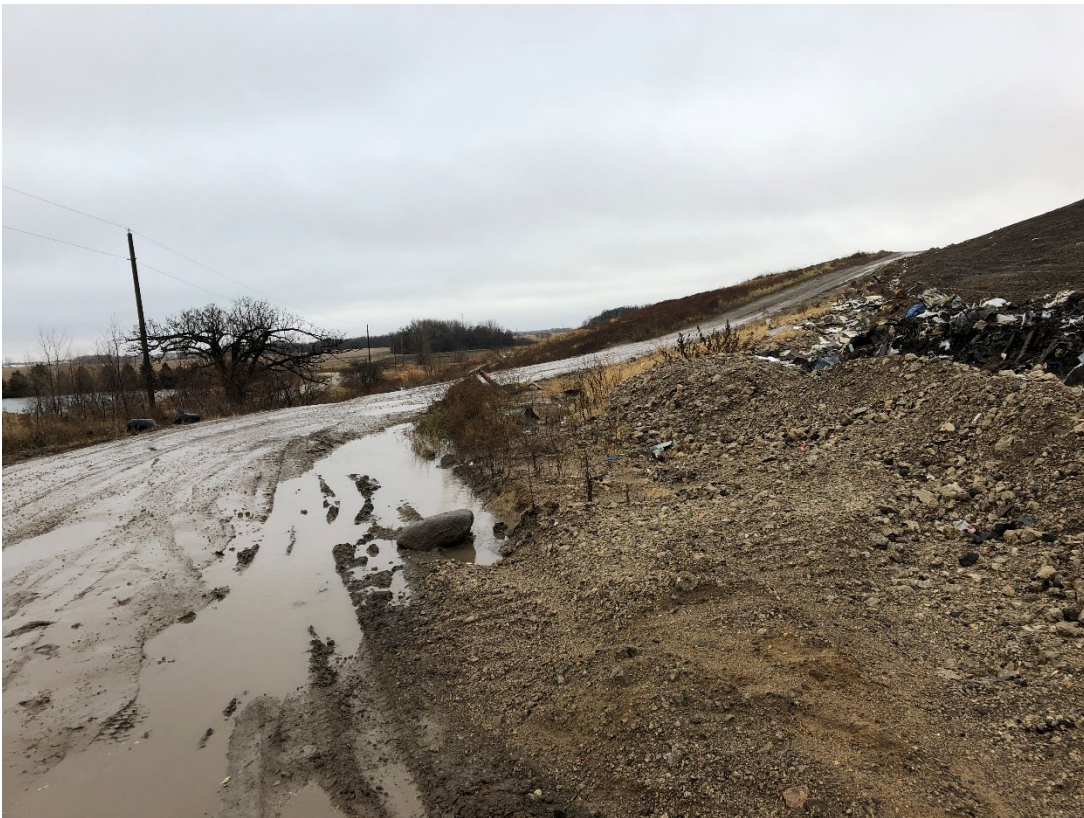
Photo 30: Location 10 – Looking South, Phase 2 Eastern Slope and Interior Access Road Entrance

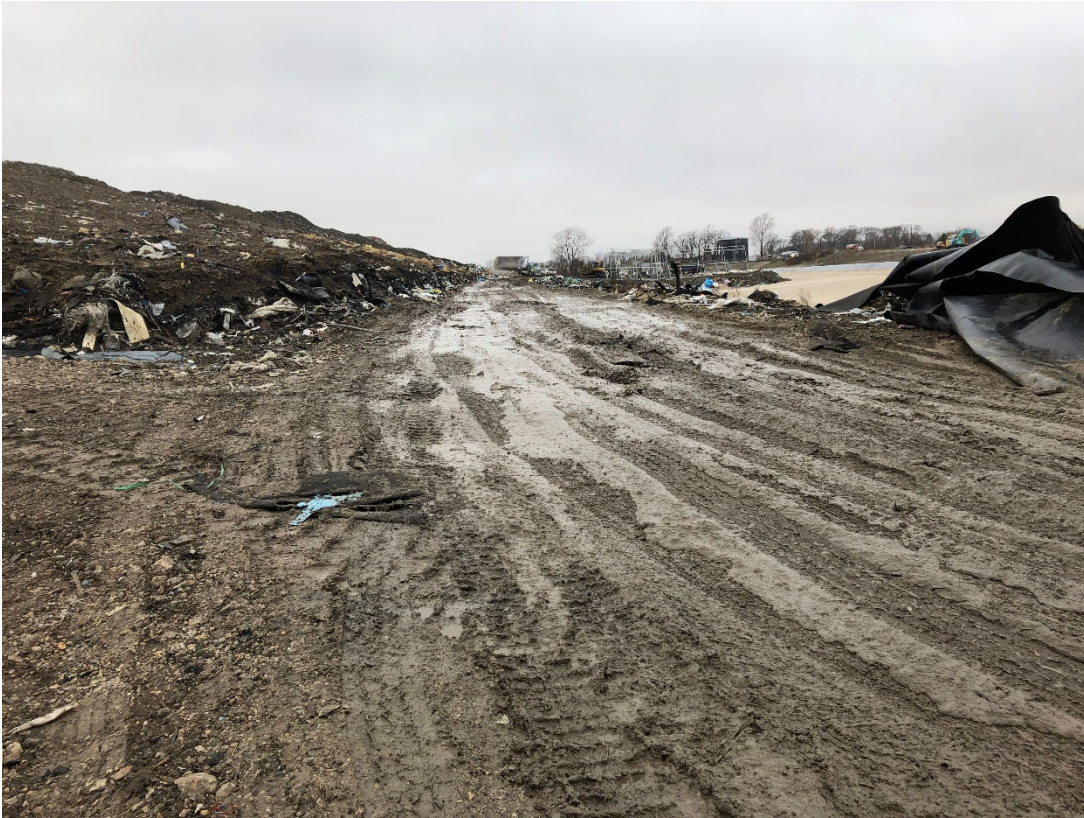
Photo 31: Location 11 – Looking West, Phase 3/4 Connection, Phase 3 Norther Interior Waste Slope

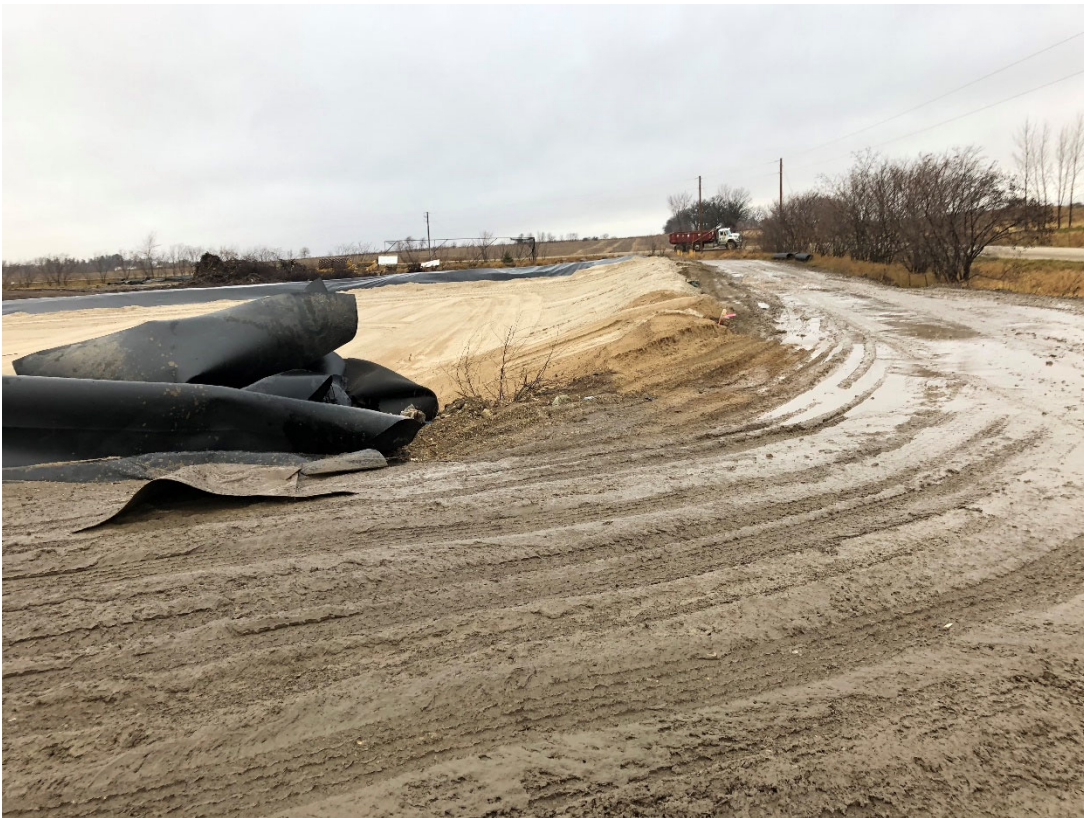
Photo 32: Location 11 – Looking North, Phase 4 Eastern Anchor Trench

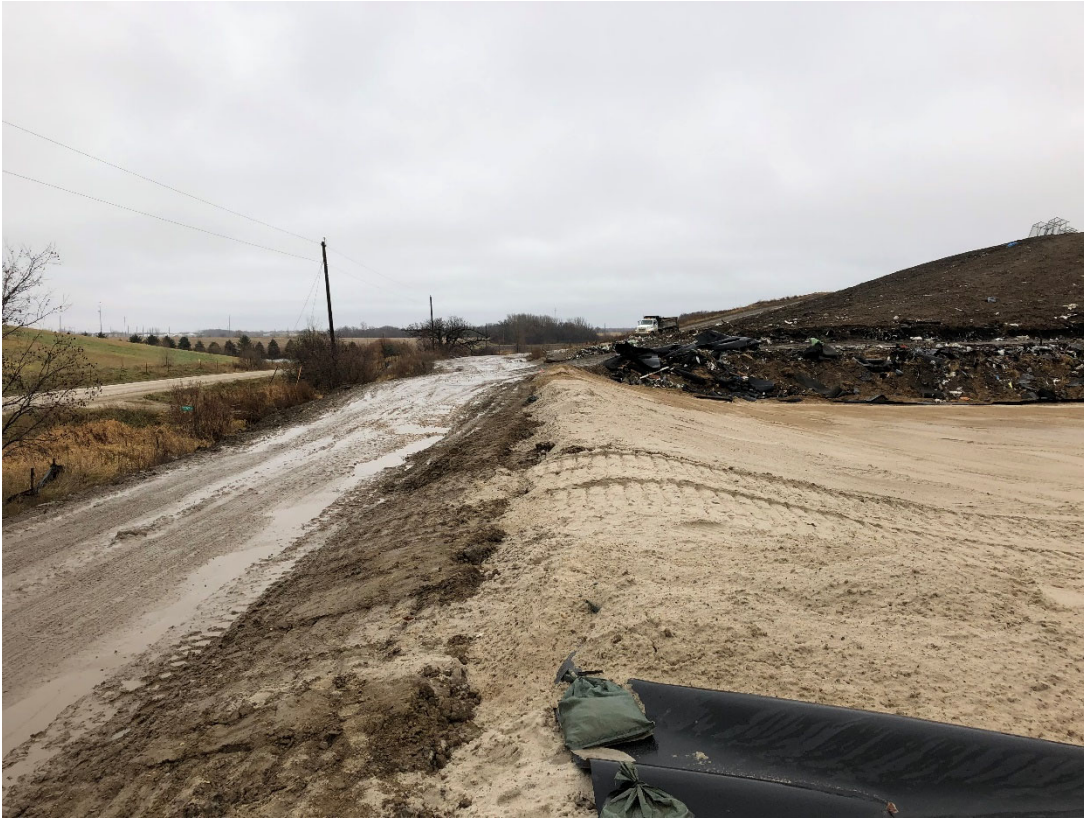
Photo 33: Location 12 – Looking South, Phase 4 Eastern Anchor Trench & Phase 3 Eastern Waste Slope

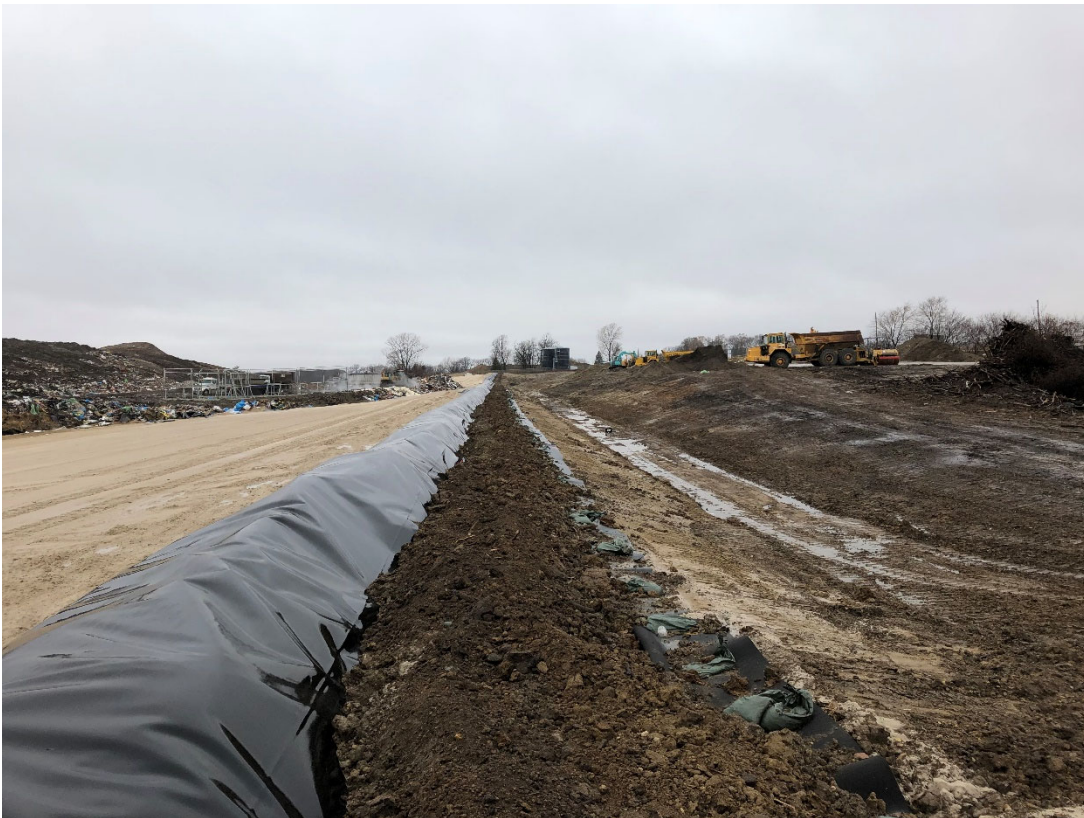
Location 12 – Looking West, Phase 4 Northern Rain Flap

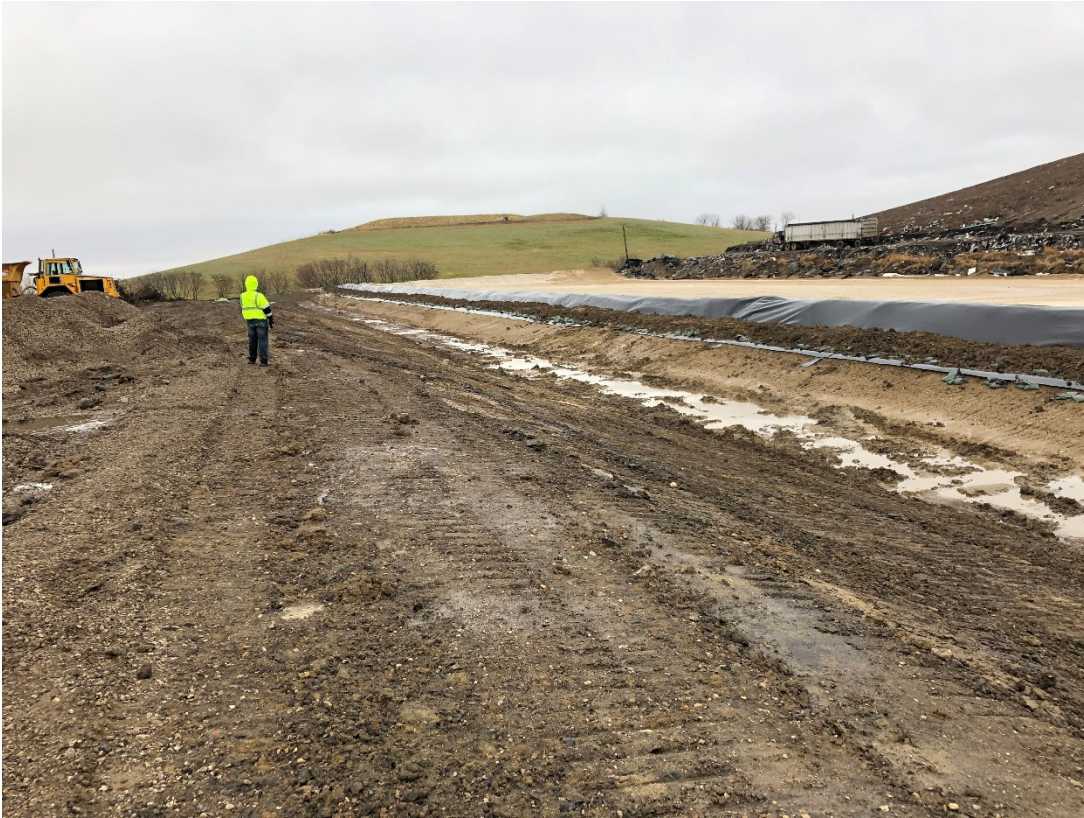
Photo 35: Location 13 – Looking East, Phase 4 Northern Rain Flap

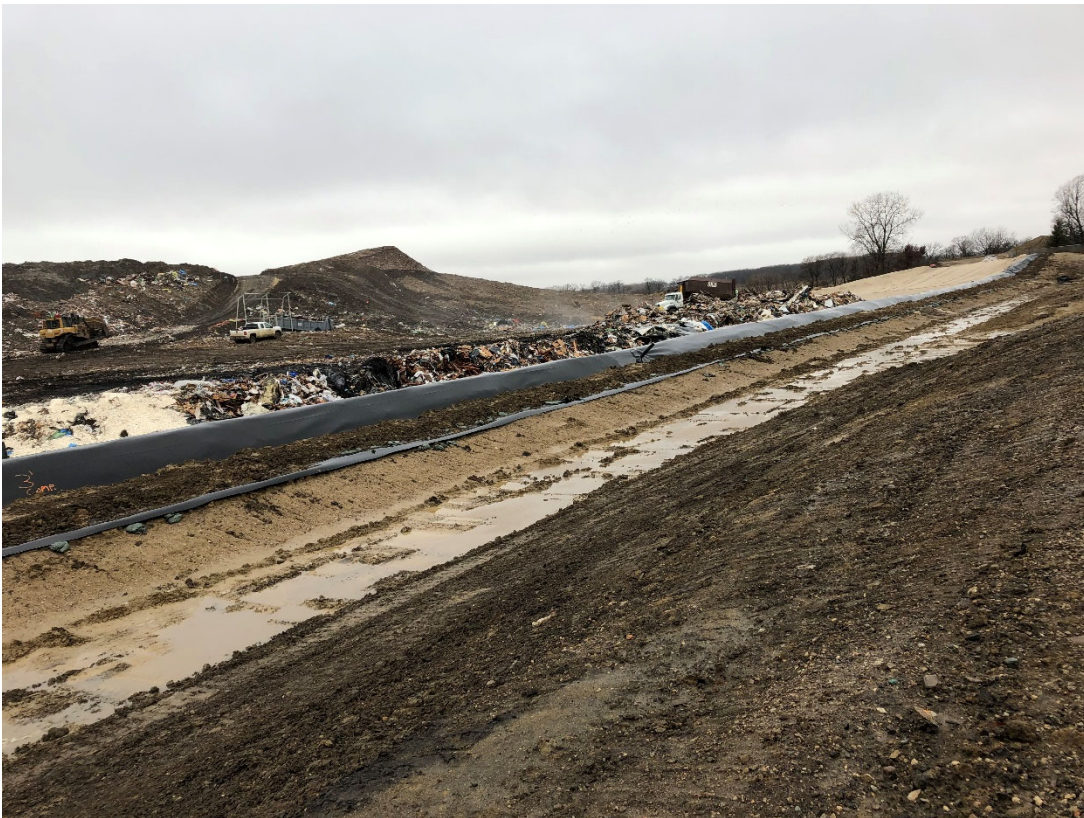
Location 13 – Looking West, Phase 4 Northern Rain Flap
