Technical Memo

To: Geoff Strack, P.E., Waste Connections
From: Brad Sullivan, P.E., Wenck Associates, Inc.
Date: January 9, 2020
Subject: WCI Austin Landfill, LLC
2019 Annual CCR Inspection Report
Wenck Project #B3053-0180

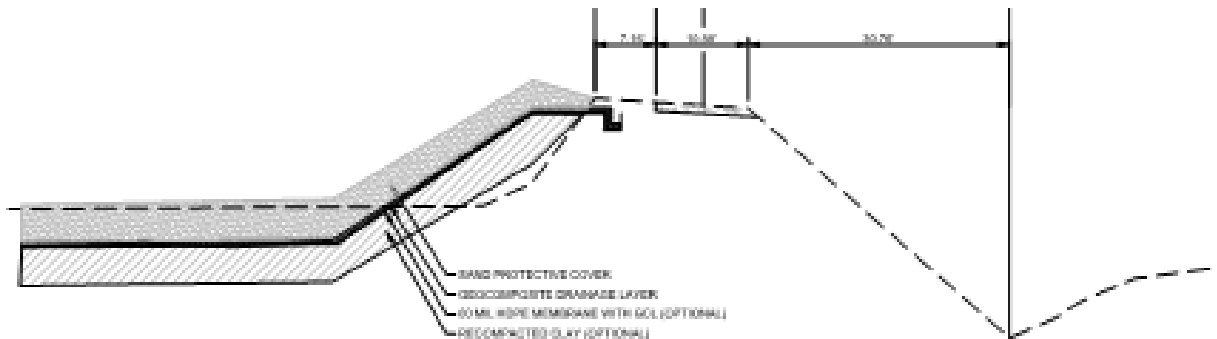
Typical Landfill Berm Detail

During the inspection, no signs of landfill cell embankment distress, no signs of waste slope instability, or other CCR landfill issues were observed. The landfill embankments and interim covered slopes were generally in good condition with a well-established vegetation cover and no signs of significant erosion.

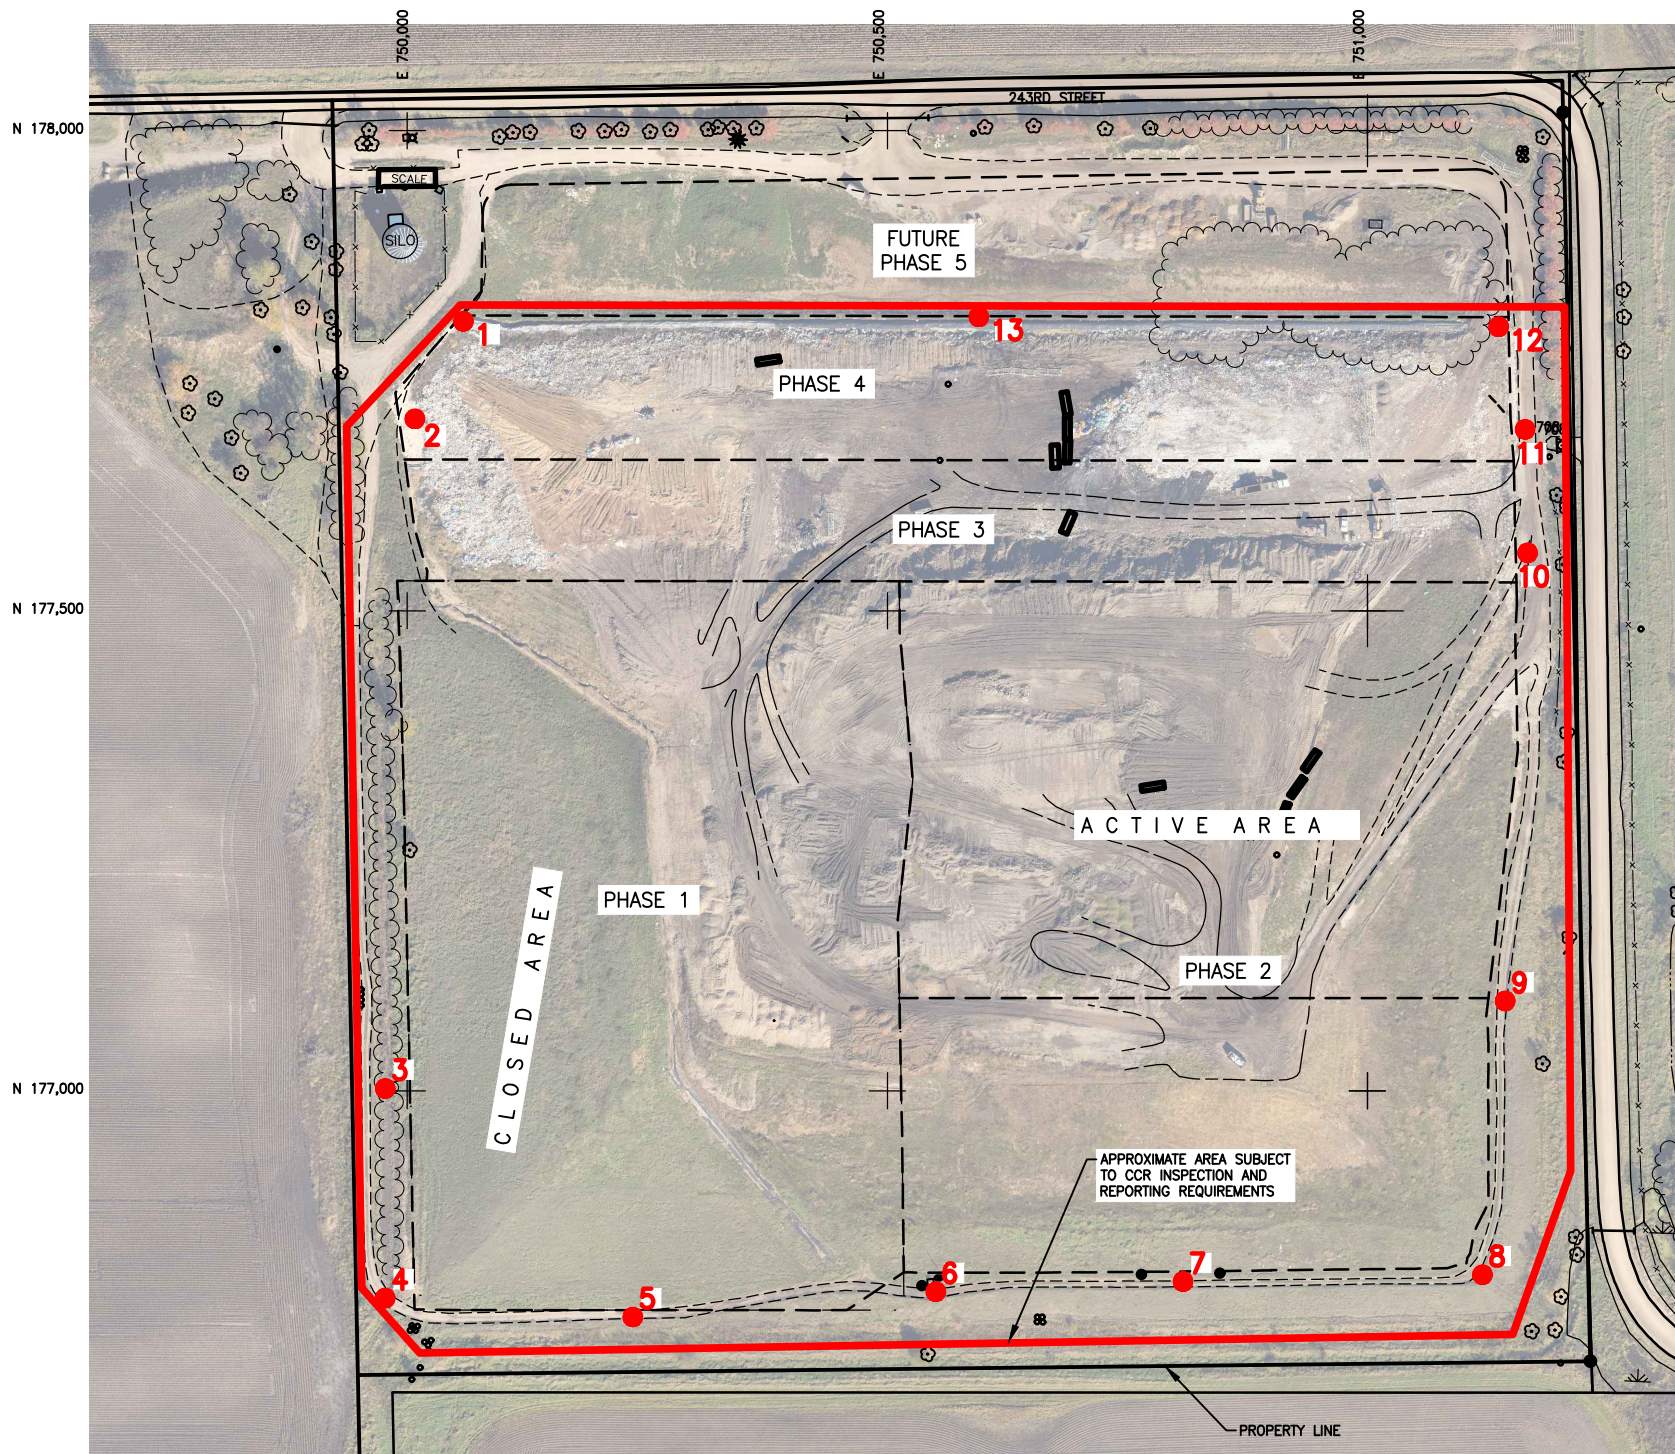
SHEET TITLE				
PHOTO LOCATIONS				
DWN BY BWS	CHK'D TS	APP'D BWS	DWG DATE SCALE	JAN. 2020 AS NOTED
PROJECT NO. 3053-0181	SHEET NO. FIGURE 1	REV NO. 0

Photos were taken during the inspection. Figure 1 presents the photo locations, and Attachment 1 contains a photo log and the photos taken.

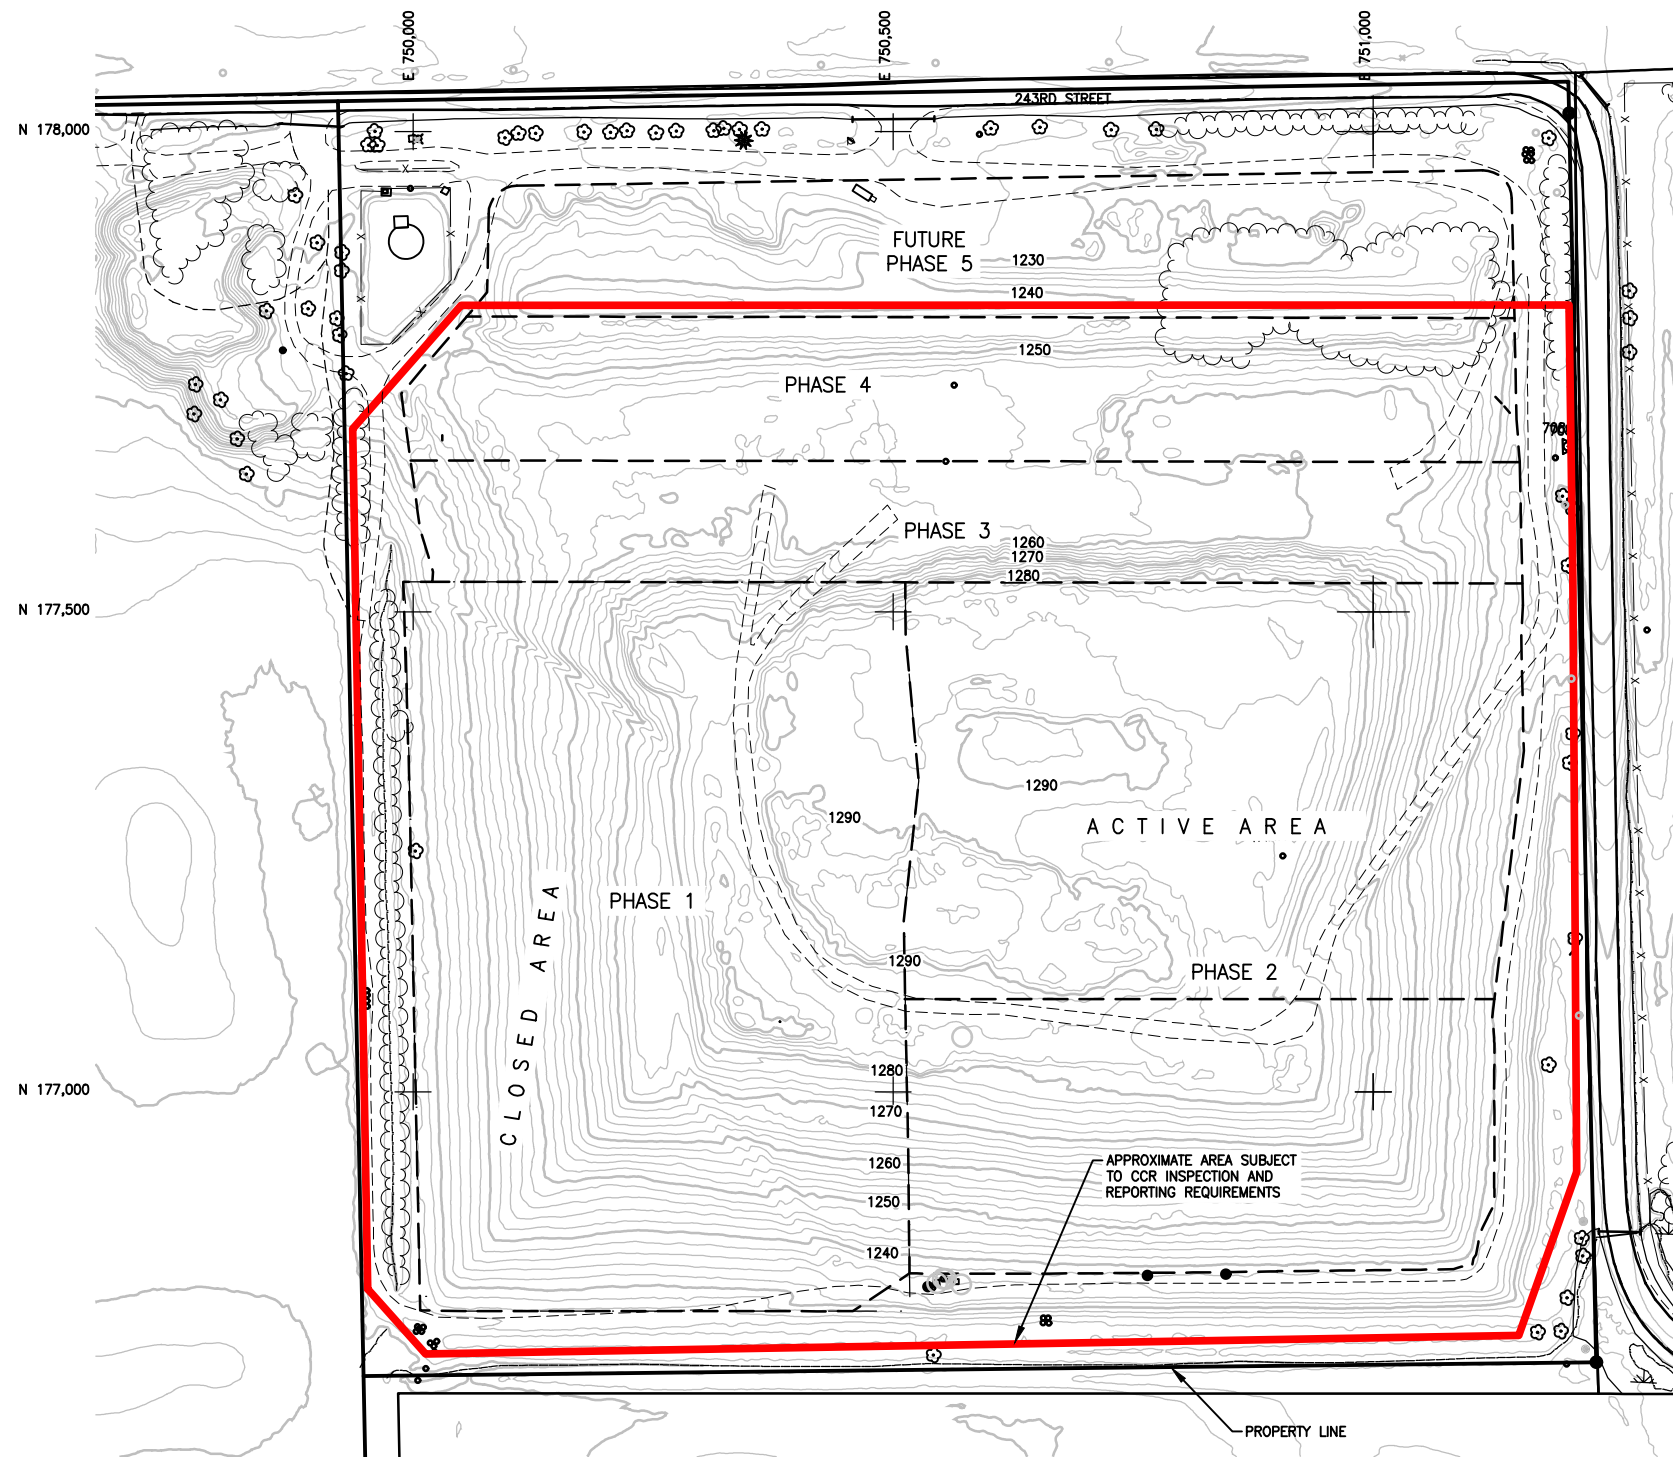
SHEET TITLE			
SITE MAP			
DWN BY	CHK'D	APP'D	DWG DATE
BWS	TS	BWS	JAN. 2019
PROJECT NO.		SCALE	
3053-0181		AS NOTED	
SHEET NO.		REV NO.	
FIGURE 2		0

There were no apparent changes to the embankment geometry of Cells 1, 2, 3, or 4 when compared to the permit drawings or the past inspection reports. The annual aerial photogrammetry survey was performed on November 12, which the estimated in-place volume is based on. A comparison 2019 and 2018 aerial survey confirm that the embankment and slope topography is substantially unchanged with no significant movement. The 2019 aerial survey is included as Figure 2.

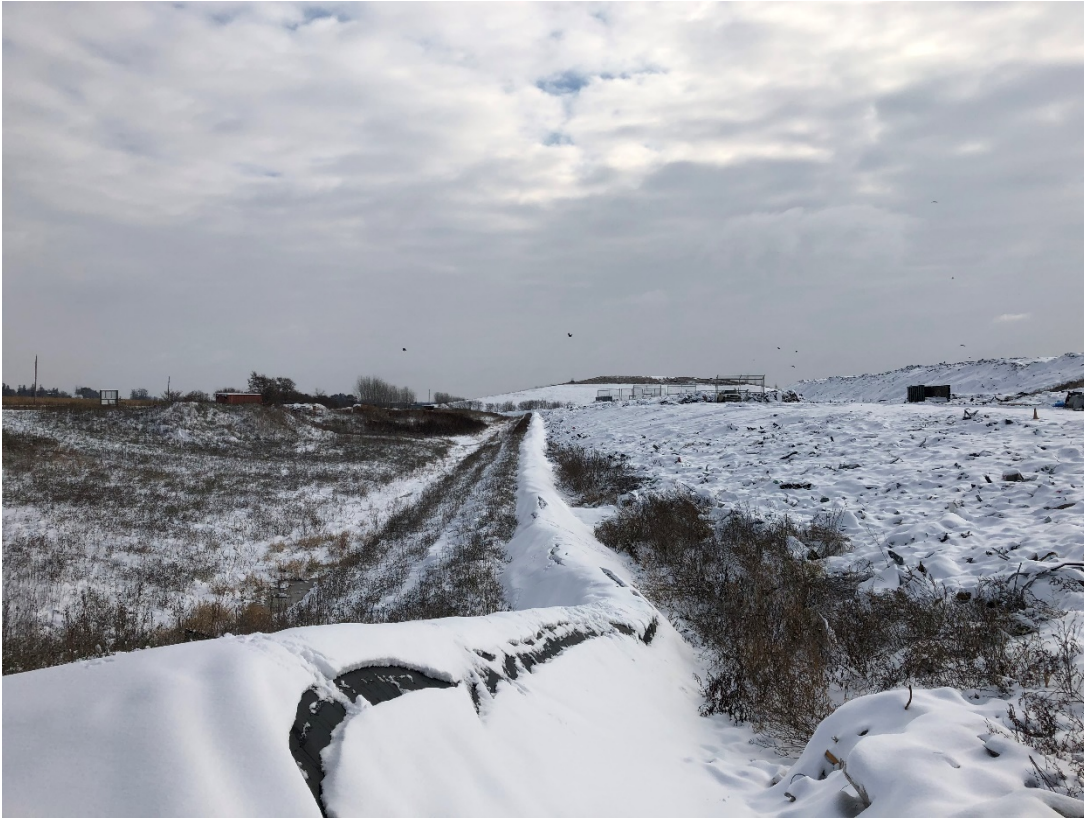
The Phase 4 landfill expansion construction was completed in 2018. The northern limit of the expansion is terminated with "rain flap" with the primary liner running out for future connection. The east and west embankments appeared per the Record Drawings.

Photo 1: Location 1 – Looking East, Phase 4 Northern Rain Flap

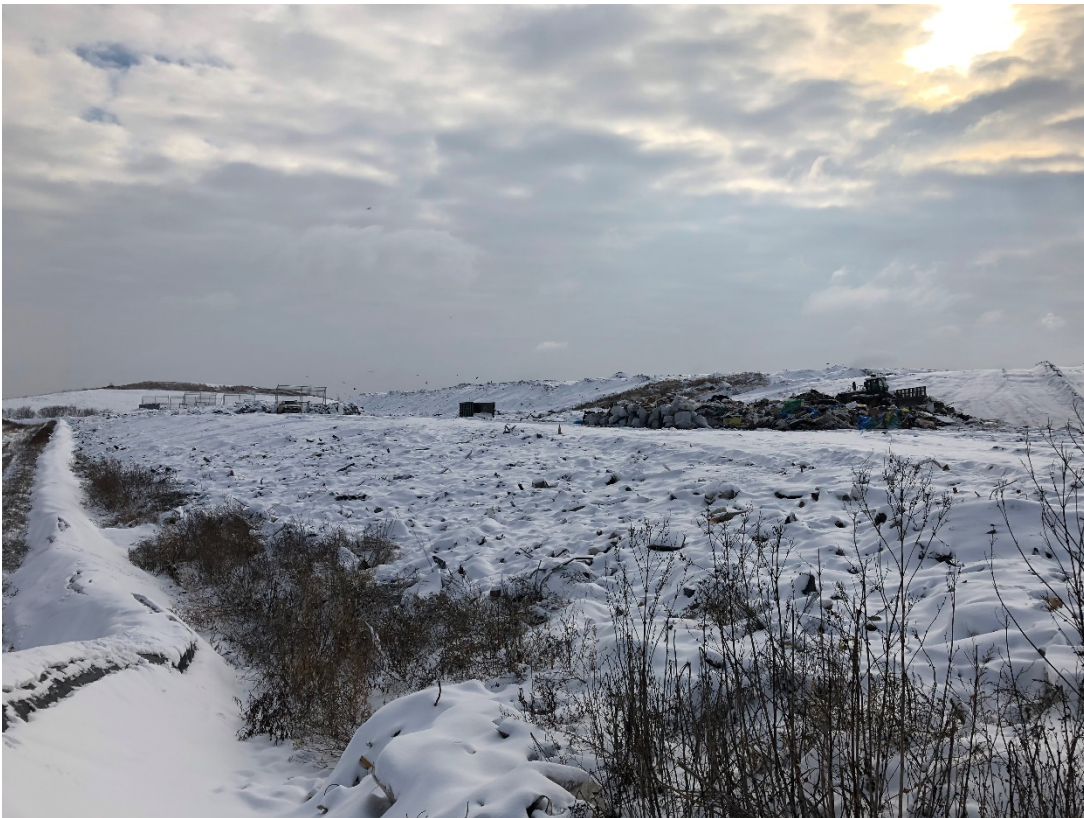
Photo 2: Location 1 – Looking Southeast, New Phase 4 Cell & Phase 3 Waste Slope

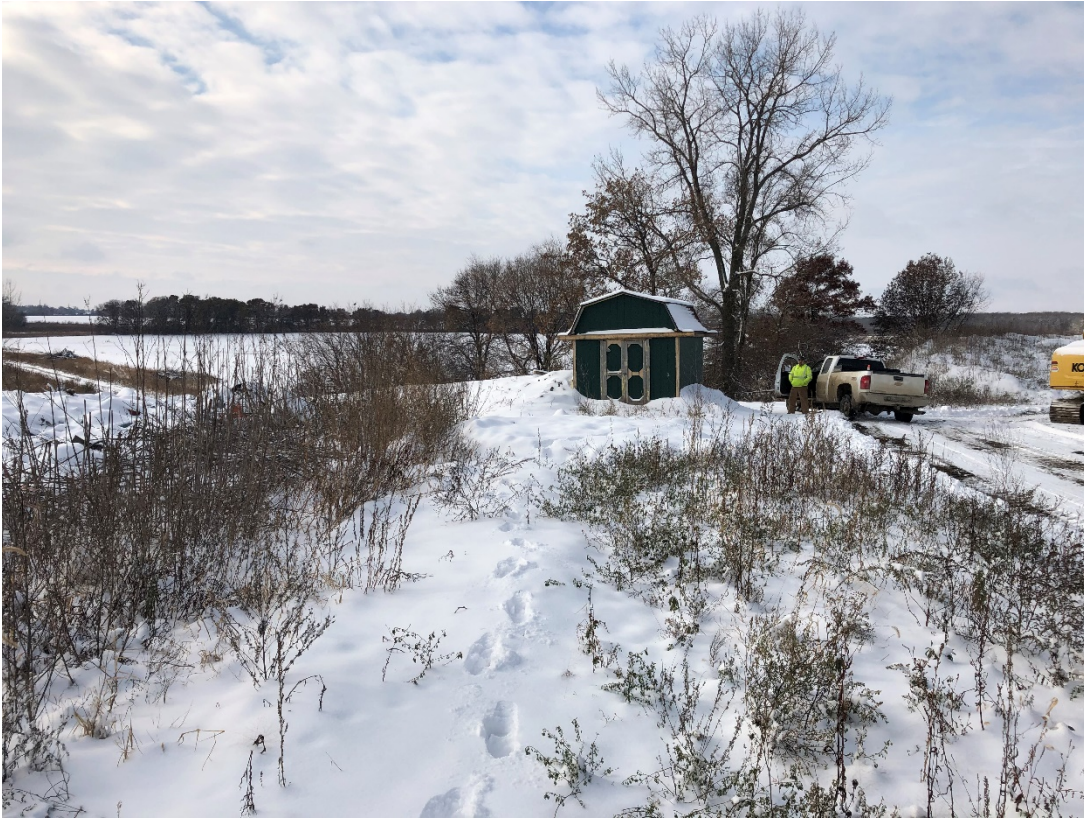
Photo 3: Location 1 – Looking Southwest, Phase 4 Anchor Trench

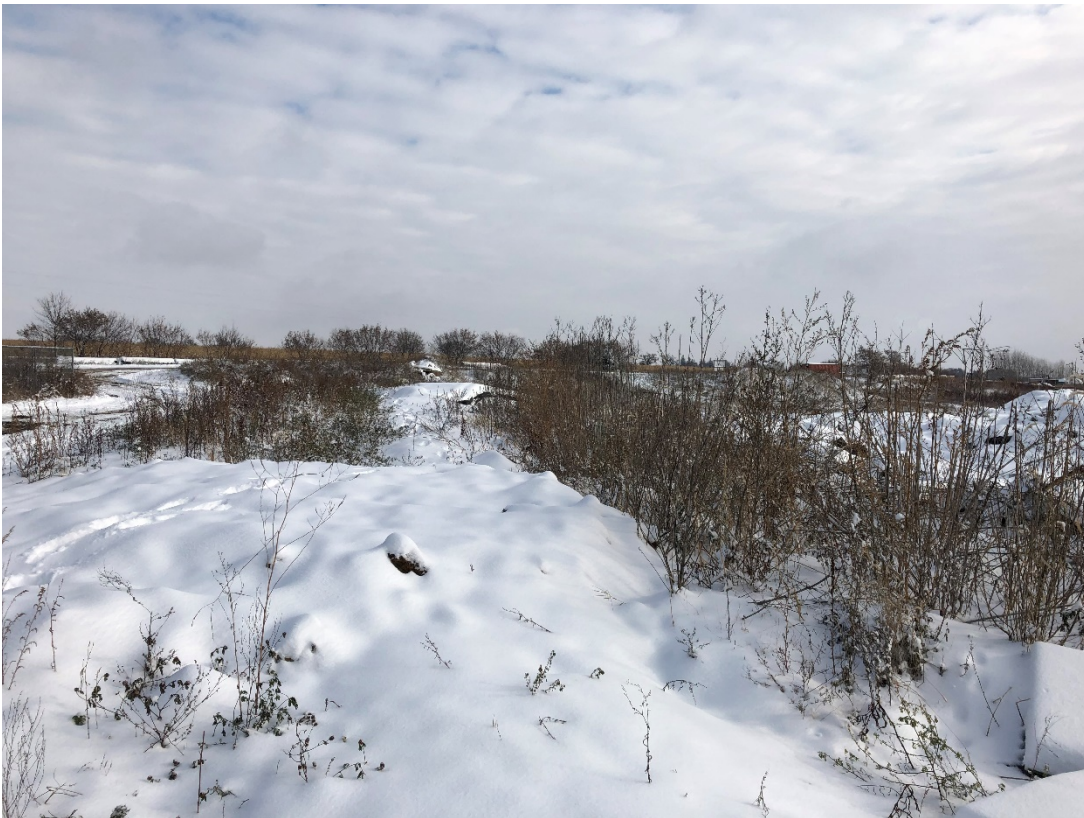
Photo 4: Location 2 – Looking Northeast, Phase 4 Anchor Trench

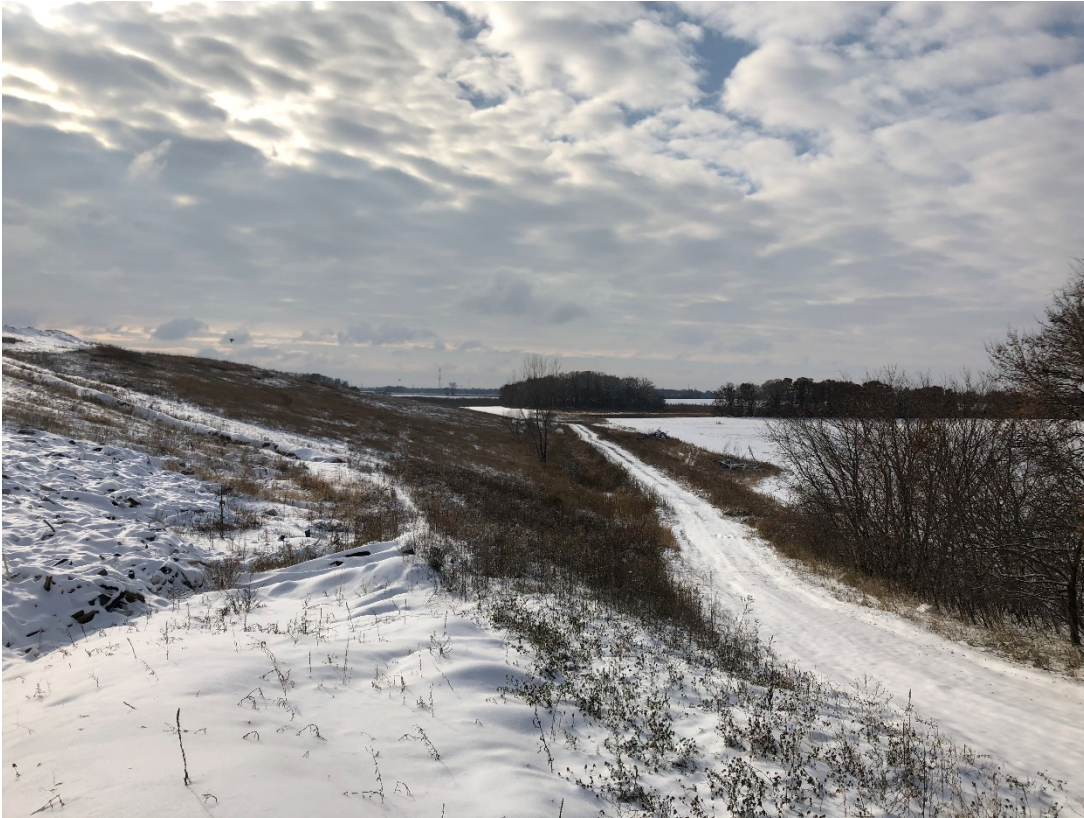
Photo 5: Location 2 – Looking South, Phase 3/1 Western Perimeter

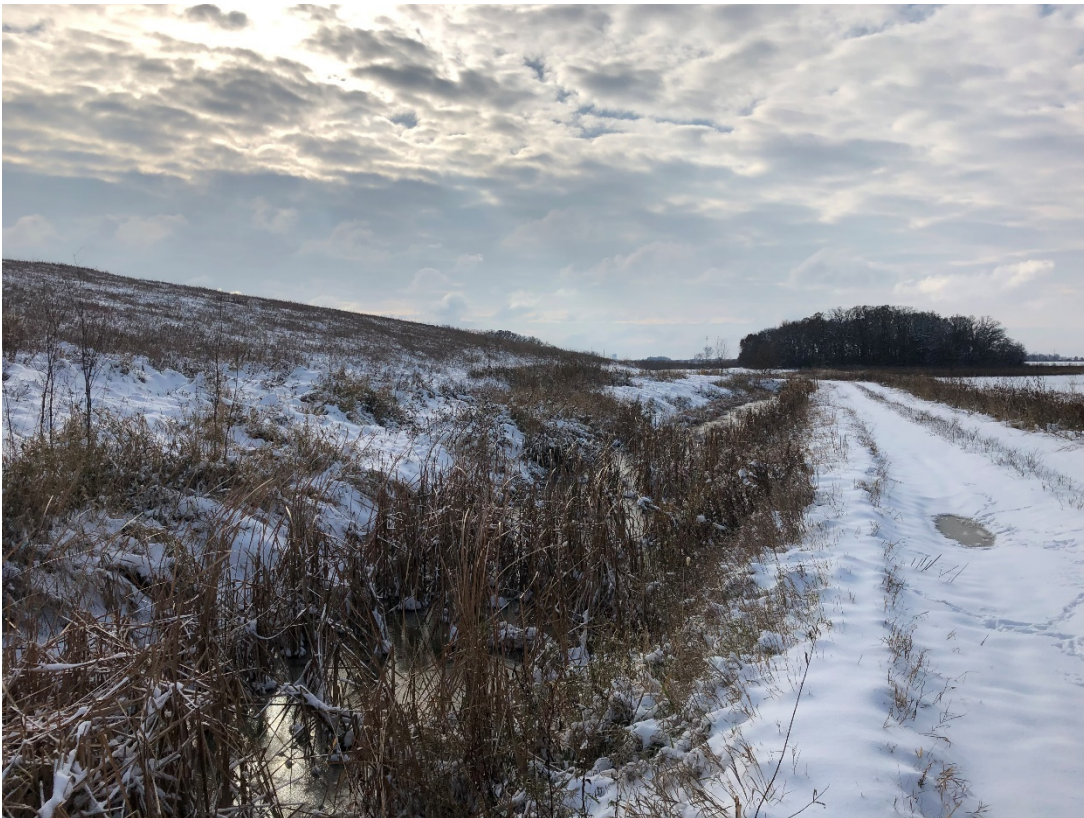
Photo 6: Location 3 – Looking South, Toe of Phase 1 Western Slope

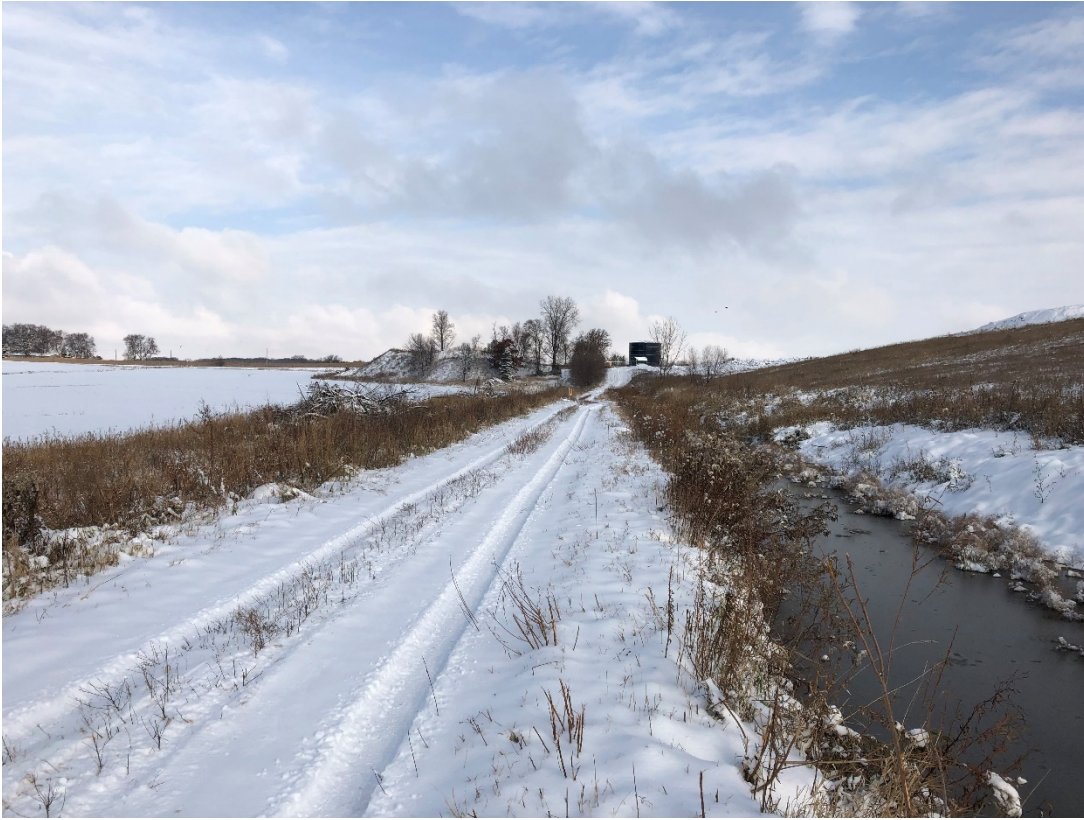
Photo 7: Location 3 – Looking North, Toe of Phase 1 Western Slope

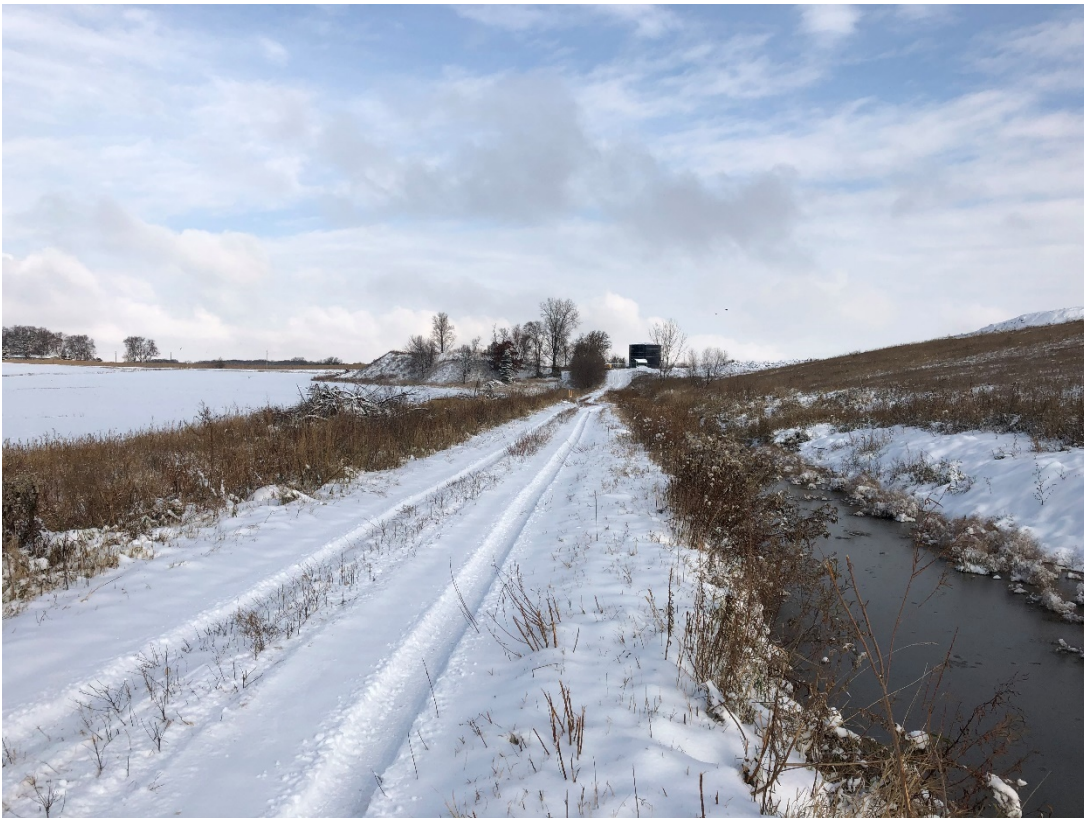
Photo 8: Location 4 – Looking North, Toe of Phase 1 Western Slope

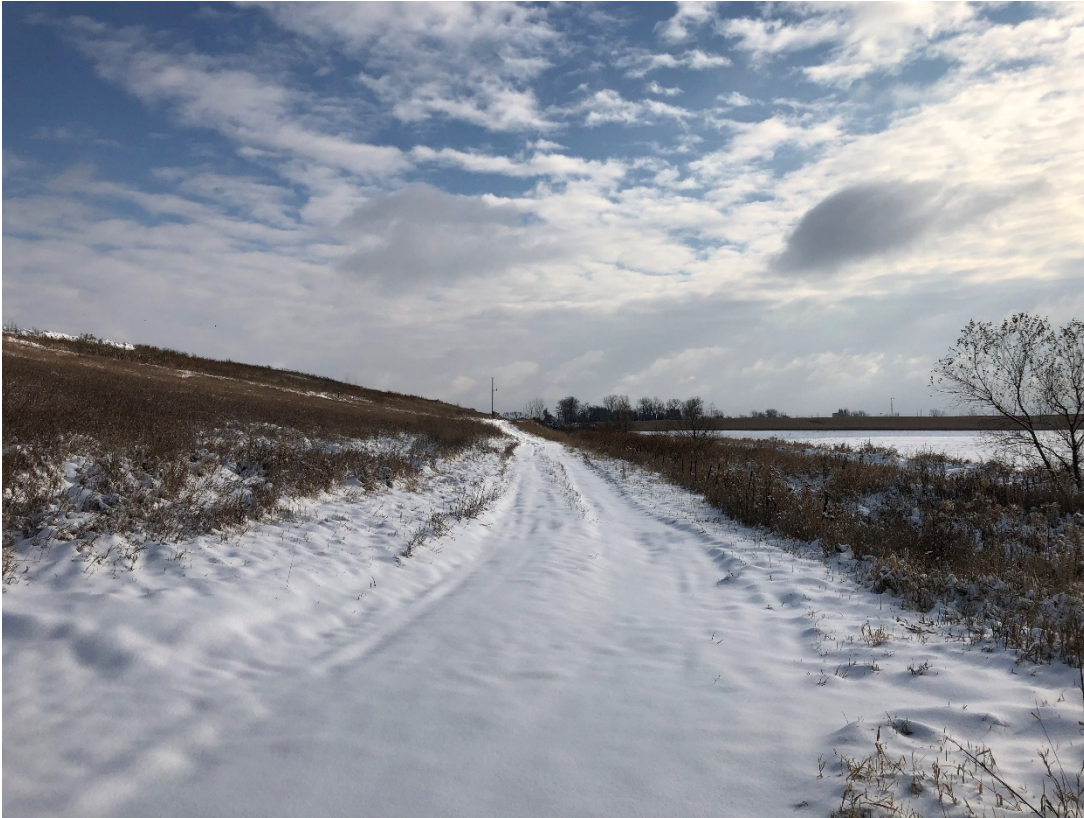
Photo 9: Location 4 – Looking East, Toe of Phase 1 Southern Slope

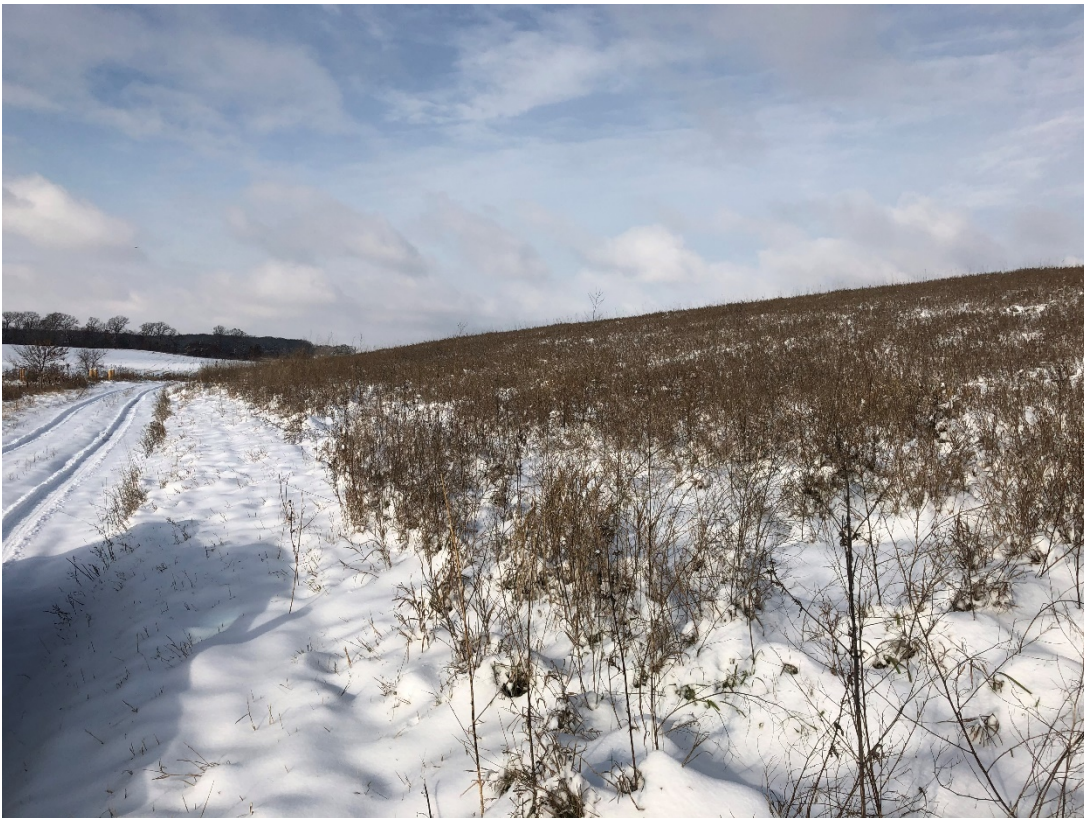
Photo 10: Location 5 – Looking West, Toe of Phase 1 Southern Slope

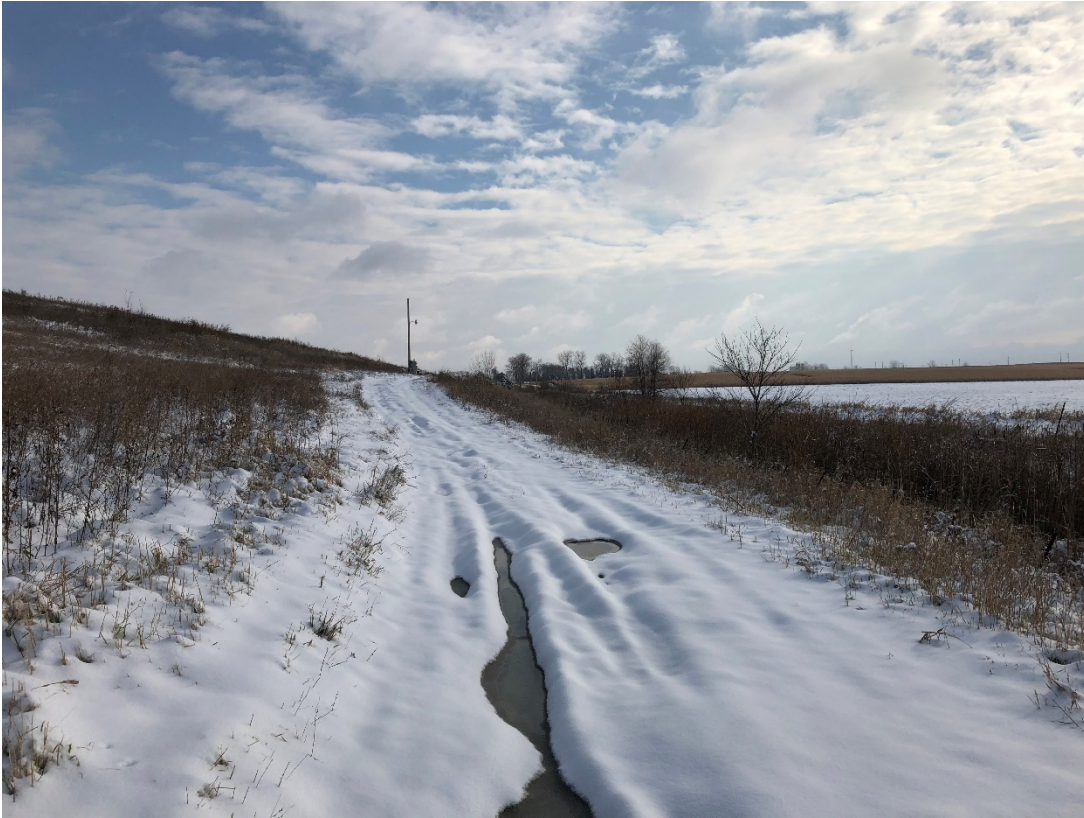
Photo 11: Location 5 – Looking East, Toe of Phase 1 Southern Slope

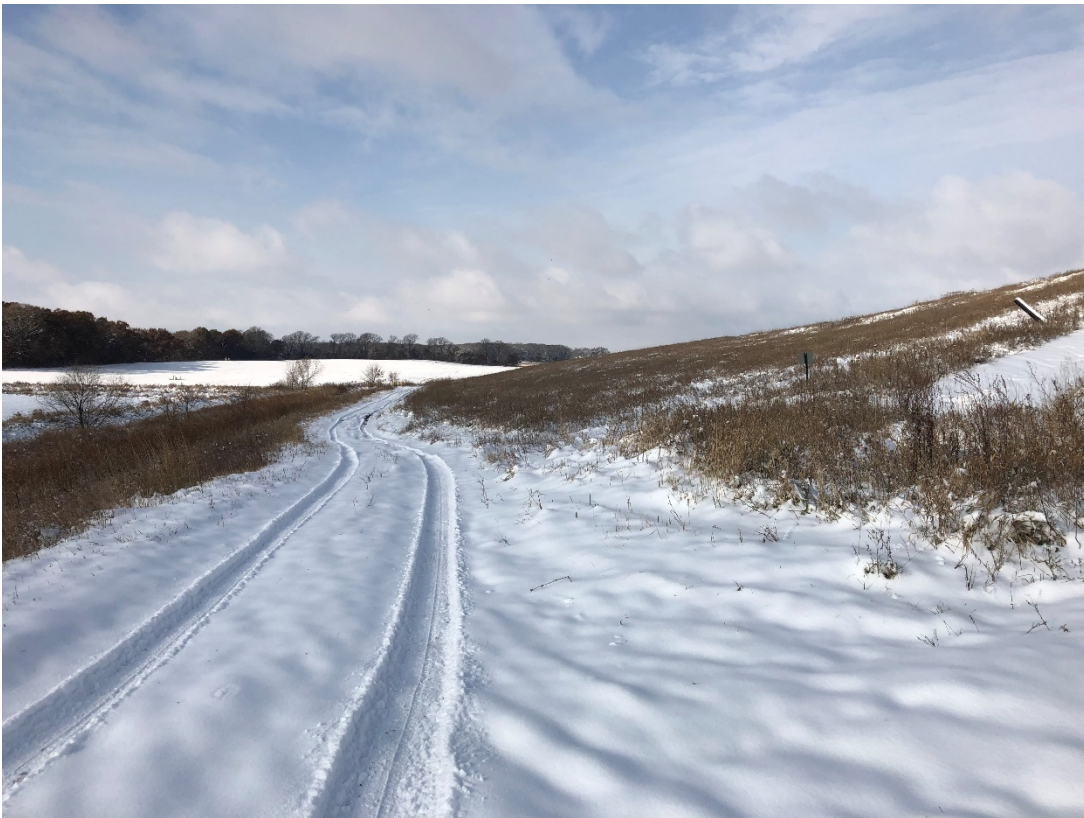
Photo 12: Location 6 – Looking West, Phase 1 Southern Slope

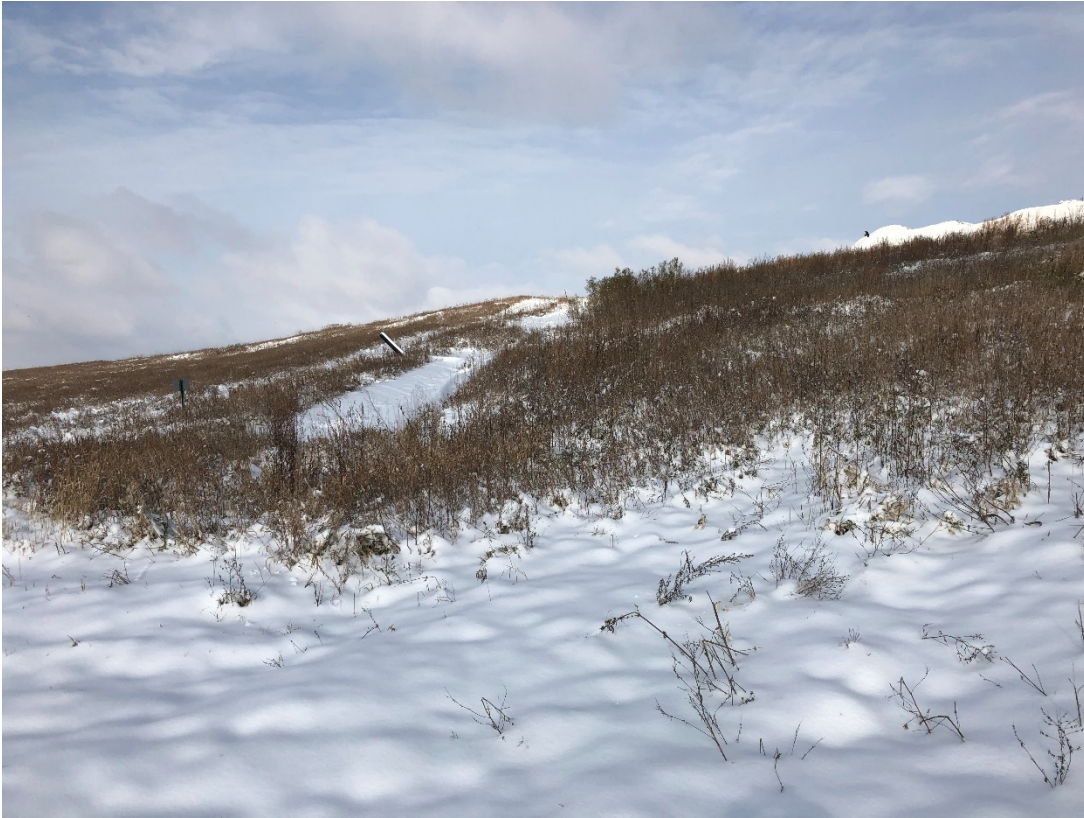
Photo 13: Location 6 – Looking West, Phase 1/2 Overlay Liner & Southern Slope

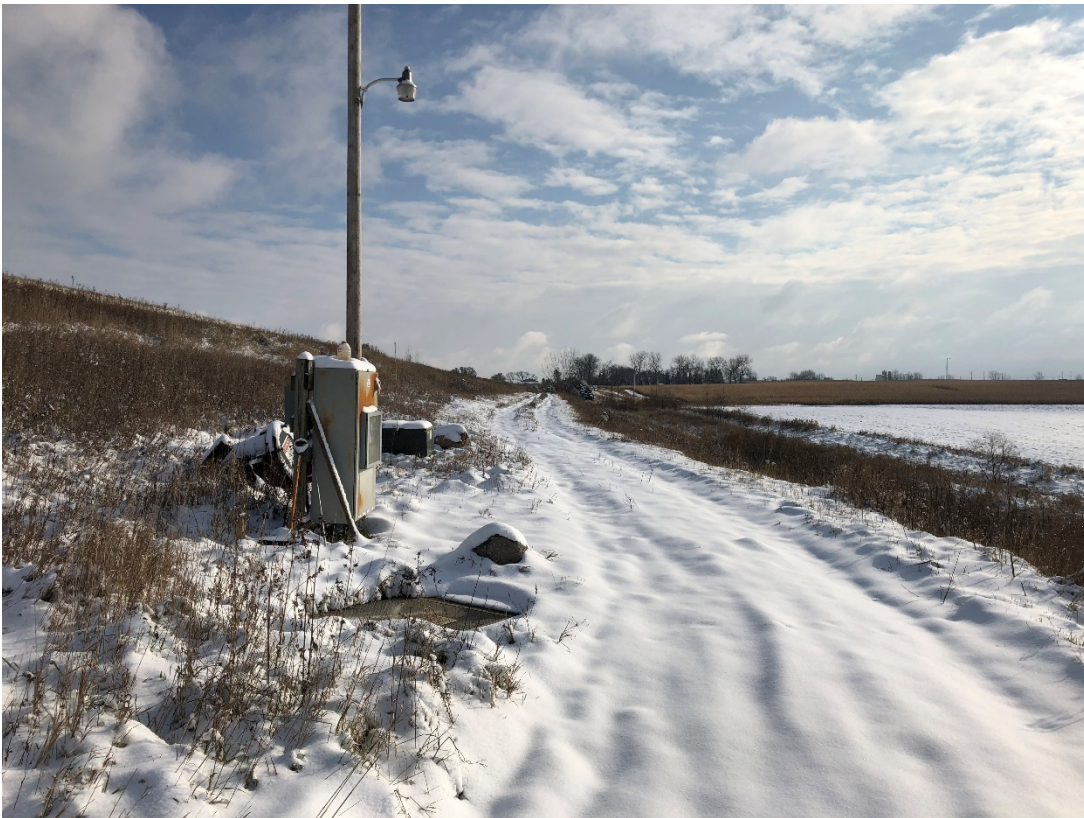
Photo 14: Location 6 – Looking East, Phase 2 Southern Slope

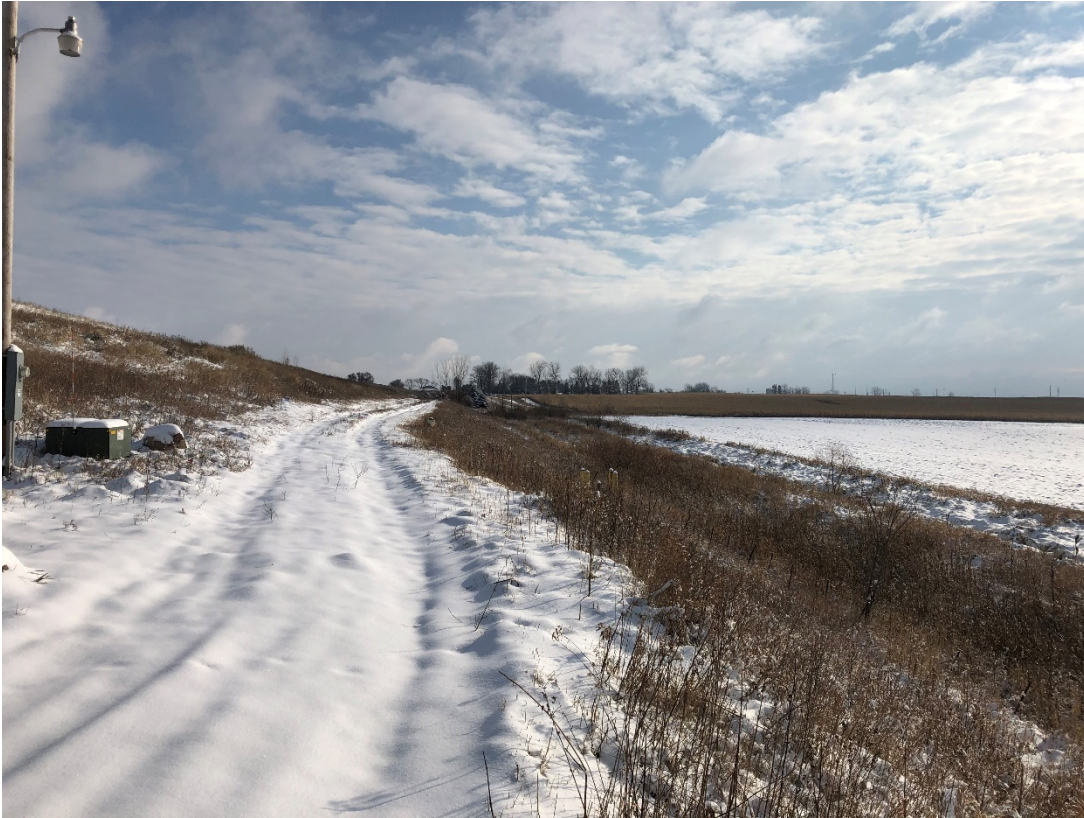
Photo 15: Location 6 – Looking East, Phase 2 Southern Berm

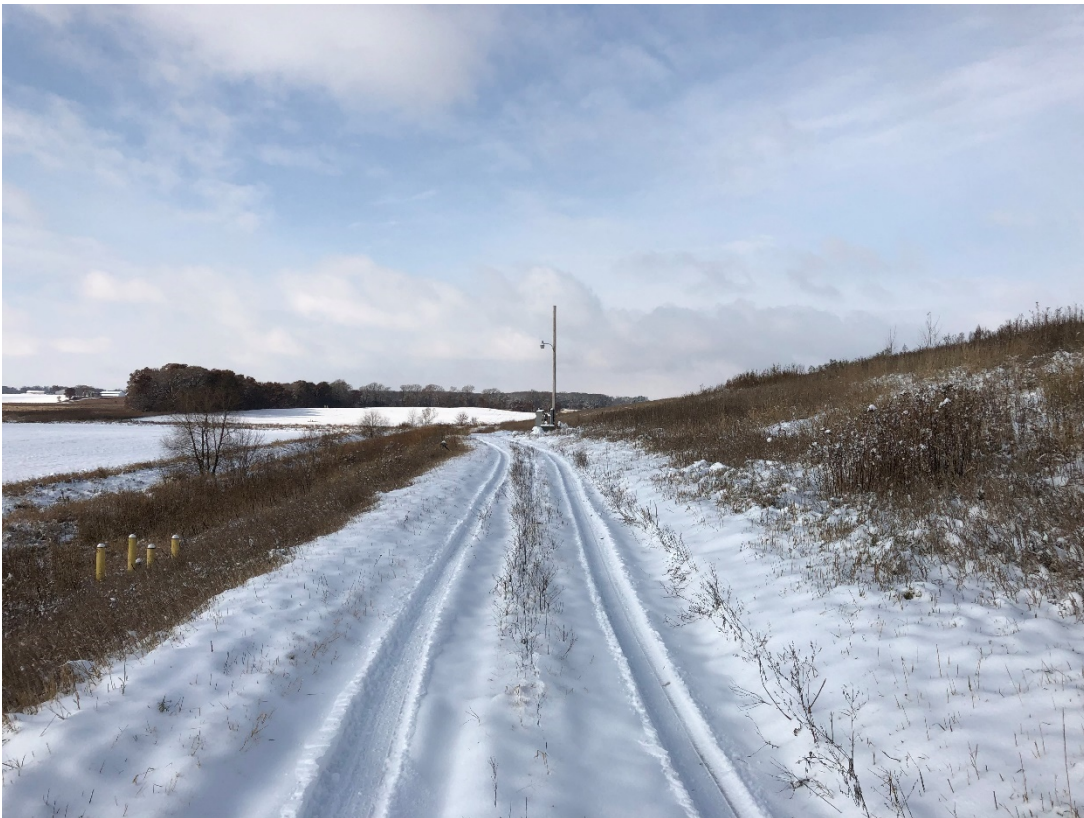
Photo 16: Location 7 – Looking West, Phase 2 Southern Perimeter Road and Slope

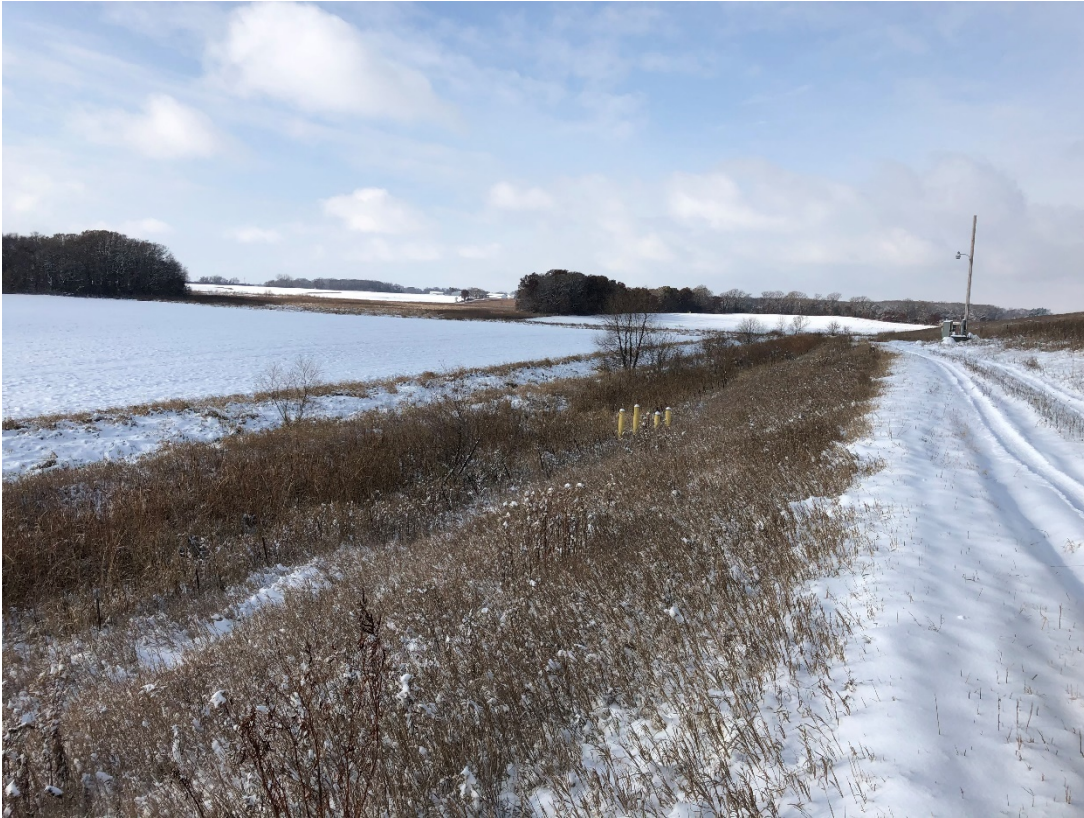
Photo 17: Location 7 – Looking West, Phase 2 Southern Berm

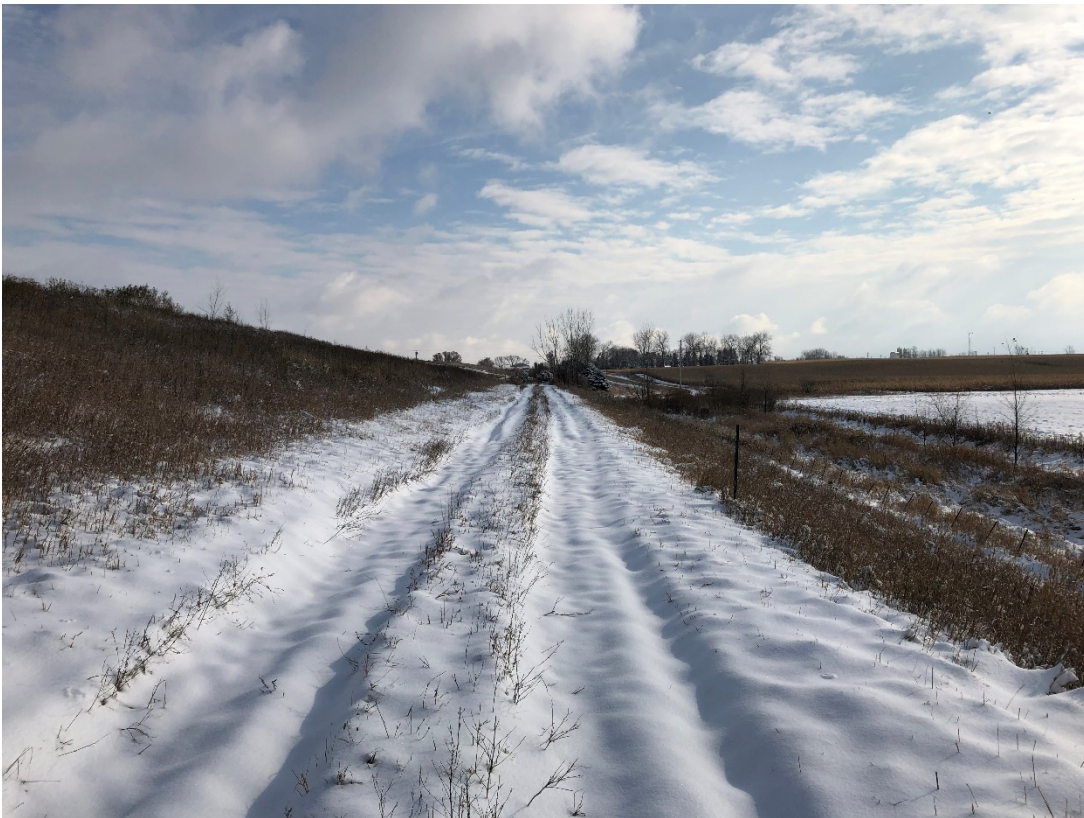
Photo 18: Location 7 – Looking East, Phase 2 Southern Perimeter Road and Slope

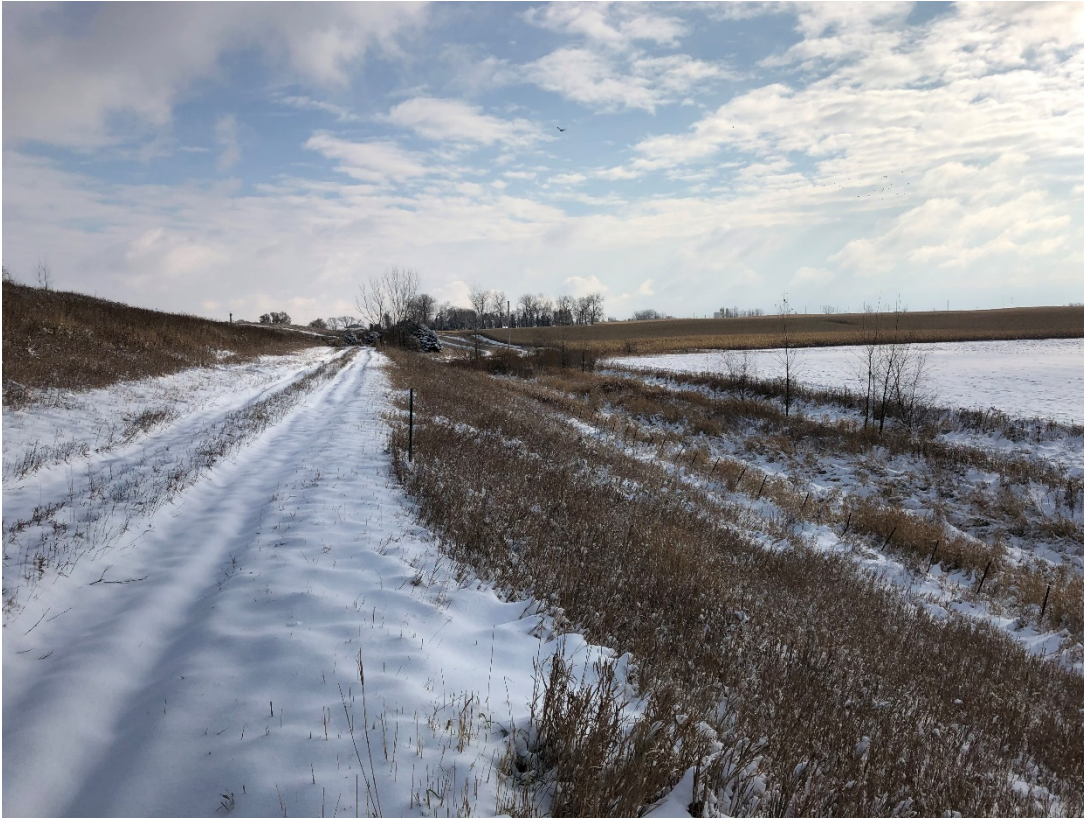
Photo 19: Location 7 – Looking East, Phase 2 Southern Berm
