Technical Memo

To: Geoff Strack, P.E., Waste Connections
From: Brad Sullivan, P.E., Wenck Associates, Inc.
Date: January 9, 2020
Subject: WCI Austin Landfill, LLC
2019 Annual CCR Inspection Report
Wenck Project #B3053-0180

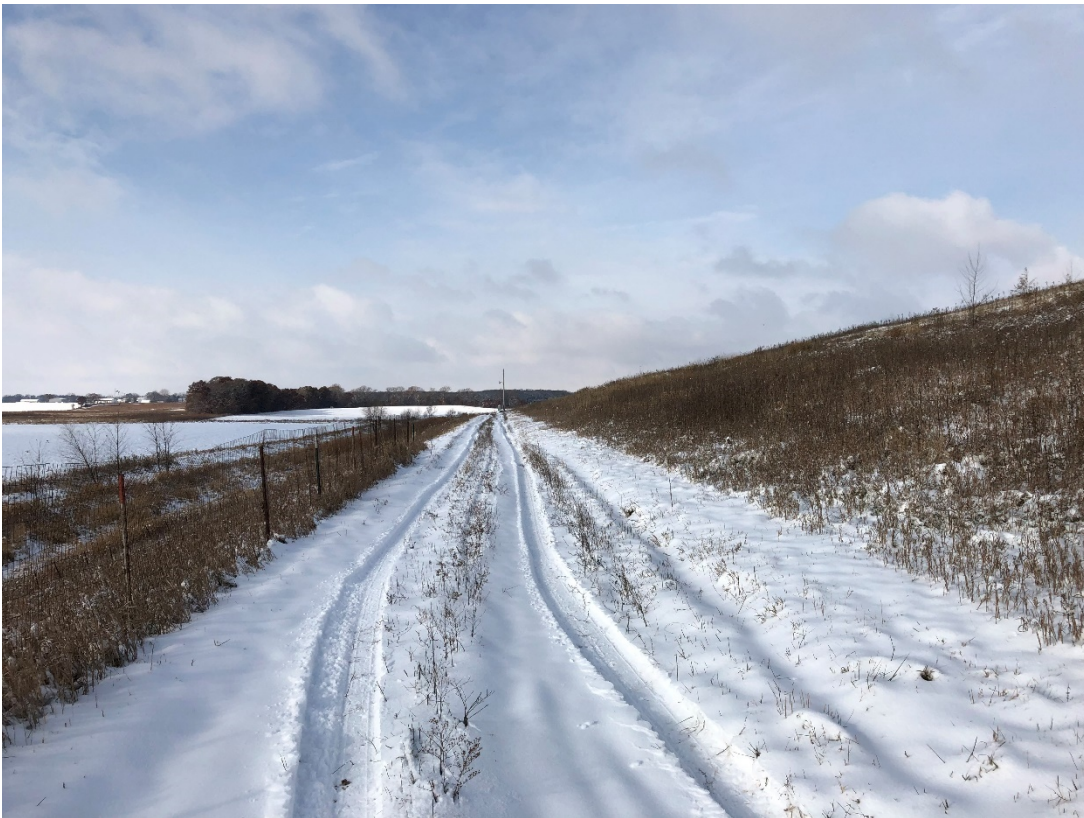
Photo 20: Location 8 – Looking West, Phase 2 Southern Perimeter Road and Slope

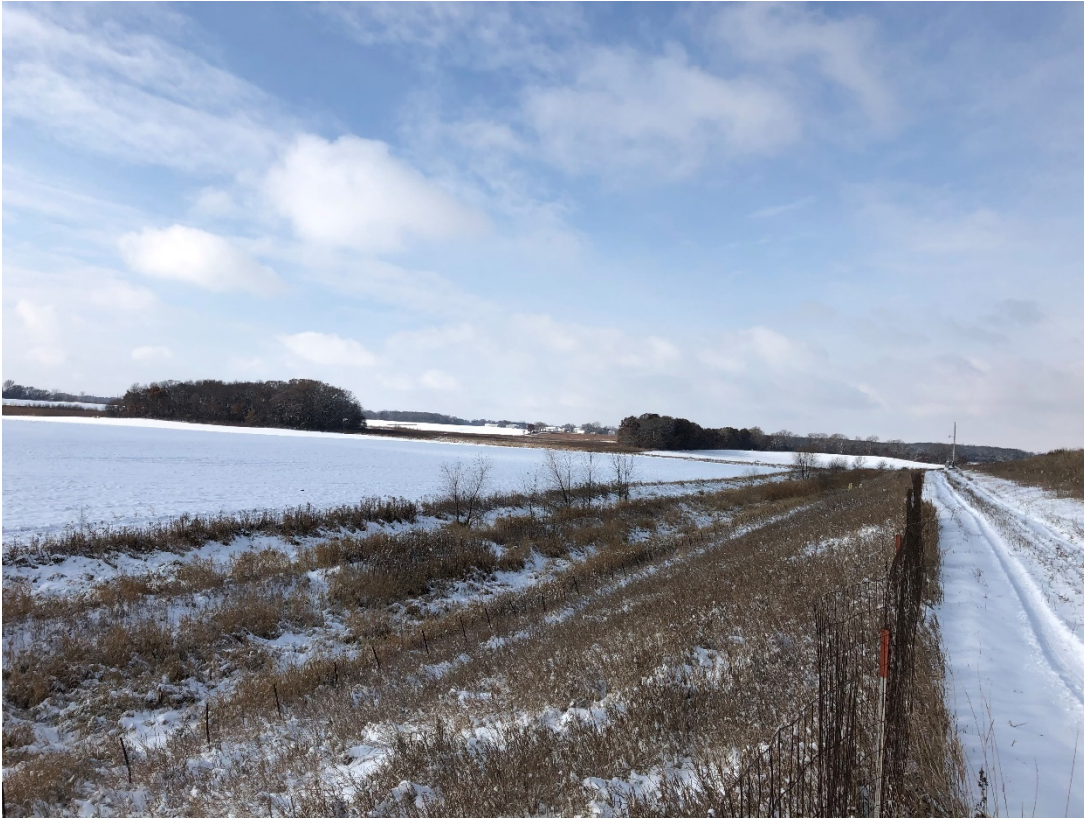
Photo 21: Location 8 – Looking West, Phase 2 Southern Berm

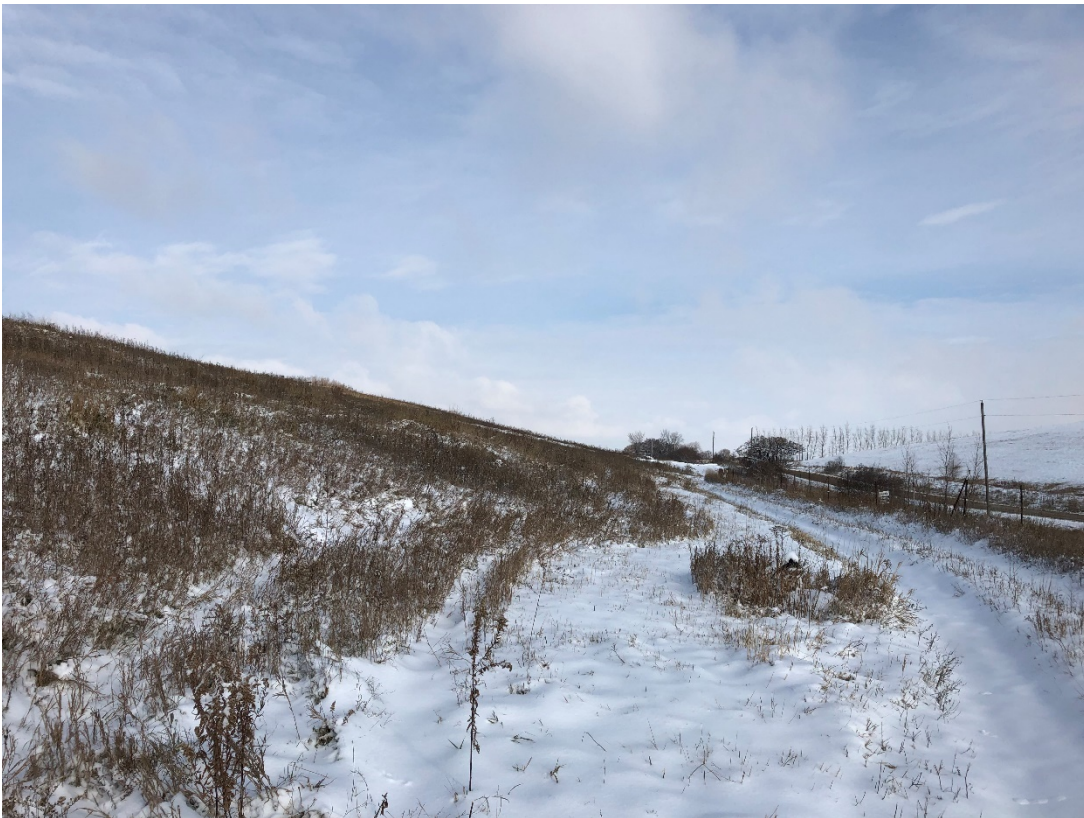
Photo 22: Location 8 – Looking North, Phase 2 Eastern Slope

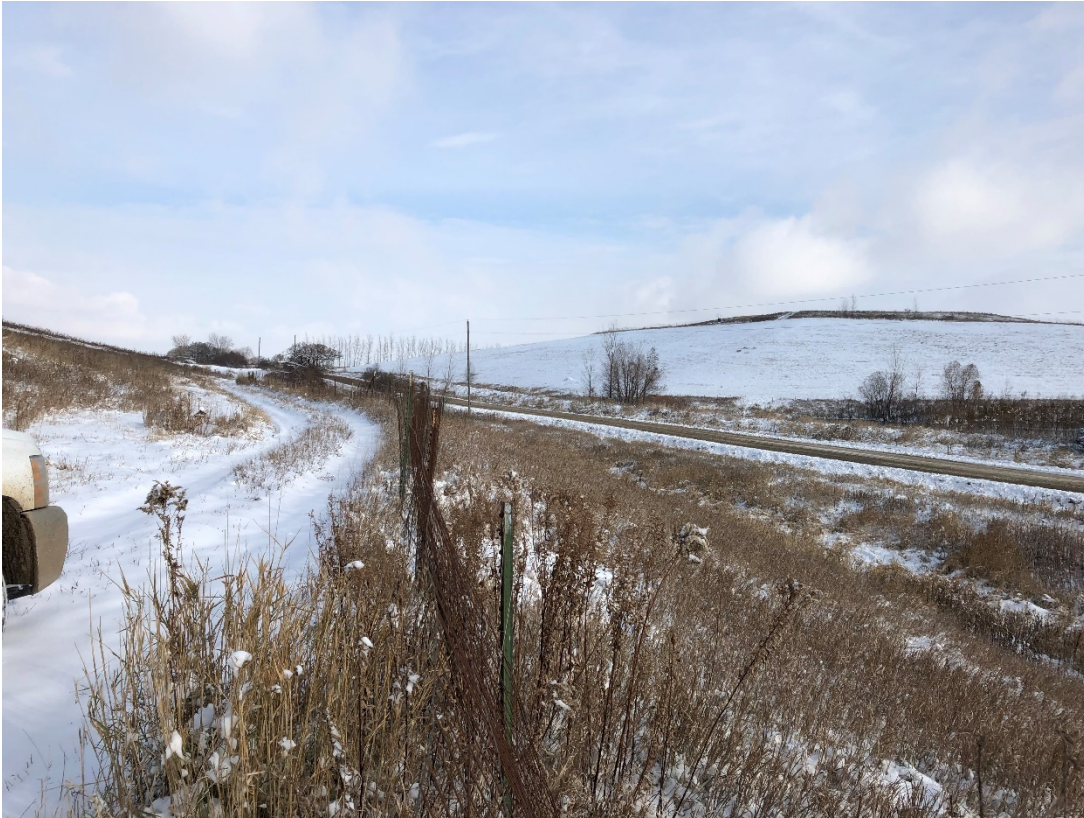
Photo 23: Location 8 – Looking North, Phase Eastern Berm

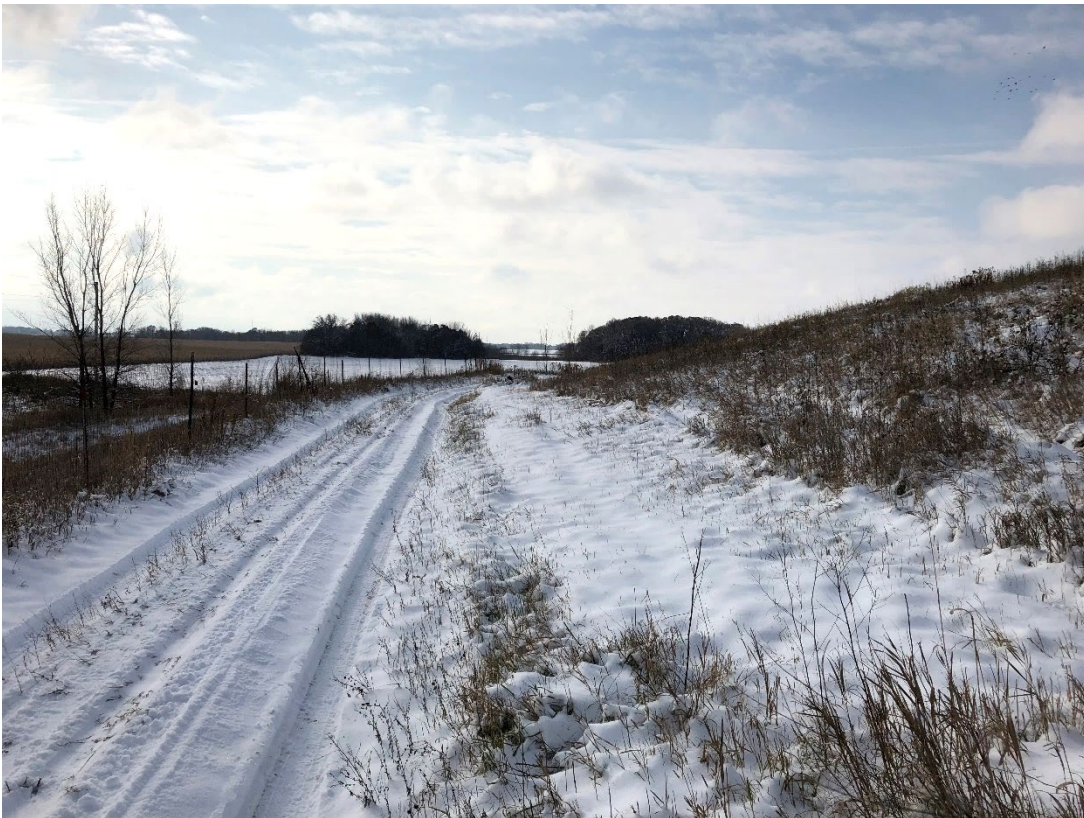
Photo 24: Location 9 – Looking South, Phase 2 Eastern Perimeter Road & Slope

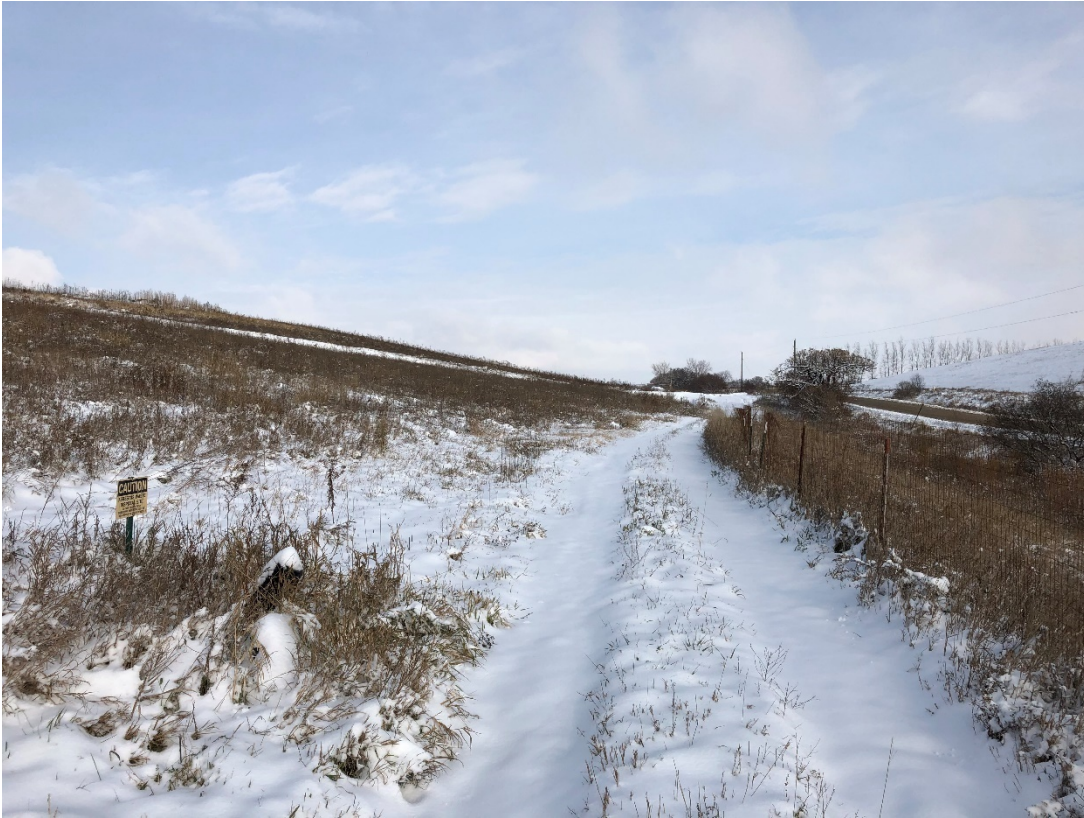
Photo 25: Location 9 – Looking North, Phase 2 Eastern Perimeter Road & Slope

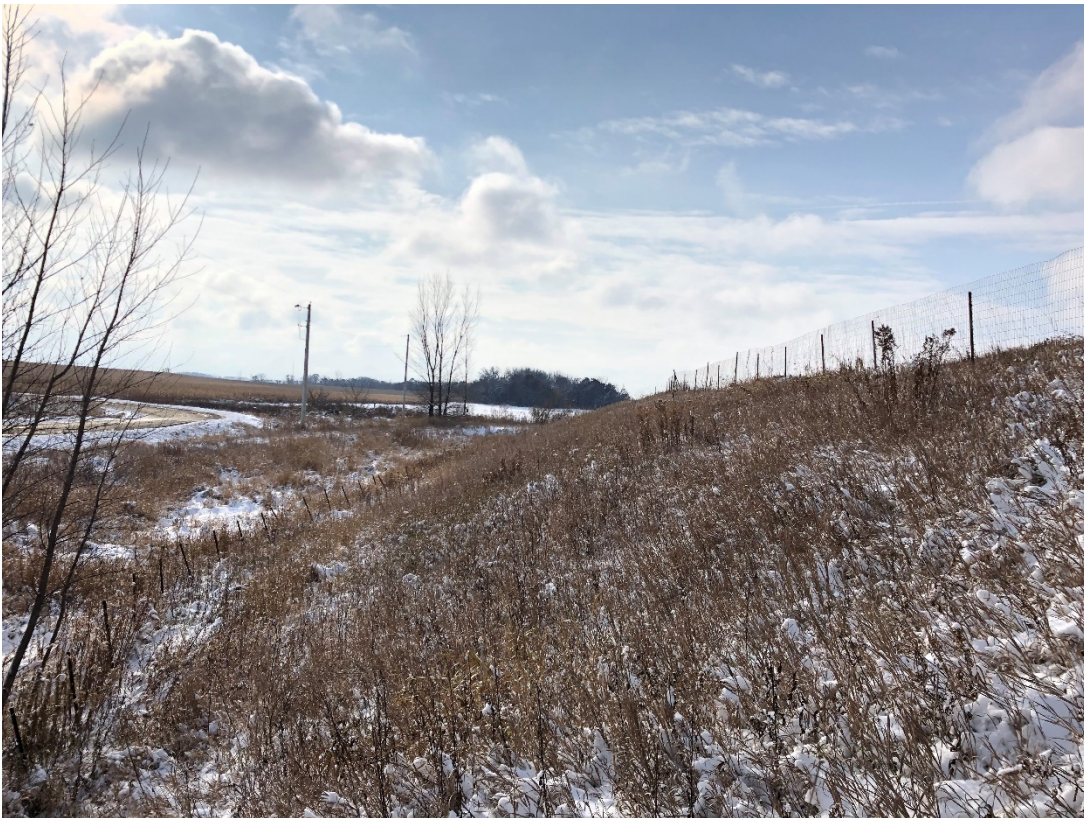
Photo 26: Location 9 – Looking South, Phase 2 Eastern Berm

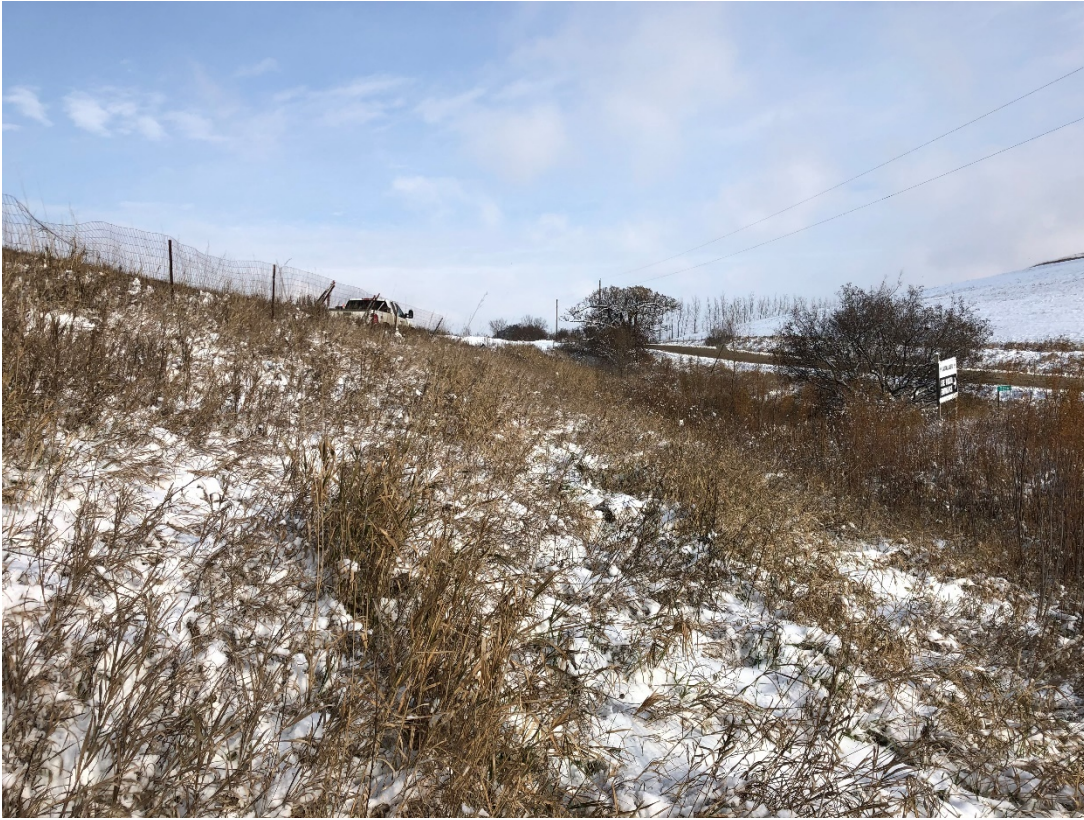
Photo 27: Location 9 – Looking North, Phase 2 Eastern Berm

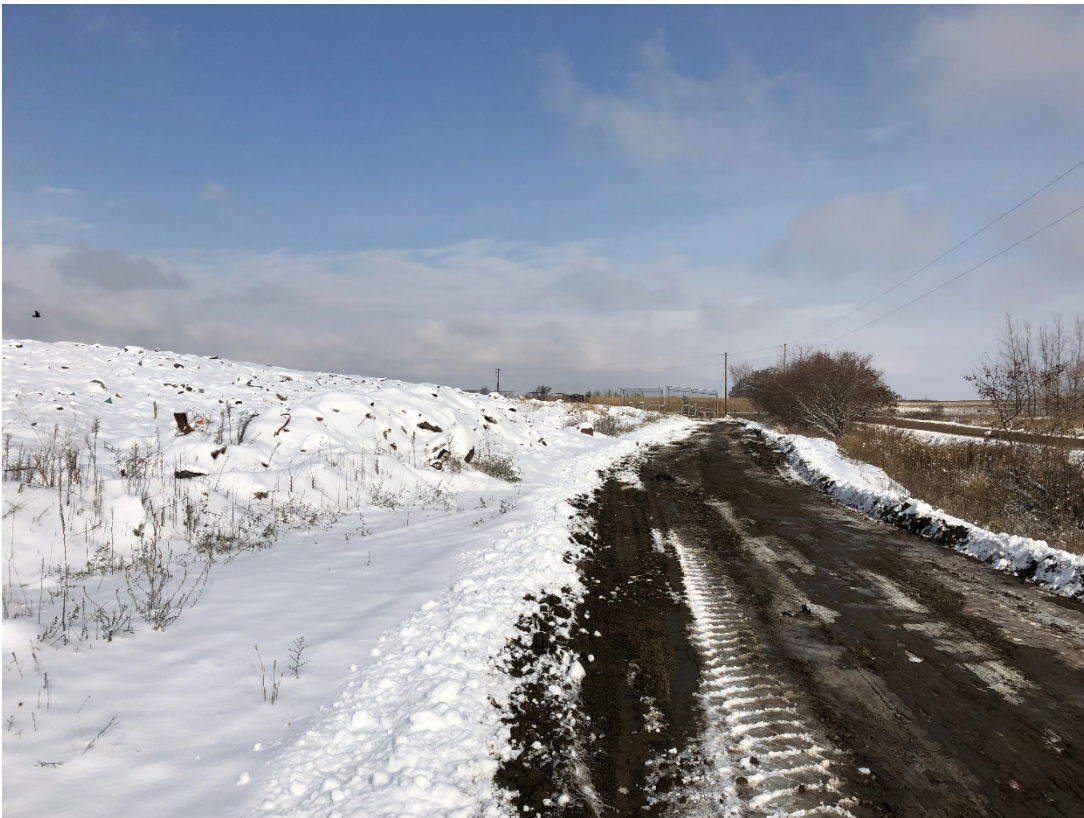
Photo 28: Location 10 – Looking North, Eastern Perimeter Road

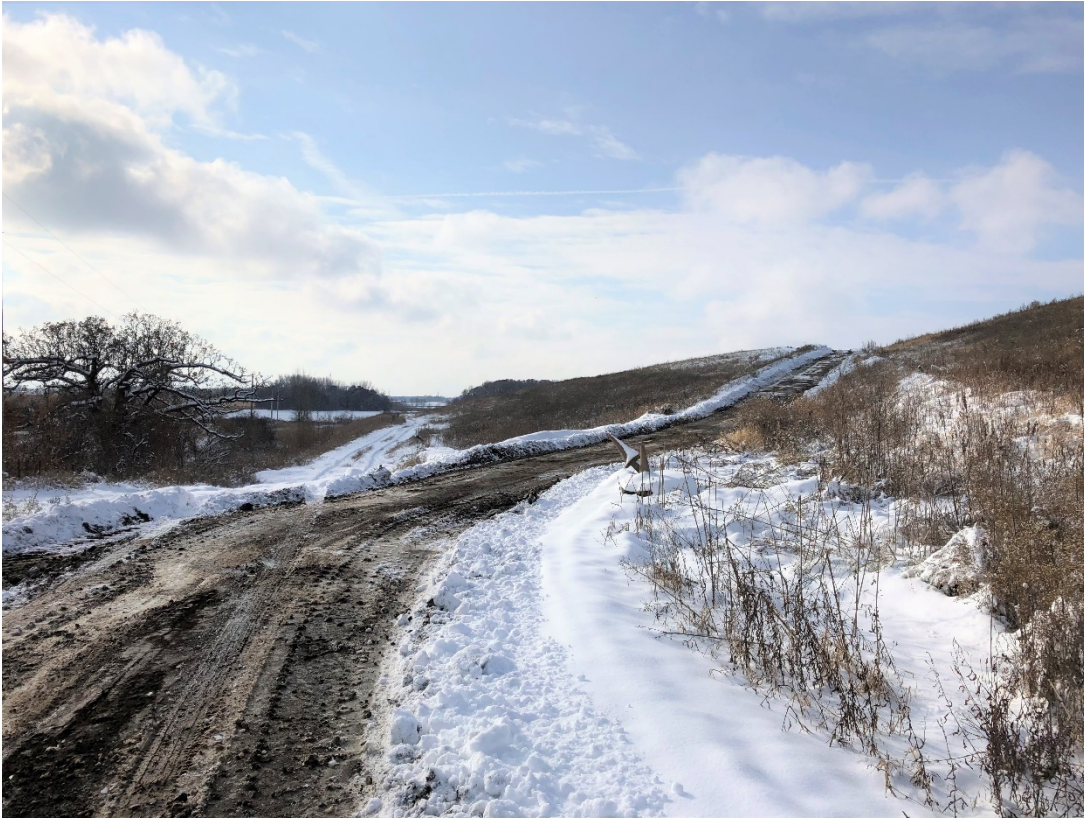
Photo 29: Location 10 – Looking South, Phase 2 Eastern Slope and Interior Access Road Entrance

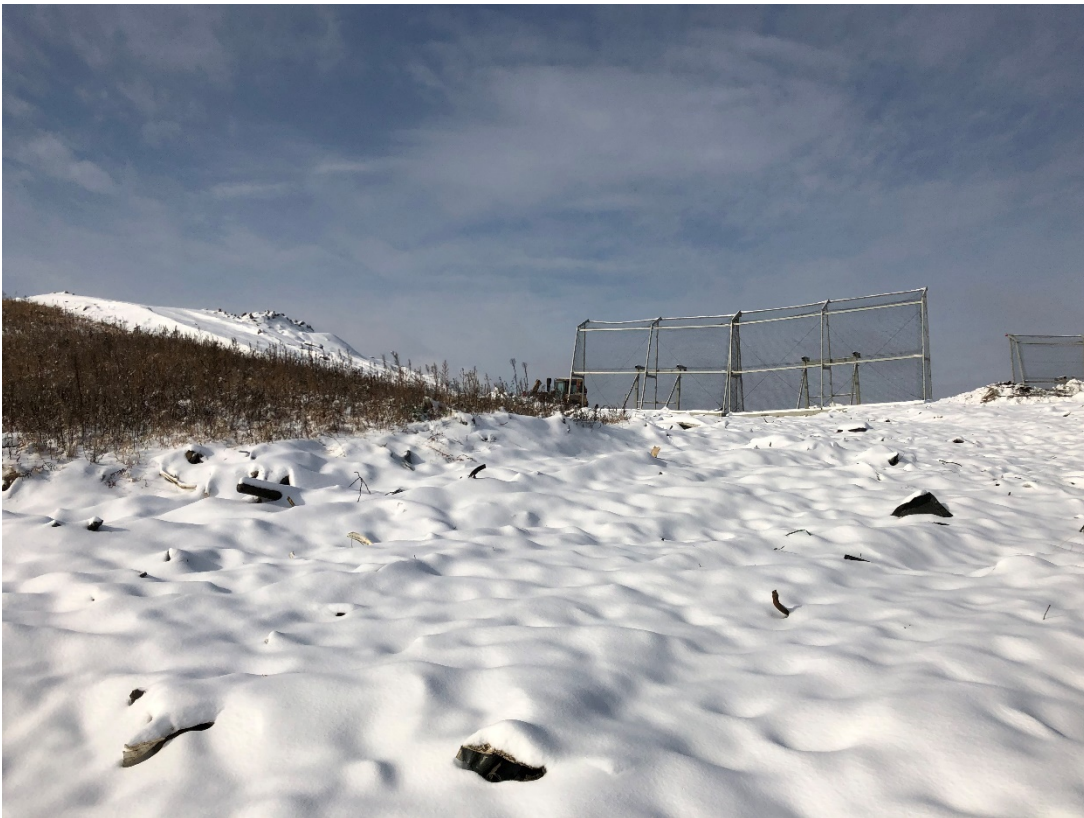
Photo 30: Location 11 – Looking West, Phase 3/4 Connection, Phase 3 Norther Interior Waste Slope

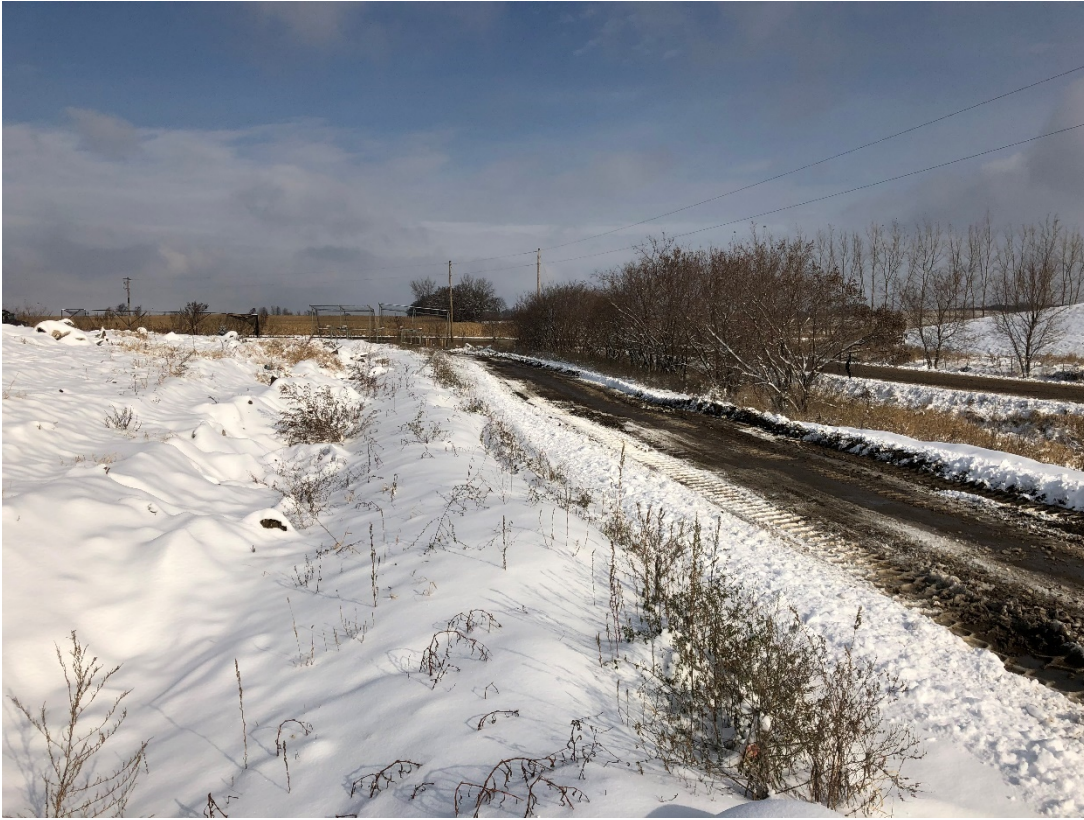
Photo 31: Location 11 – Looking North, Phase 4 Eastern Anchor Trench

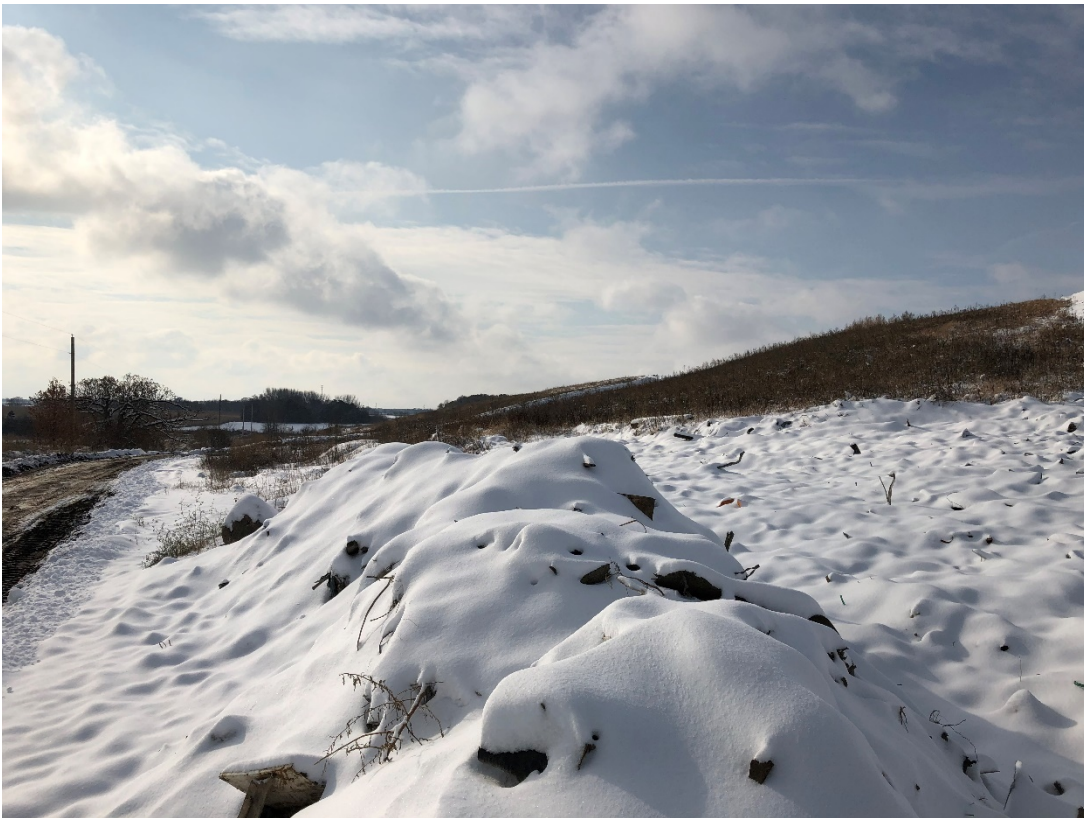
Photo 32: Location 12 – Looking South, Phase 4 Eastern Anchor Trench & Phase 3 Eastern Waste Slope

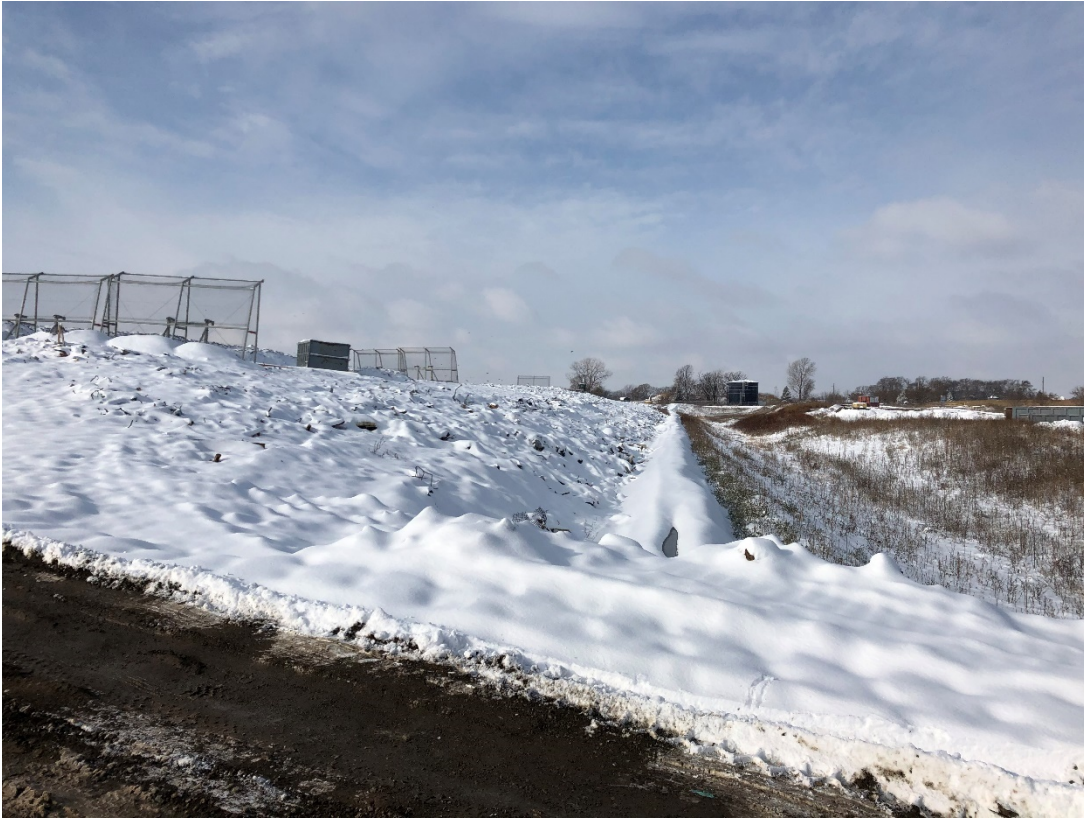
Photo 33: Location 12 – Looking West, Phase 4 Northern Rain Flap

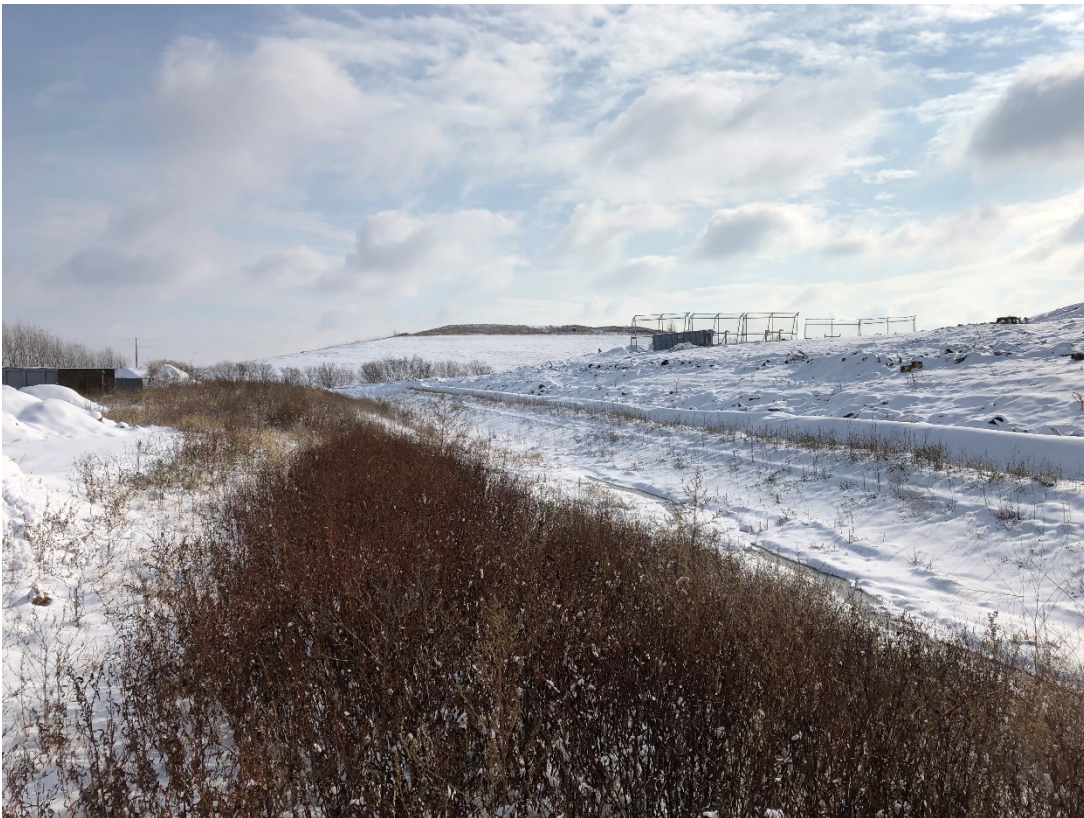
Photo 34: Location 13 – Looking East, Phase 4 Northern Rain Flap

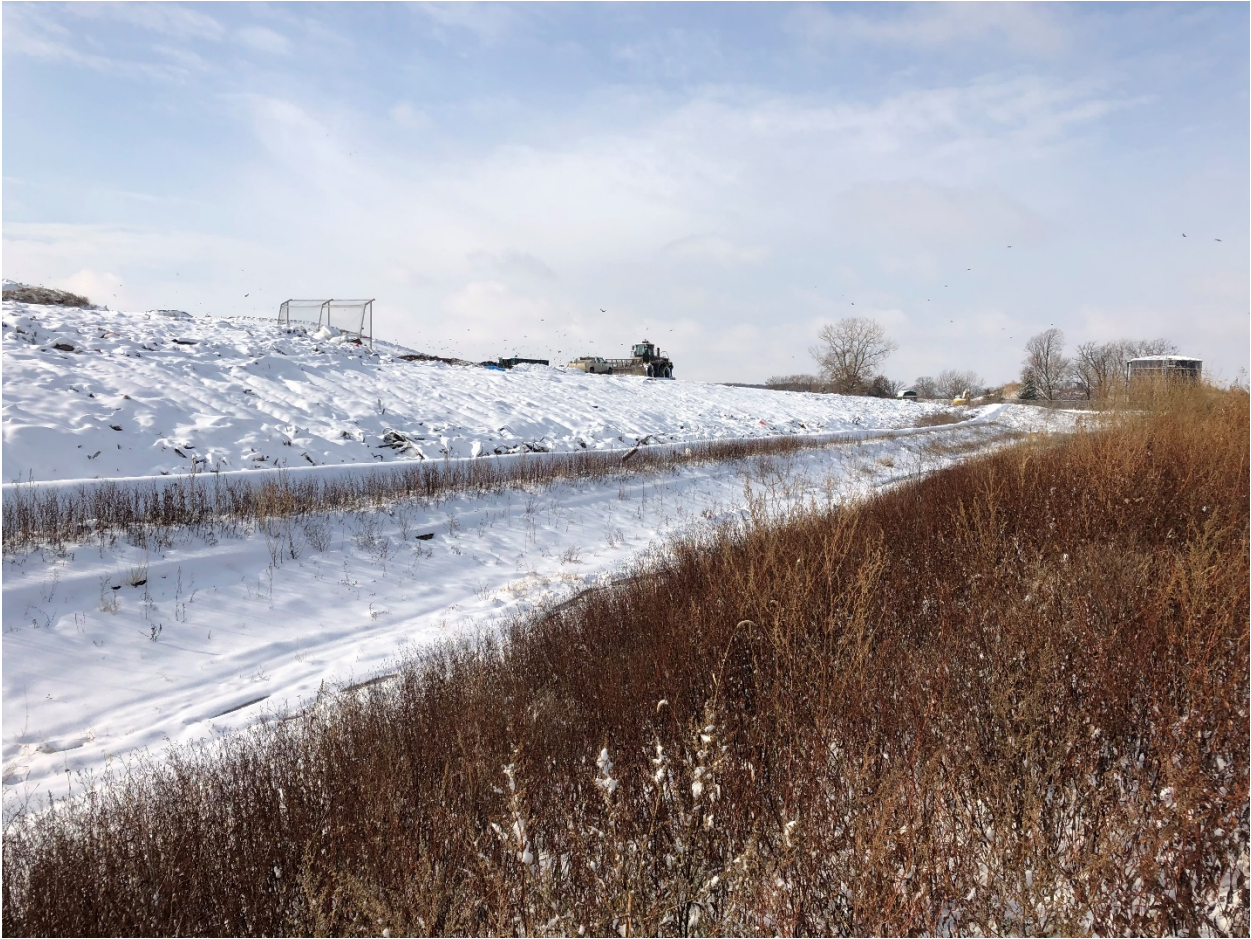
Photo 35: Location 13 – Looking West, Phase 4 Northern Rain Flap
