To: Geoff Strack, PE, Waste Connections From: Bradley W Sullivan, PE, Stantec
File: 227704387 Date: January 7, 2022

Reference: WCI Austin Landfill, LLC 2021 Annual CCR Inspection Report

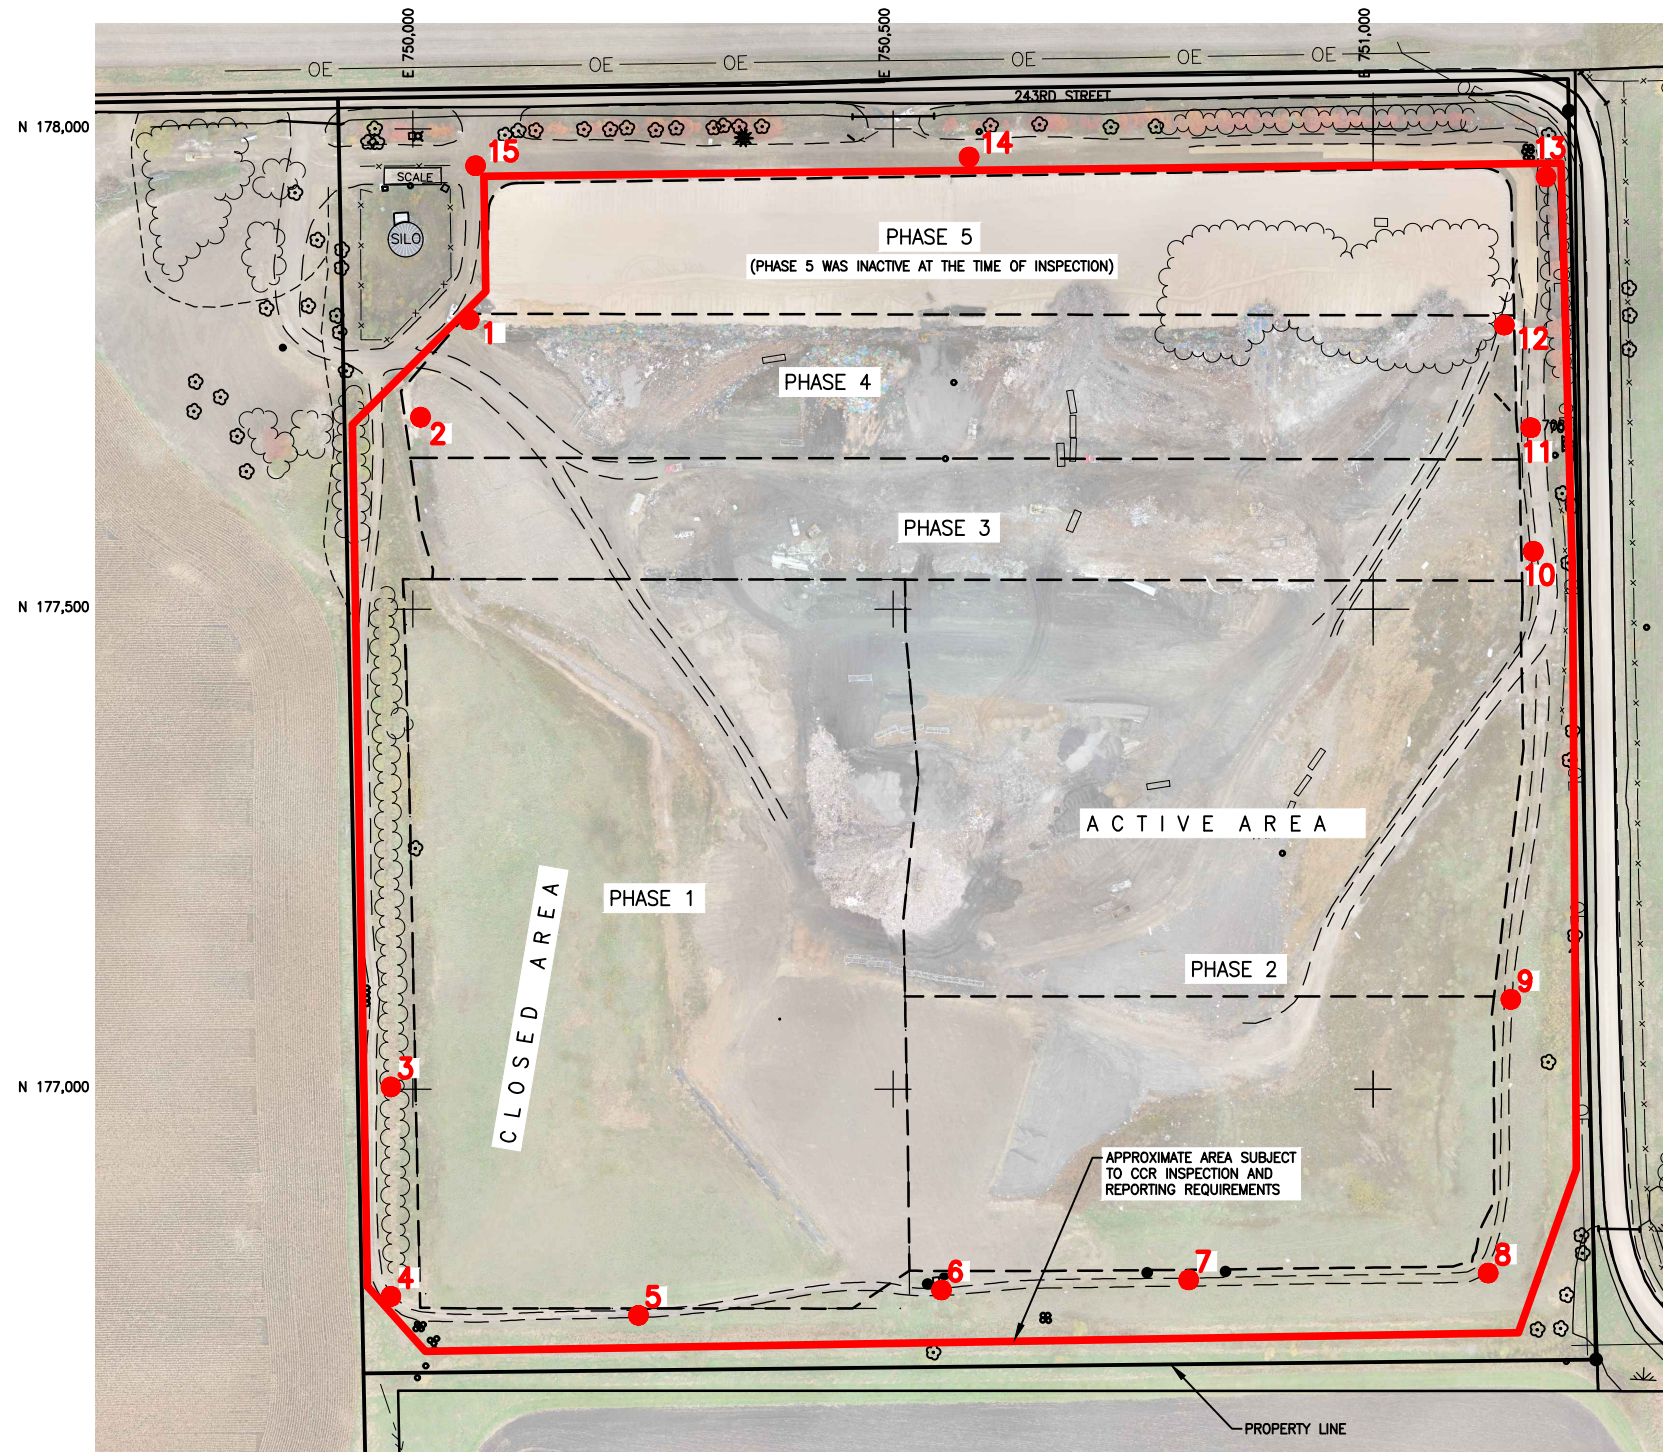
SHEET TITLE PHOTO LOCATIONS			
DWN BY JVB	CHK'D TJS	APP'D BWS	DWG DATE JAN. 2022
PROJECT NO. 227704387	SHEET NO. FIGURE 1	REV NO. 0	SCALE AS NOTED

Photos were taken during the inspection. Figure 1 presents the photo locations, and Attachment 1 contains a photo log and the photos taken.

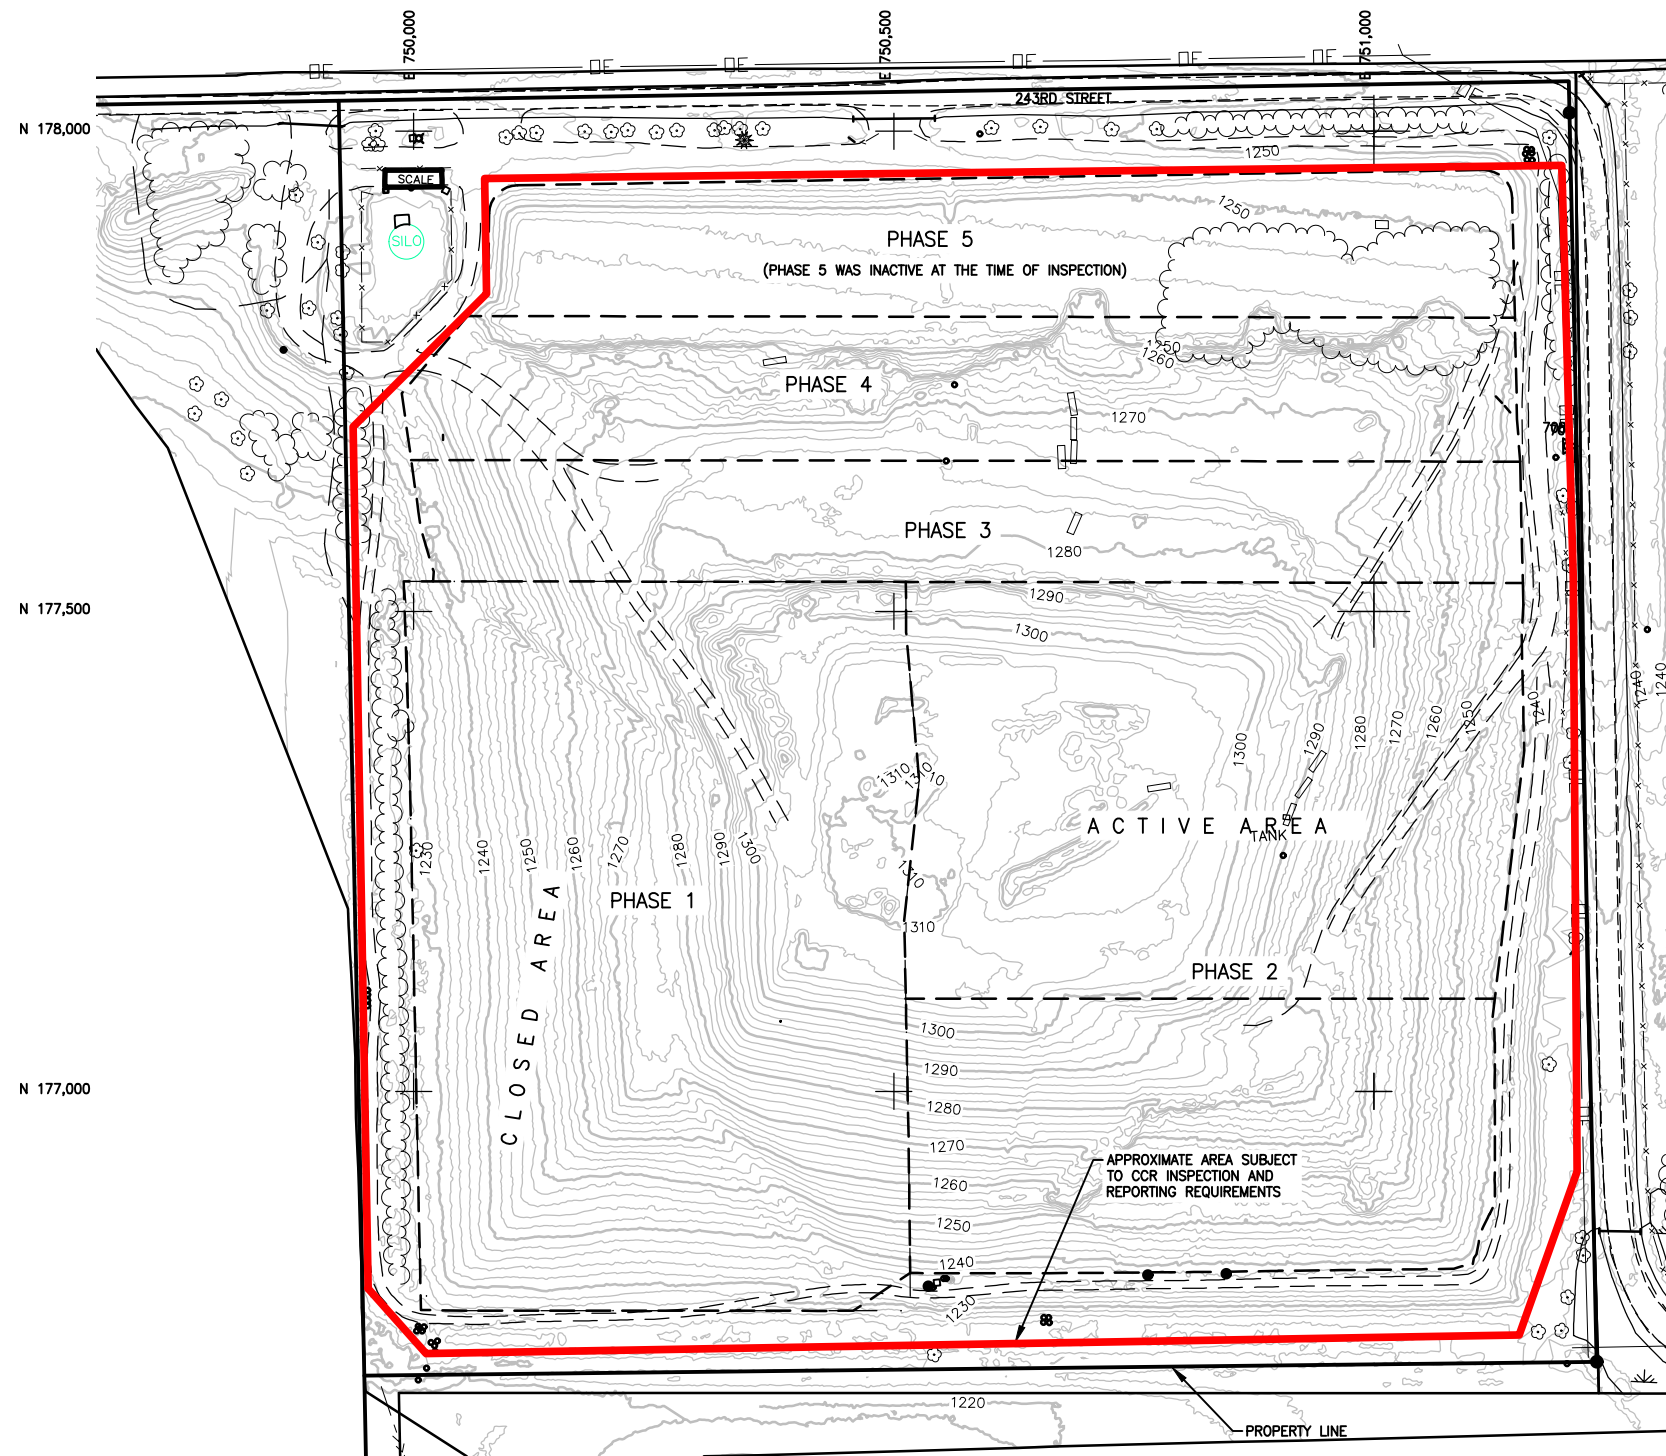
SHEET TITLE SITE MAP			
DWN BY JVB	CHK'D TJS	APP'D BWS	DWG DATE JAN. 2021
PROJECT NO. 227704387		SCALE AS NOTED	
SHEET NO. FIGURE 2		REV NO. 0

There were no apparent changes to the embankment geometry of Cells 1, 2, 3, or 4, other than the construction of Phase 5, when compared to the permit drawings or the past inspection reports. This year's annual aerial photogrammetry survey was performed on October 22, 2021, which the estimated in-place volume of total waste (including all accepted wastes) is based on. A comparison 2021 and 2020 aerial survey confirm that the embankment and slope topography is substantially unchanged with no significant movement. The 2021 aerial survey is included as Figure 2.

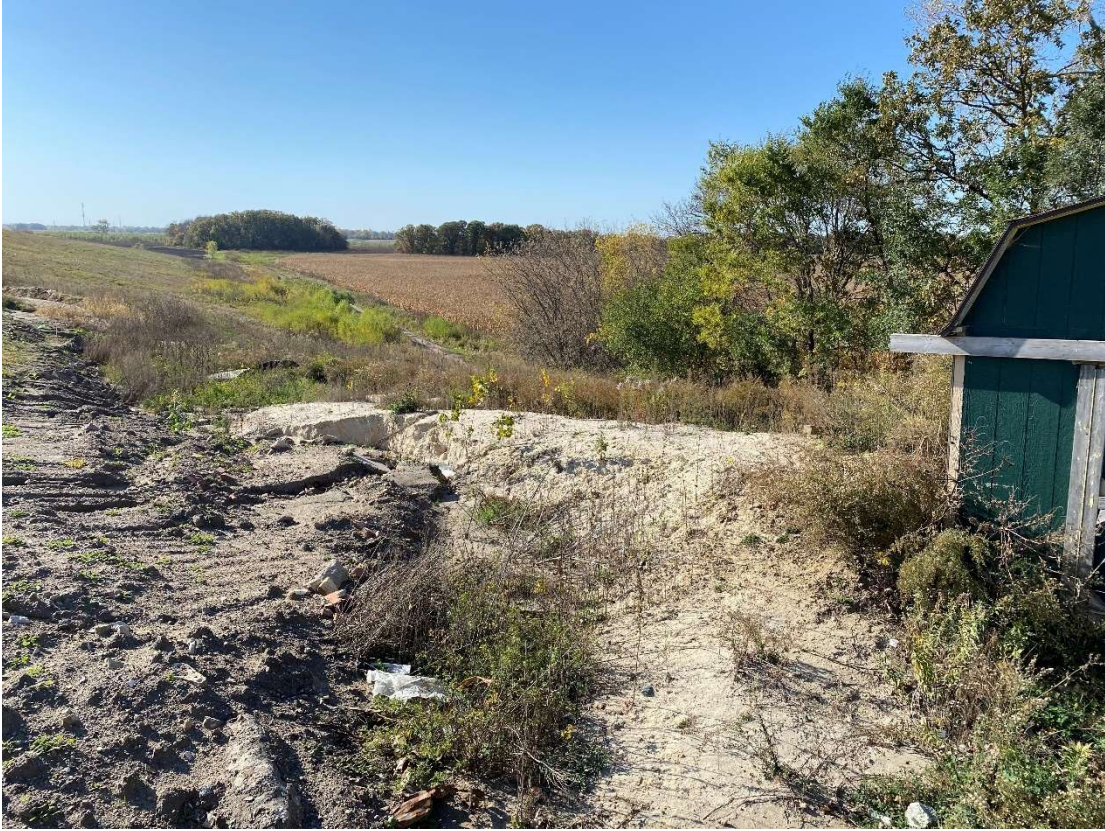
Location 1 – Looking Southwest, Phase 4 Anchor Trench

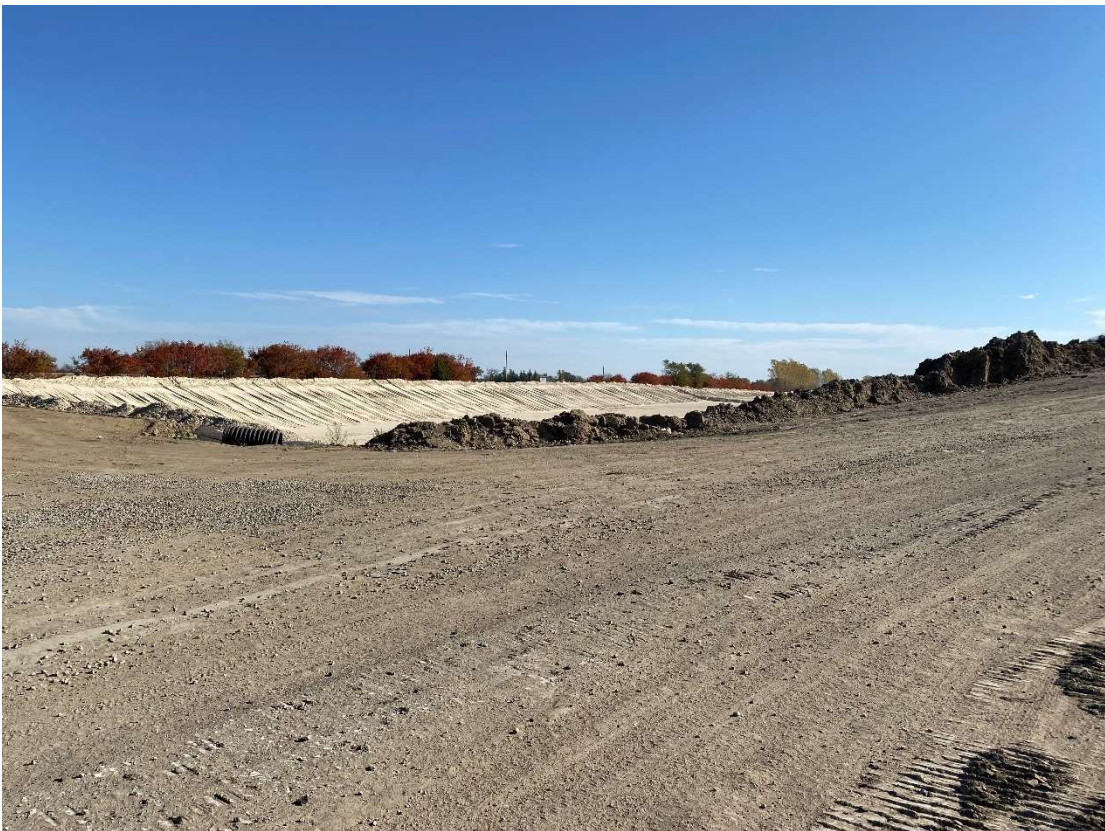
Location 2 – Looking Northeast, Phase 4 Anchor Trench

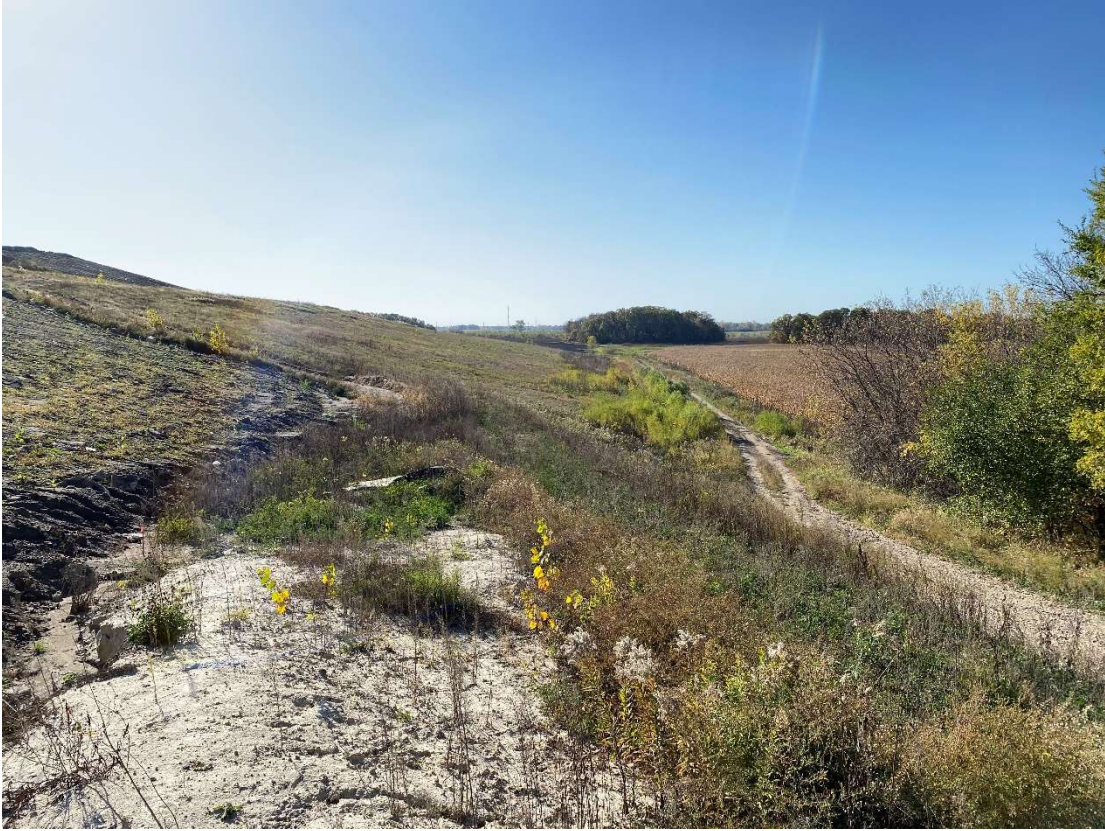
Location 2 – Looking South, Phase 3/1 Western Perimeter

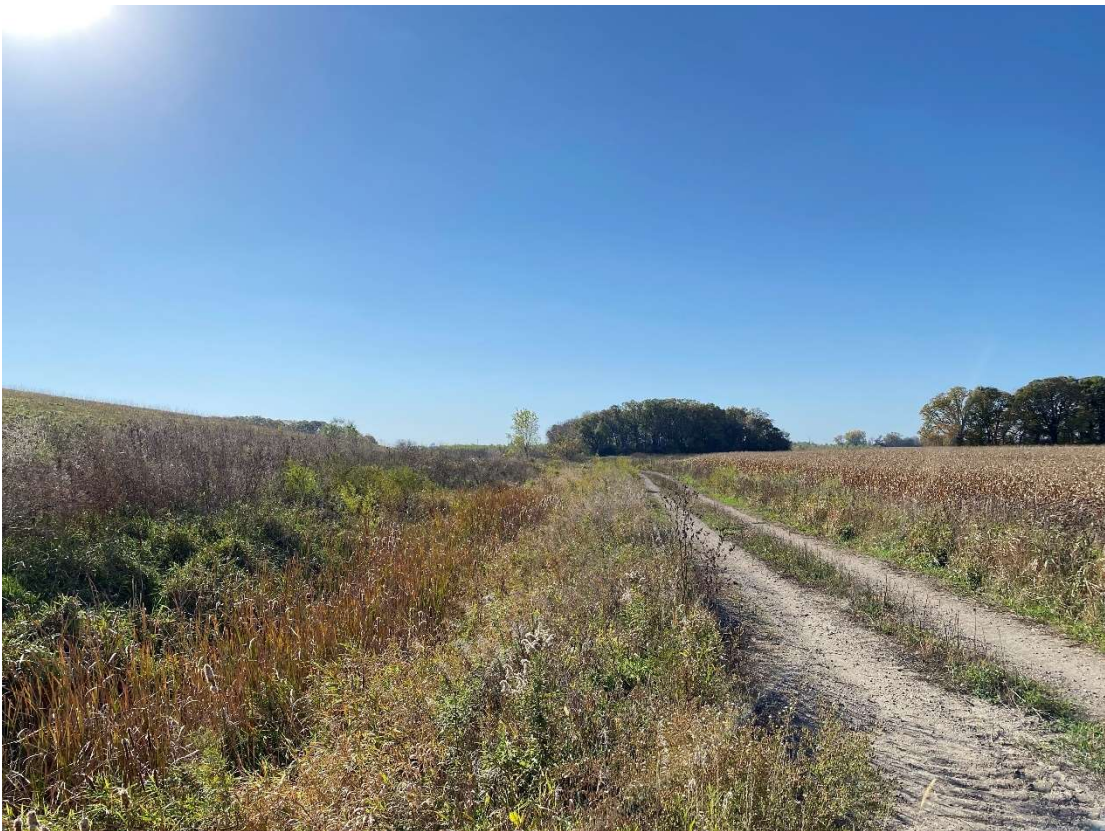
Location 3 – Looking South, Toe of Phase 1 Western Slope

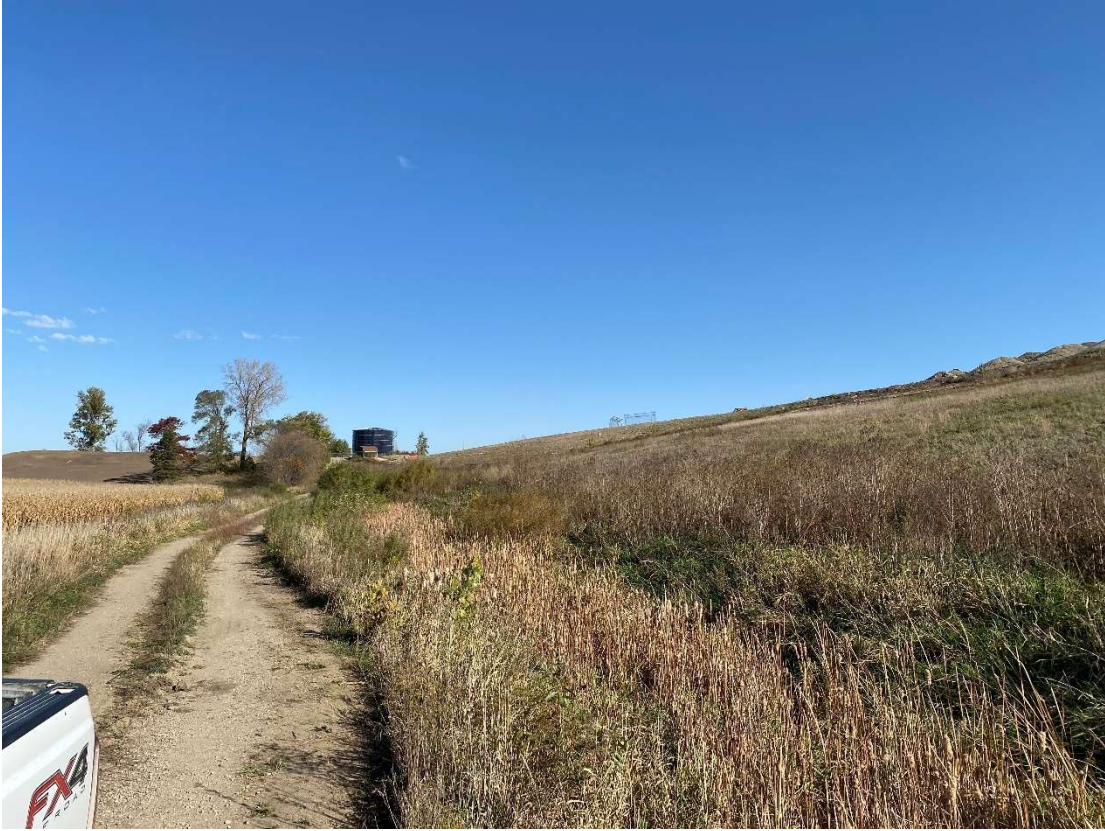
Location 3 – Looking North, Toe of Phase 1 Western Slope

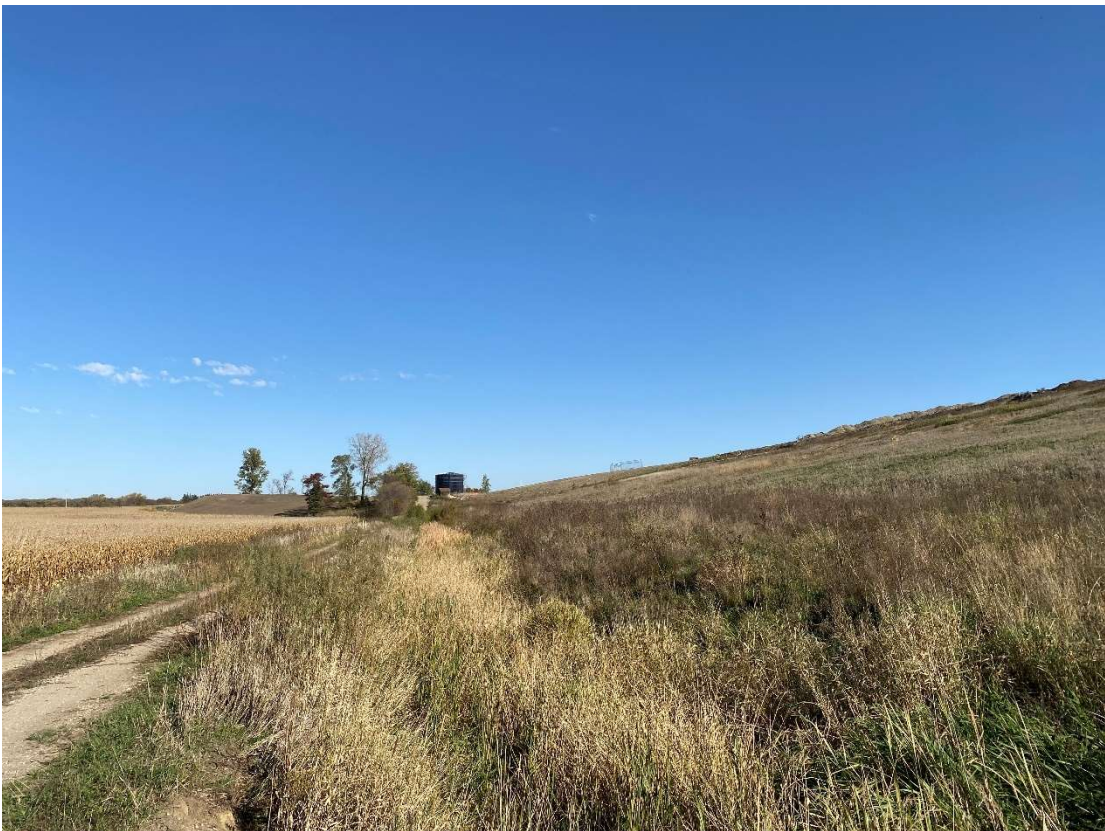
Location 4 – Looking North, Toe of Phase 1 Western Slope

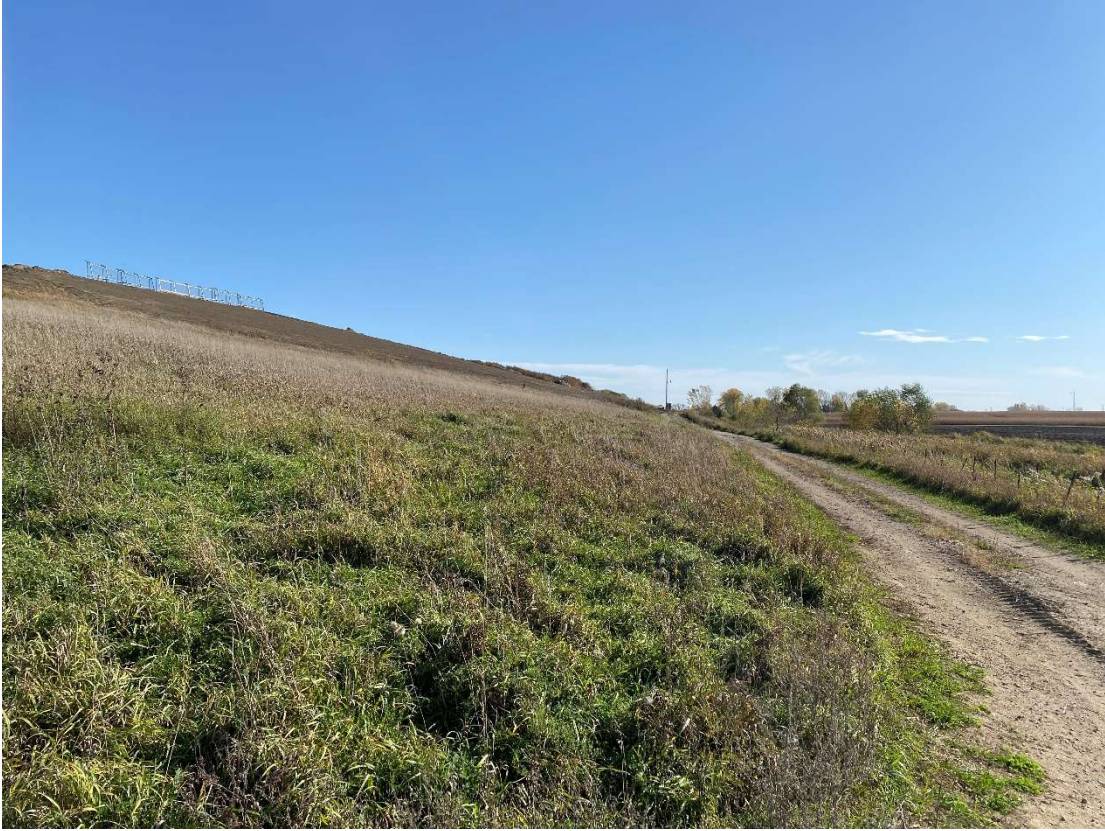
Location 4 – Looking East, Toe of Phase 1 Southern Slope

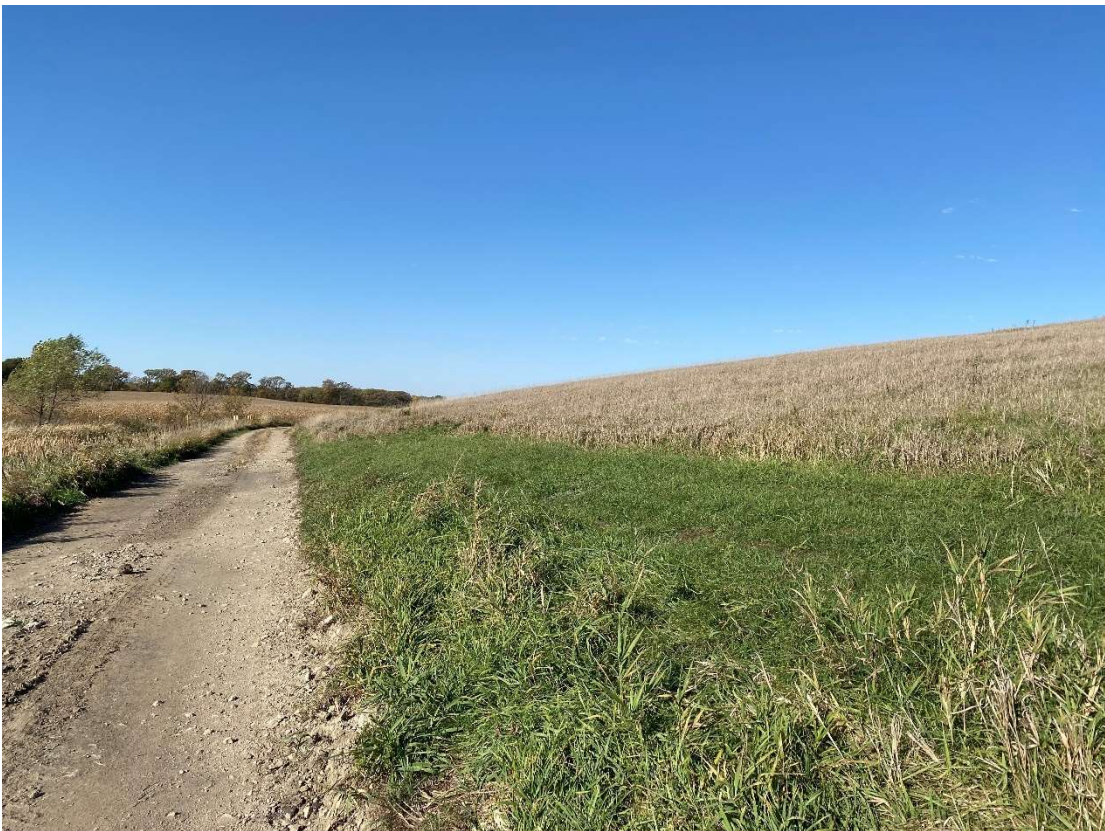
Location 5 – Looking West, Toe of Phase 1 Southern Slope

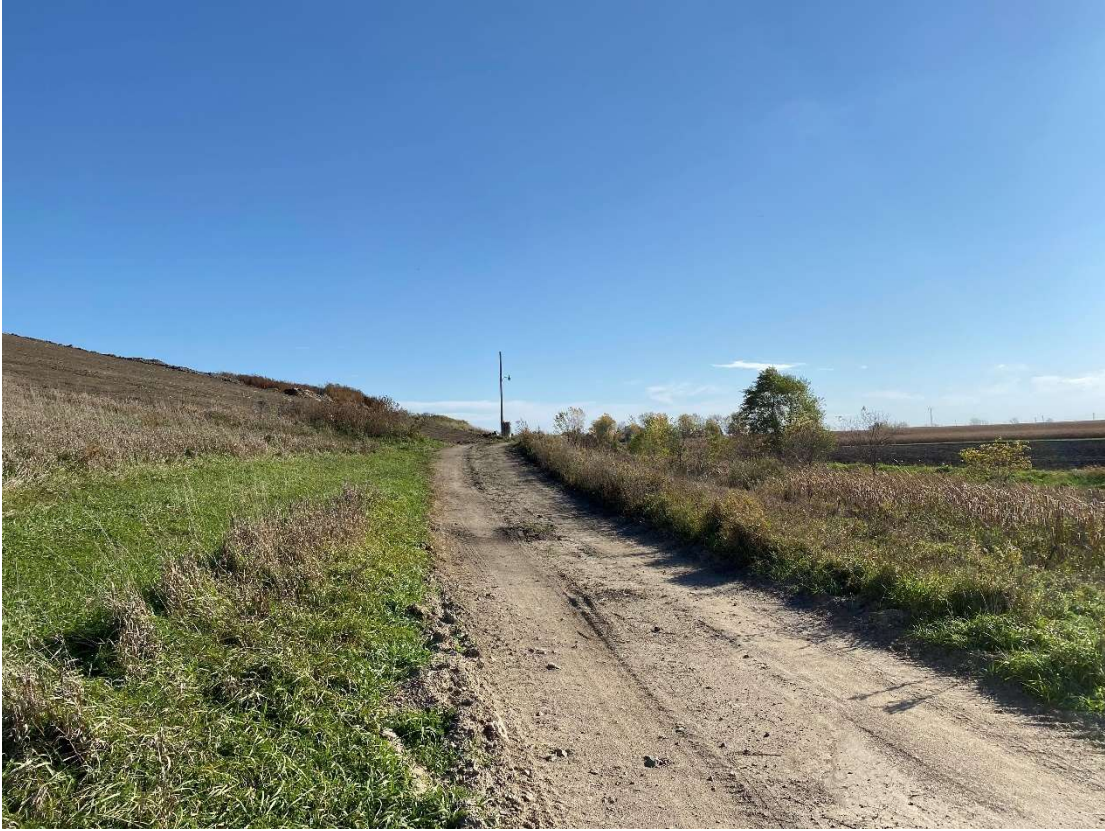
Location 5 – Looking East, Toe of Phase 1 Southern Slope

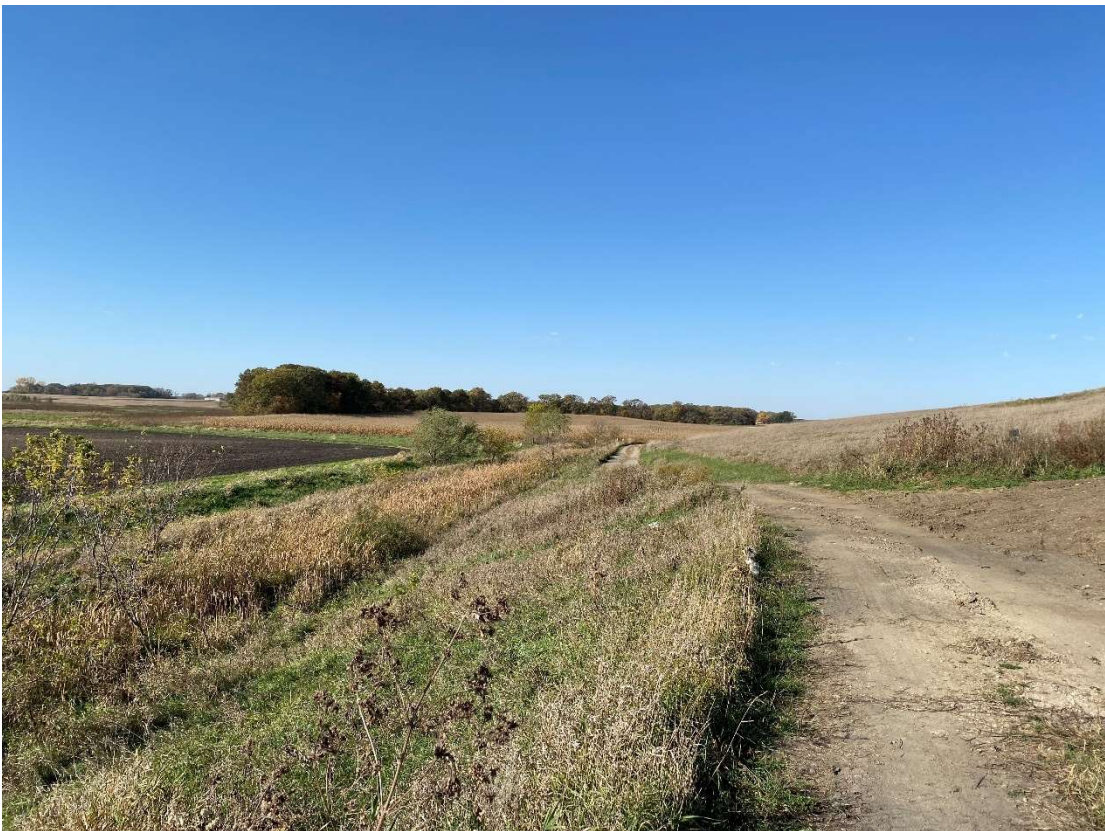
Location 6 – Looking West, Phase 1 Southern Slope

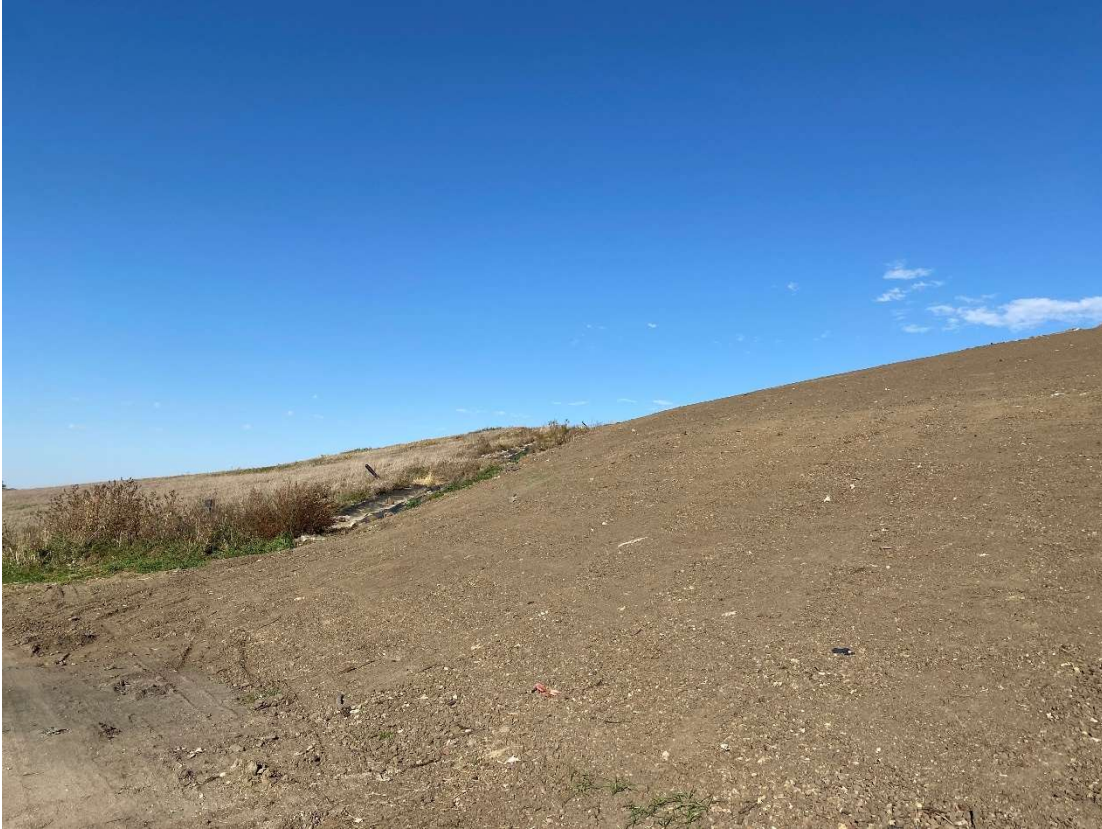
Location 6 – Looking West, Phase 1/2 Overlay Liner & Southern Slope

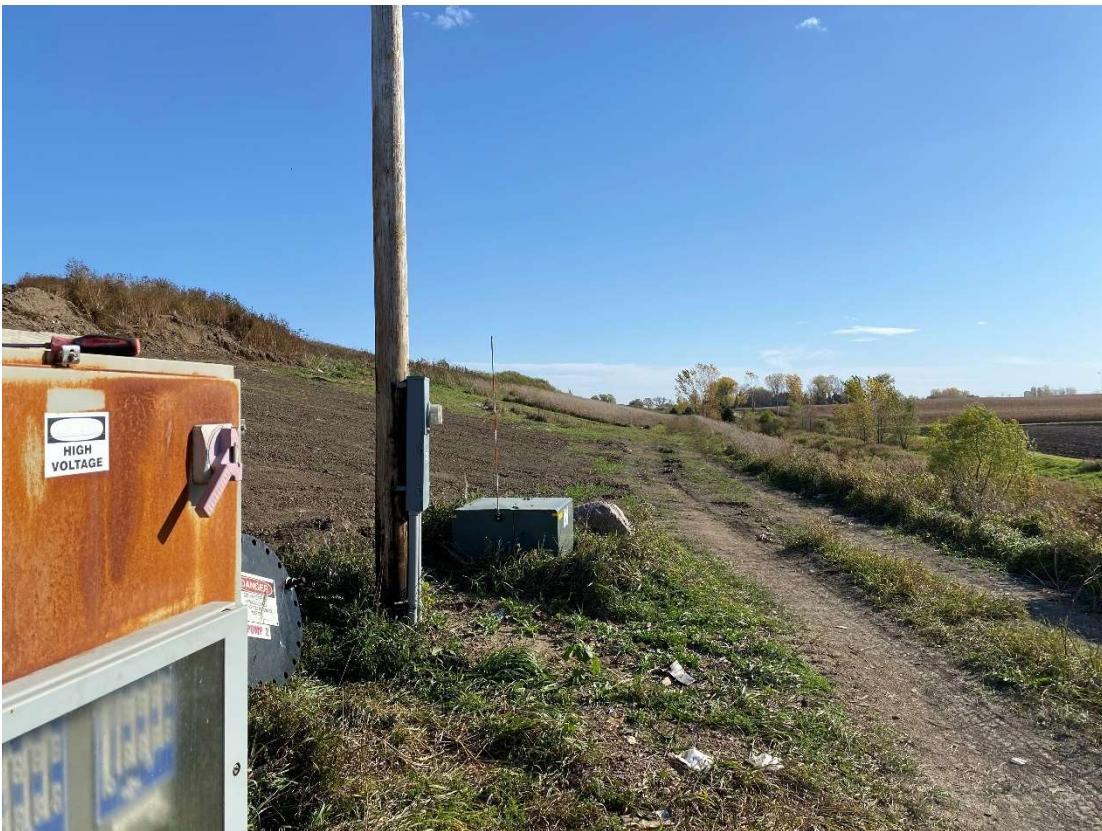
Location 6 – Looking East, Phase 2 Southern Slope

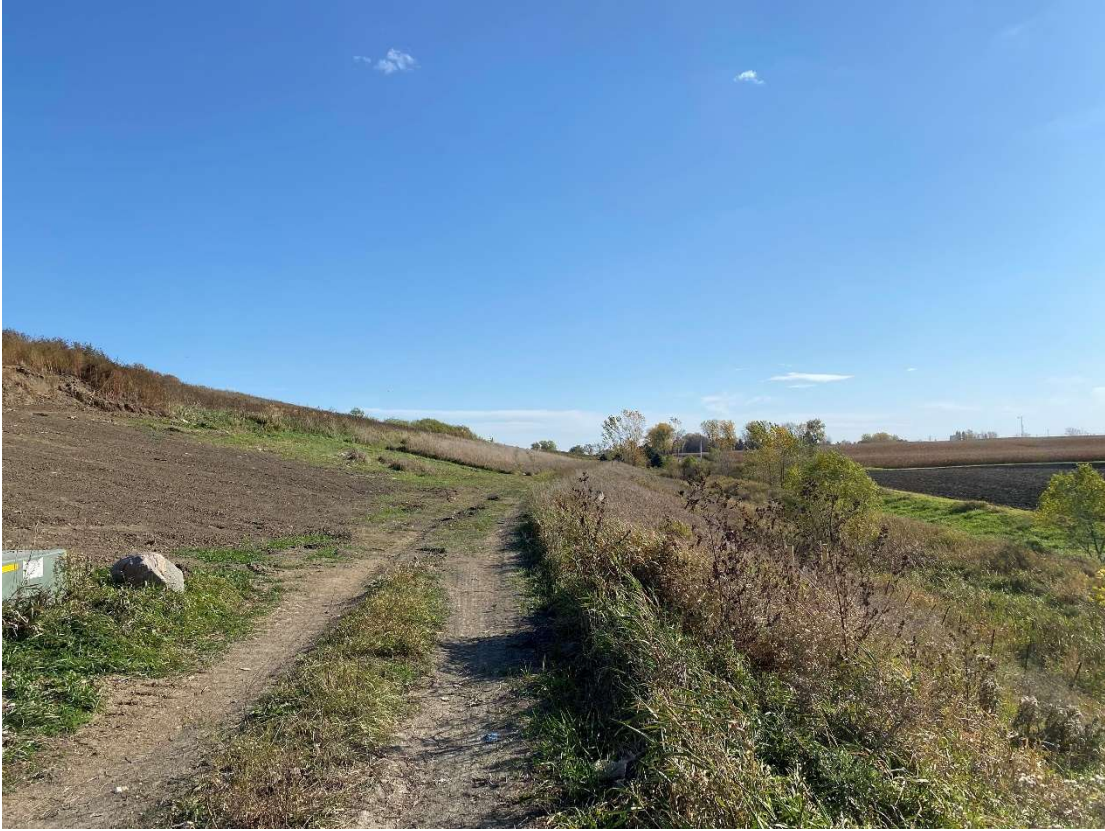
Photo 14: Location 6 – Looking East, Phase 2 Southern Berm

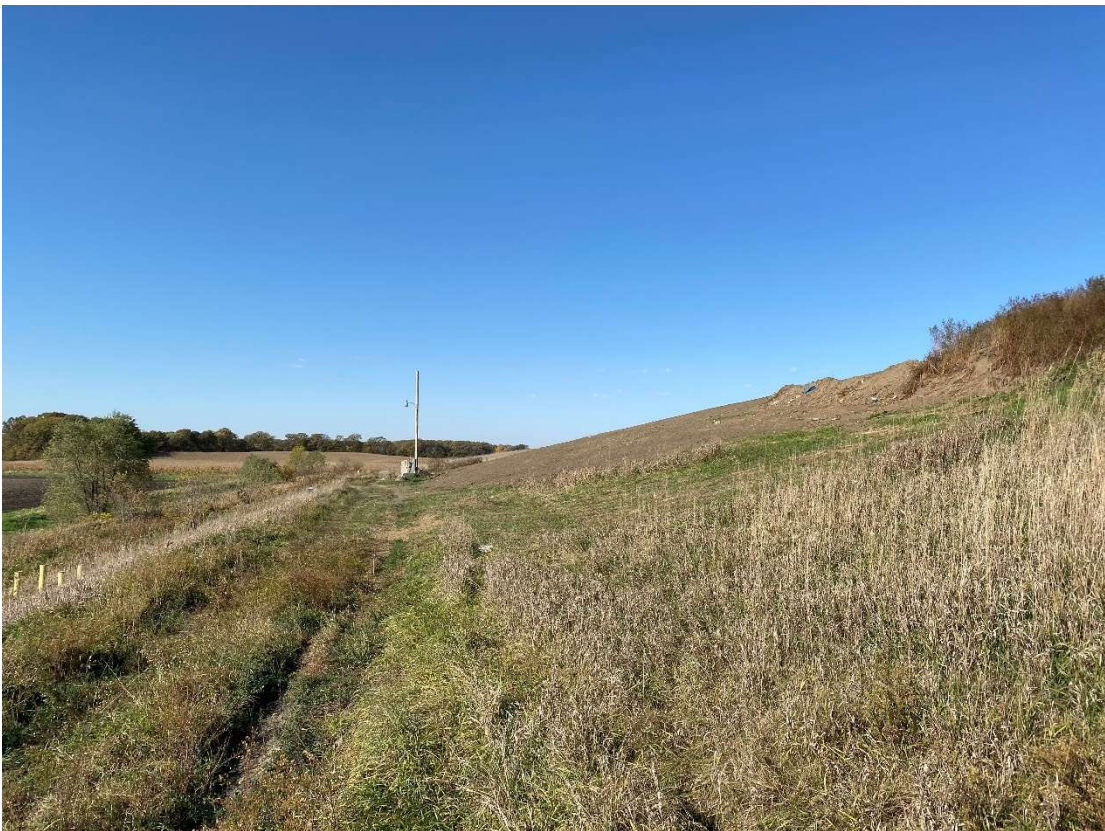
Location 7 – Looking West, Phase 2 Southern Perimeter Road and Slope

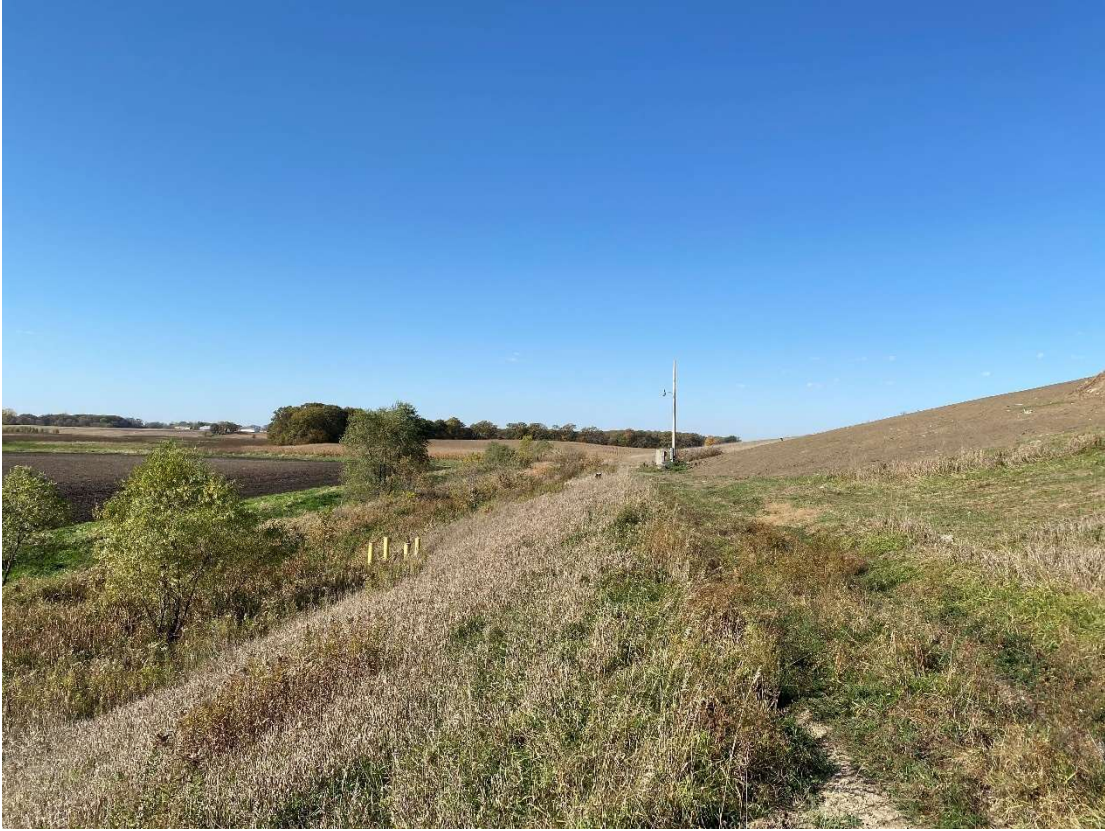
Location 7 – Looking West, Phase 2 Southern Berm

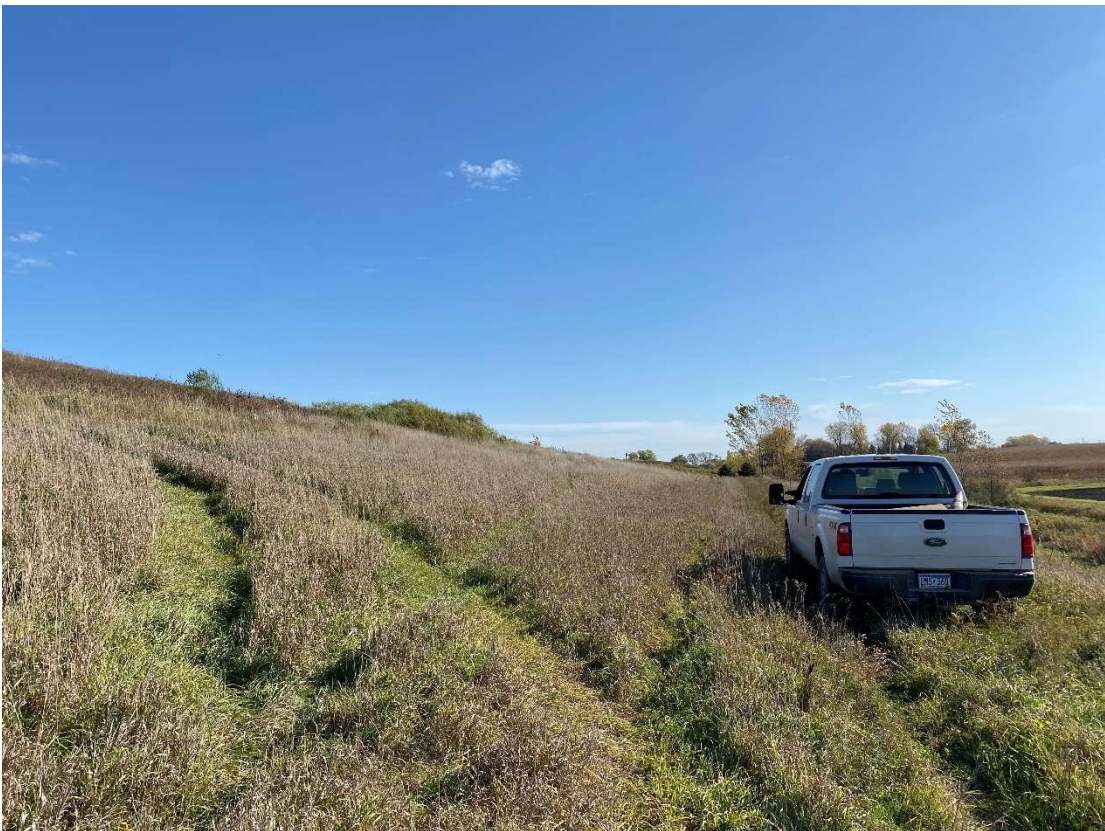
Location 7 – Looking East, Phase 2 Southern Perimeter Road and Slope

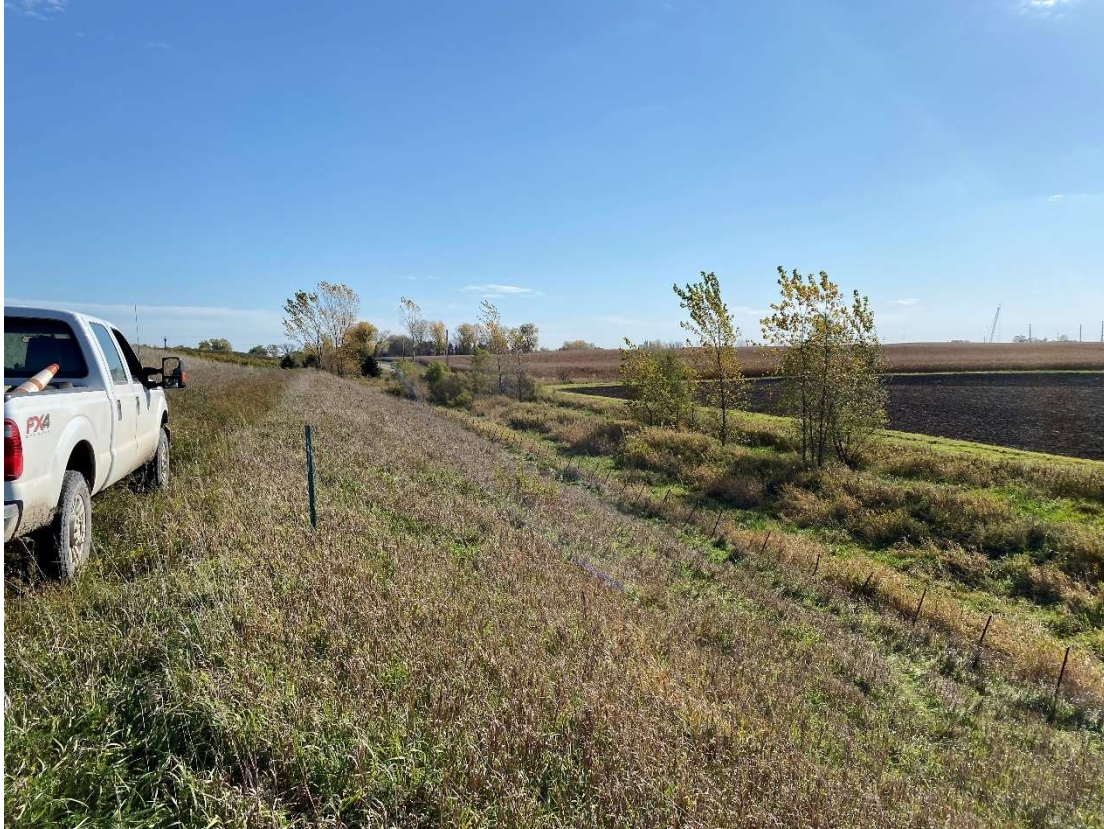
Location 7 – Looking East, Phase 2 Southern Berm

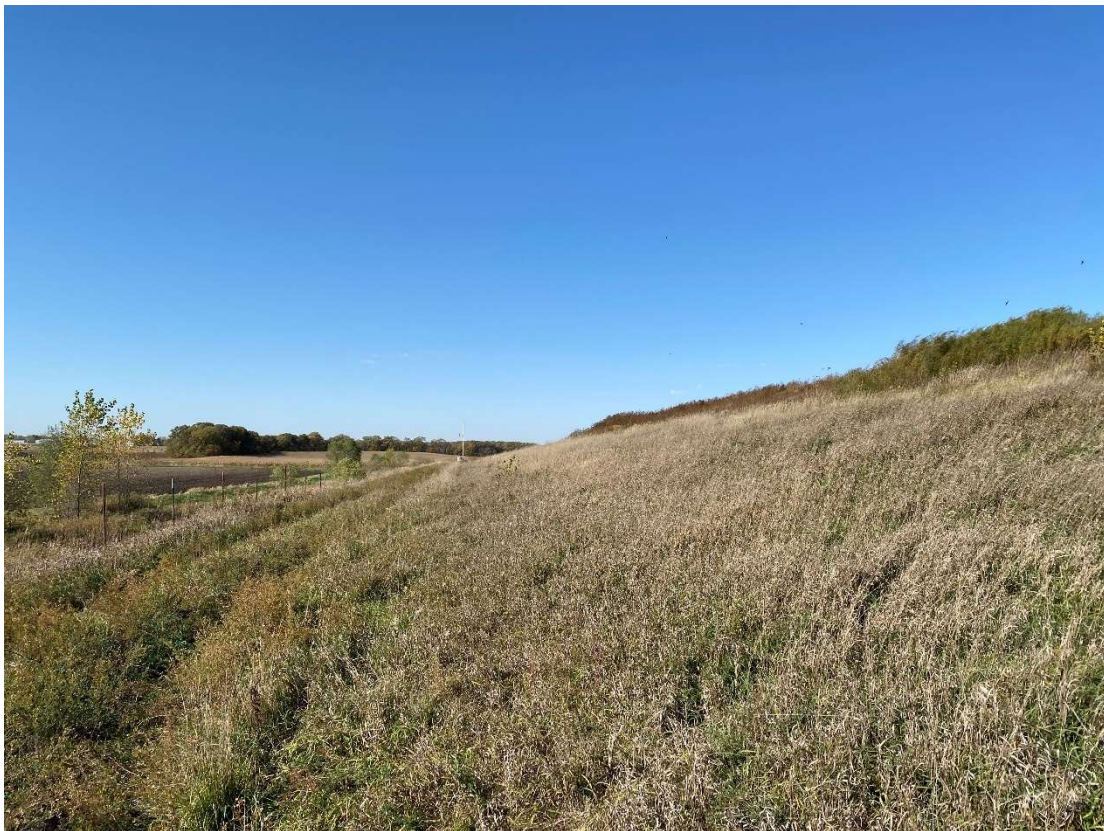
Location 8 – Looking West, Phase 2 Southern Perimeter Road and Slope

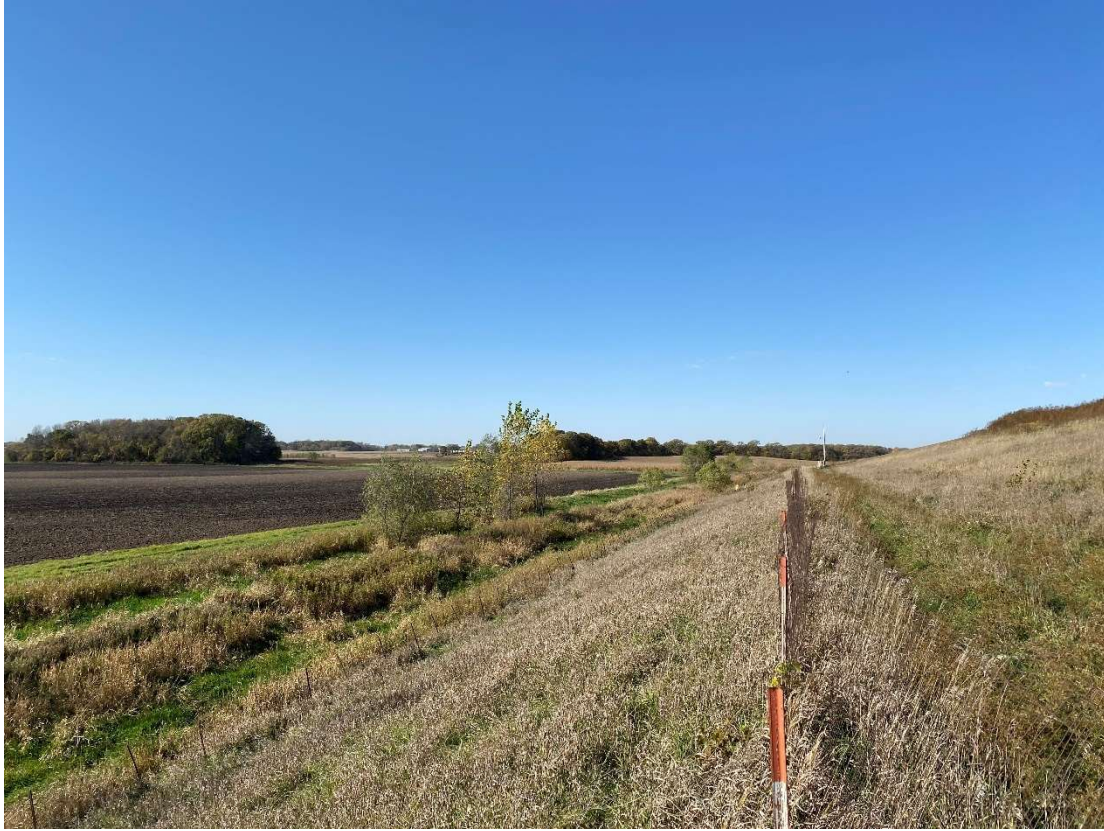
Location 8 – Looking West, Phase 2 Southern Berm
