To: Geoff Strack, PE, Waste Connections From: Bradley W Sullivan, PE, Stantec
File: 227704387 Date: January 7, 2022

Reference: WCI Austin Landfill, LLC 2021 Annual CCR Inspection Report

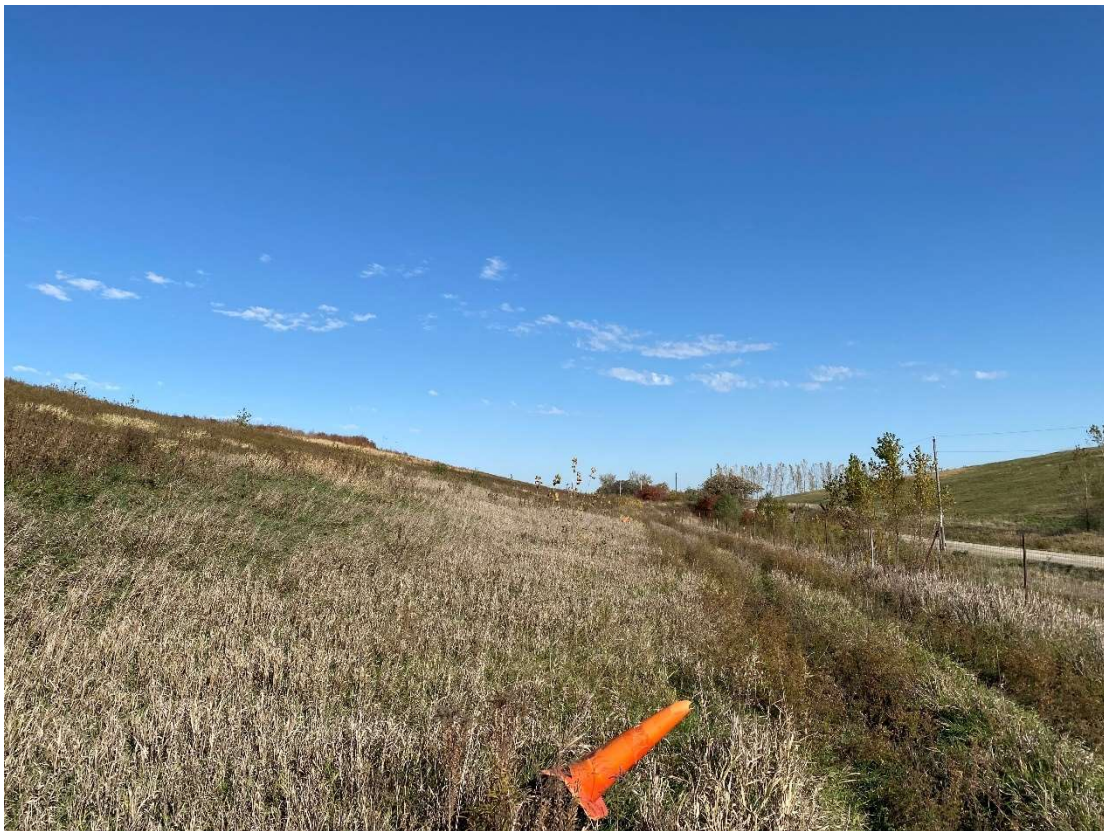
Location 8 – Looking North, Phase 2 Eastern Slope

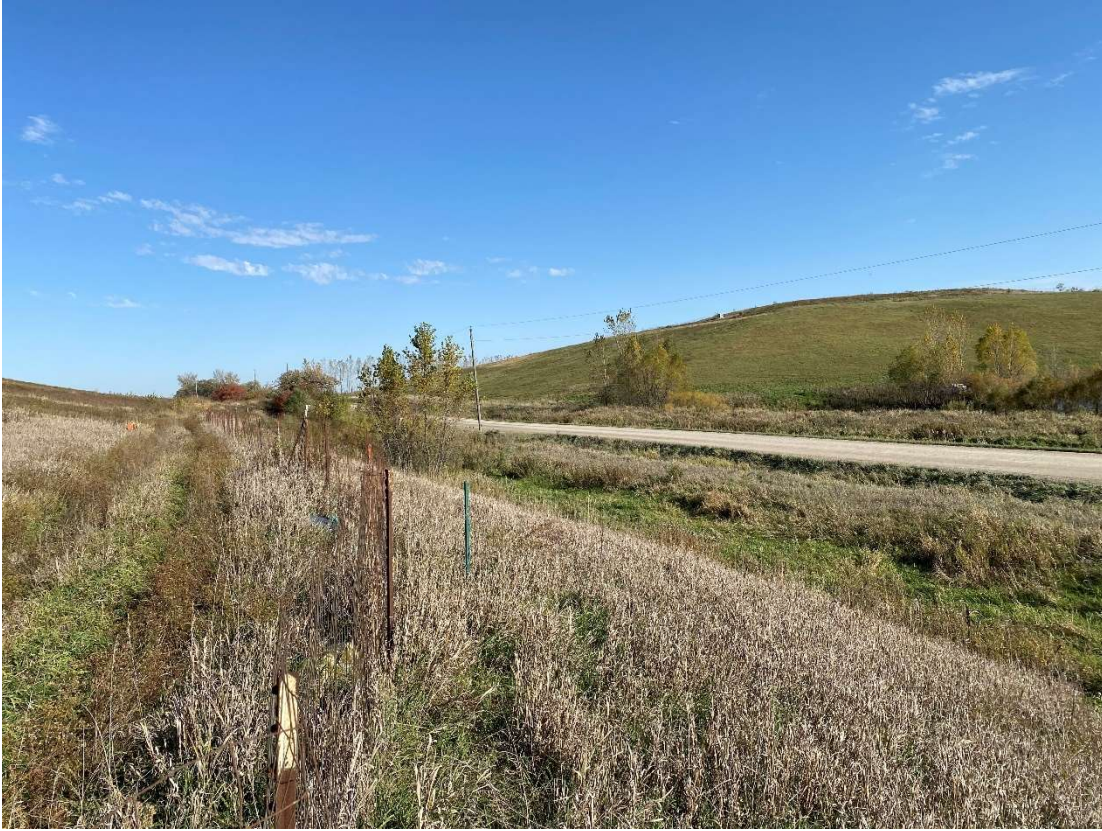
Location 8 – Looking North, Phase Eastern Berm

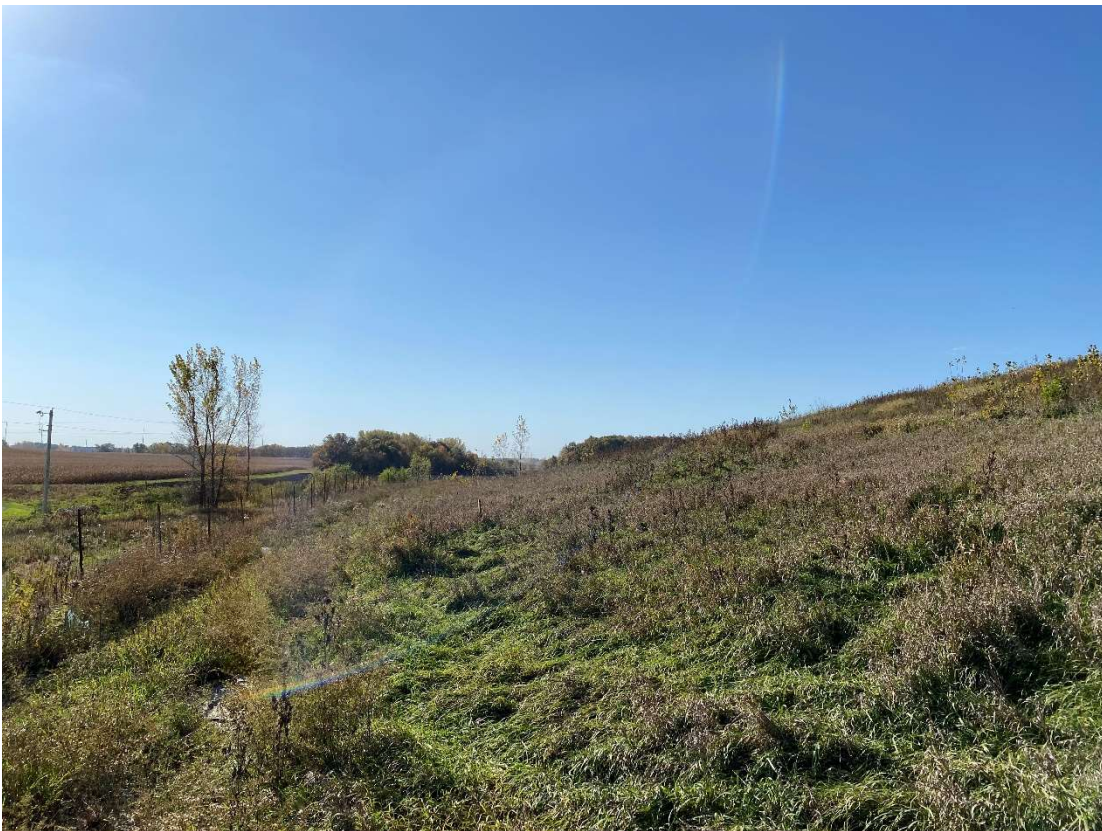
Location 9 – Looking South, Phase 2 Eastern Perimeter Road & Slope

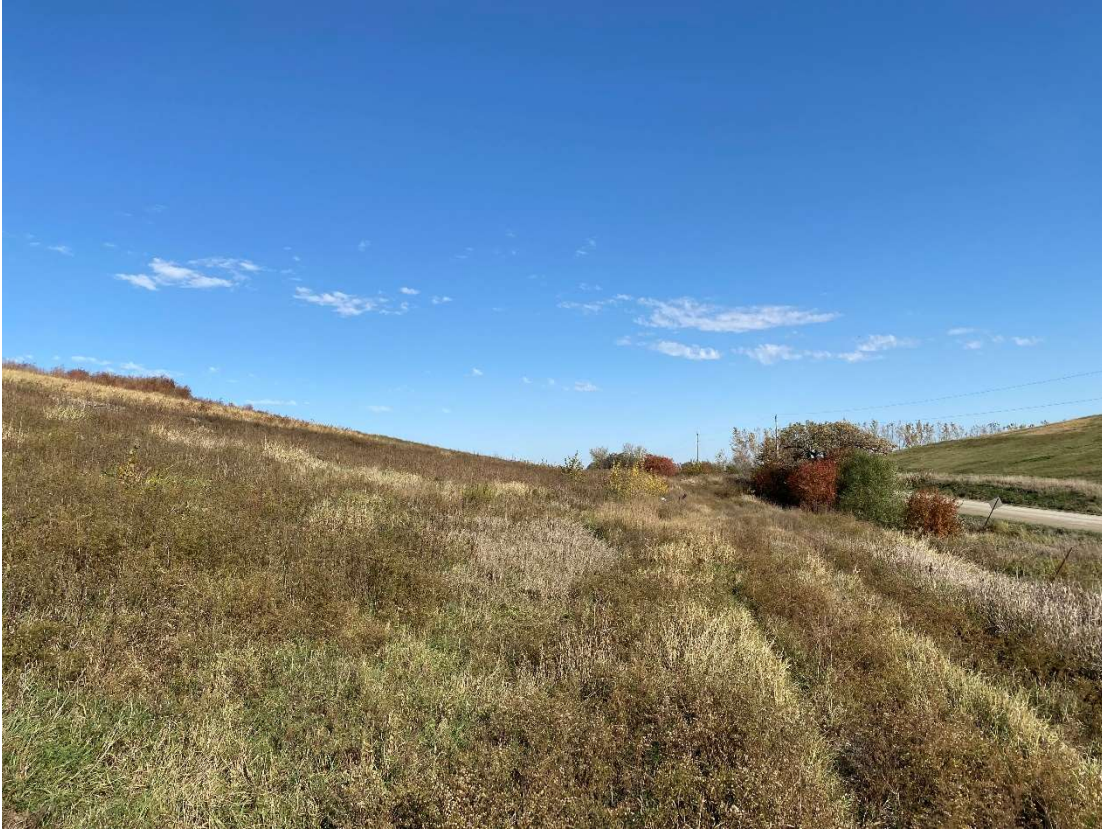
Location 9 – Looking North, Phase 2 Eastern Perimeter Road & Slope

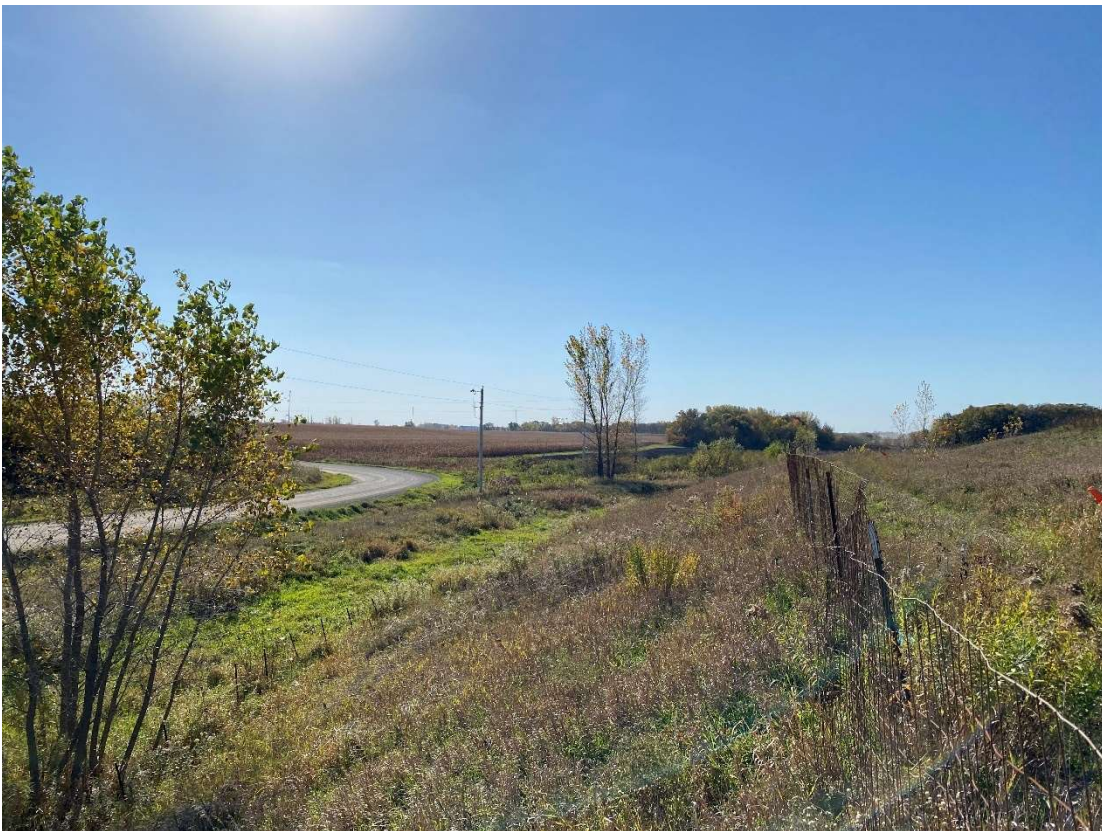
Location 9 – Looking South, Phase 2 Eastern Berm

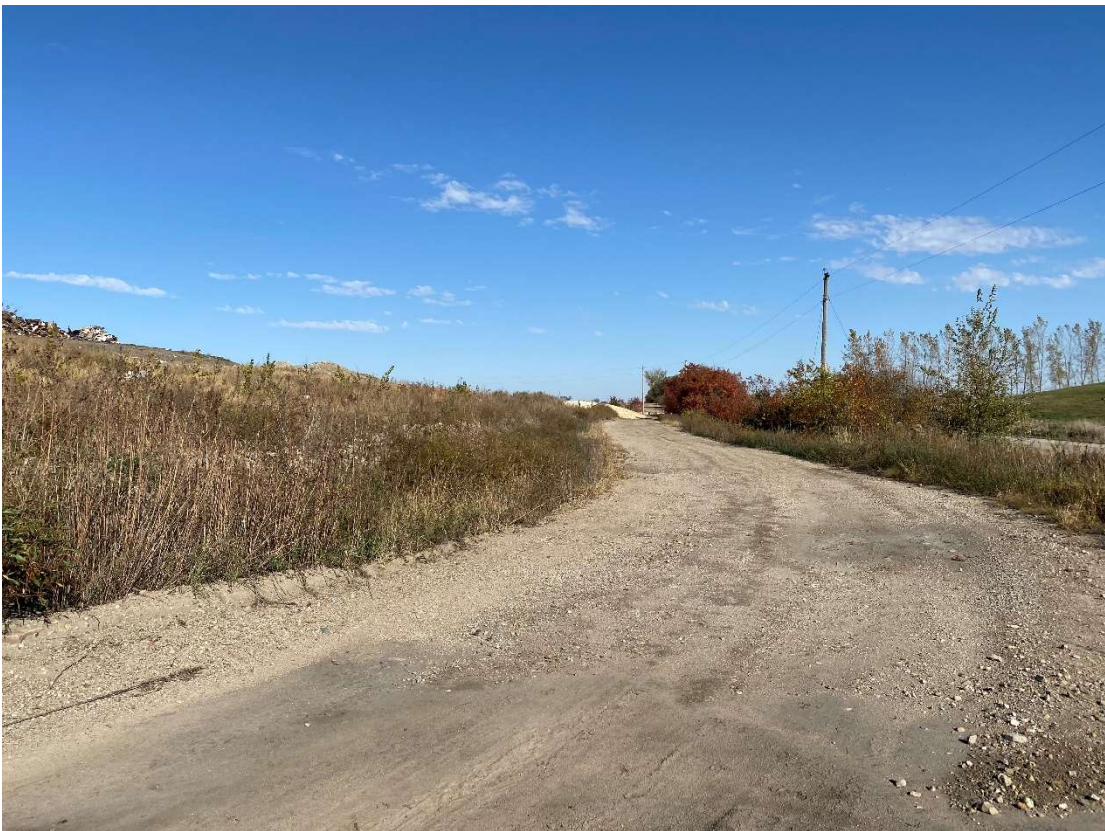
Location 10 – Looking North, Eastern Perimeter Road

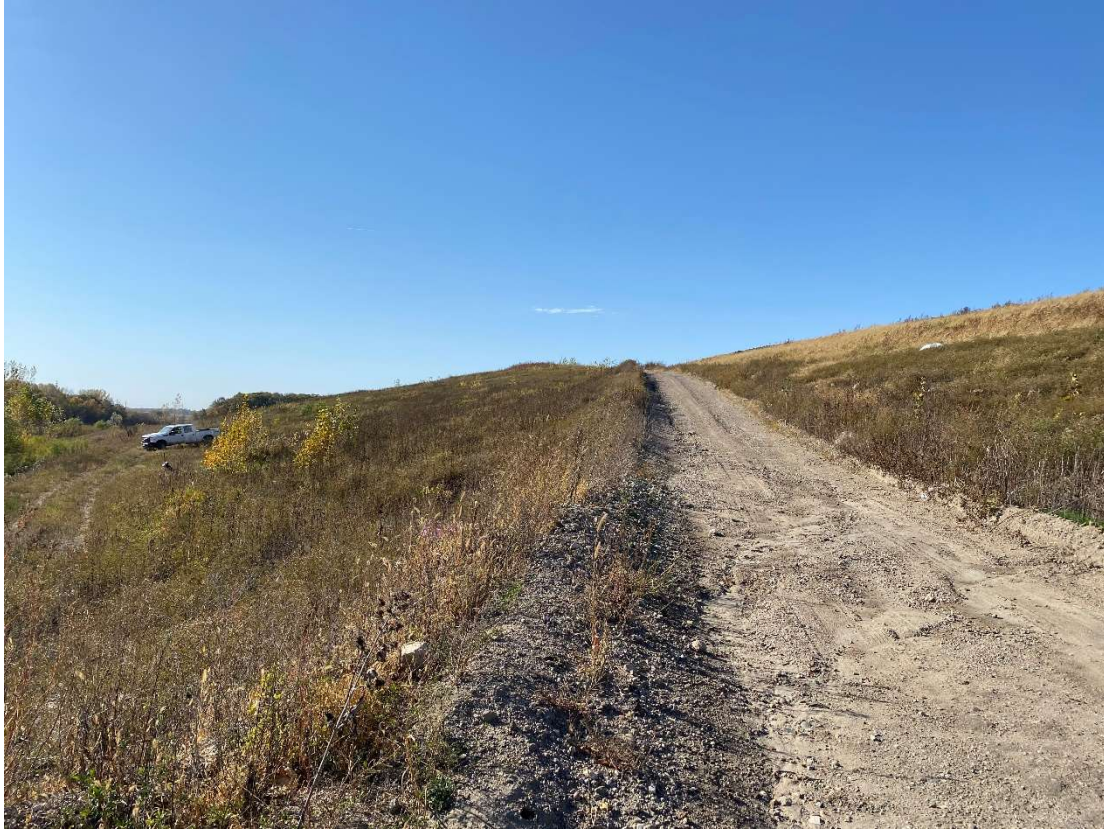
Location 10 – Looking South, Phase 2 Eastern Slope and Interior Access Road Entrance

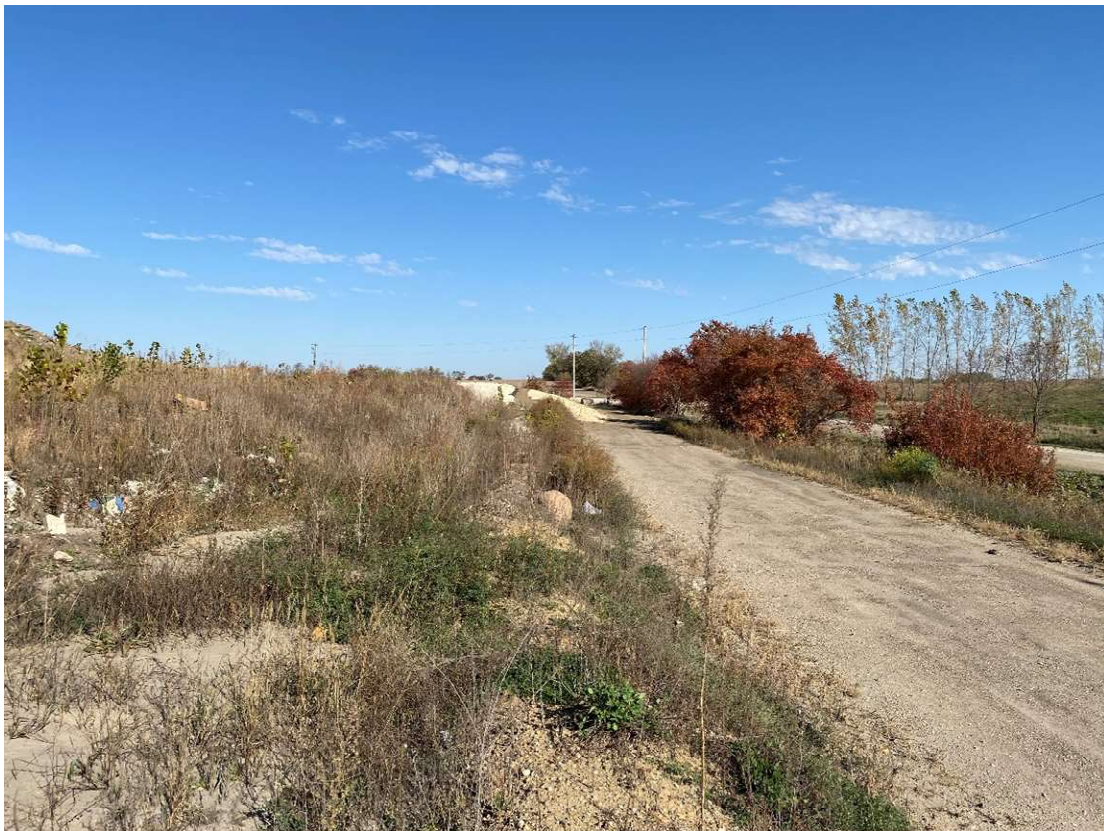
Photo 30: Location 11 – Looking North, Phase 4 Eastern Anchor Trench

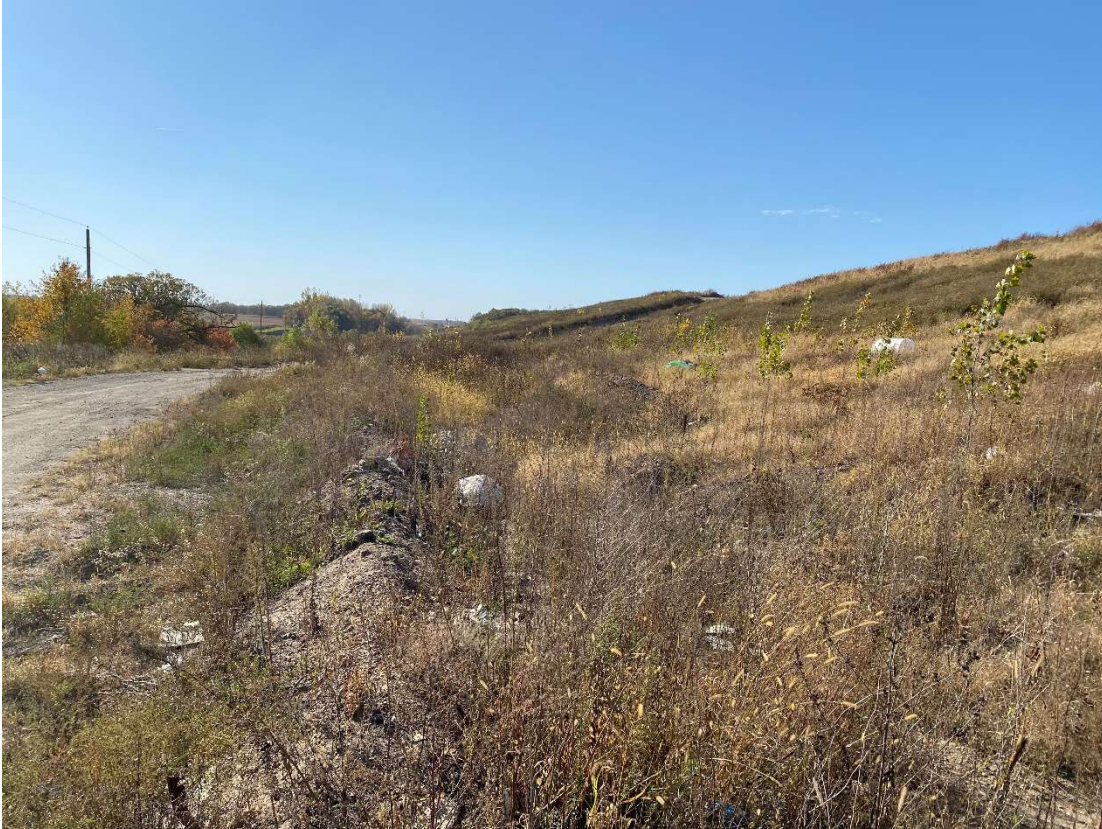
Location 12 – Looking South, Phase 4 Eastern Anchor Trench & Phase 3 Eastern Waste Slope

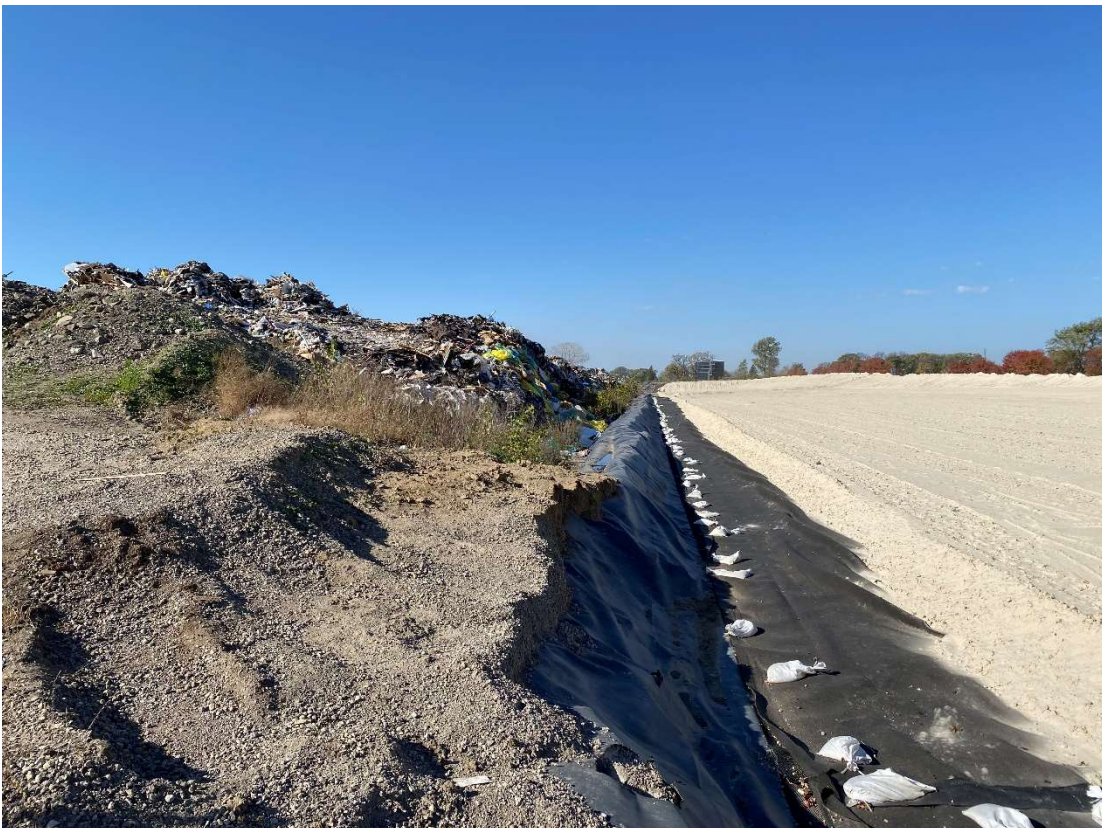
Location 12 – Looking West, Phase 4 Northern Rain Flap

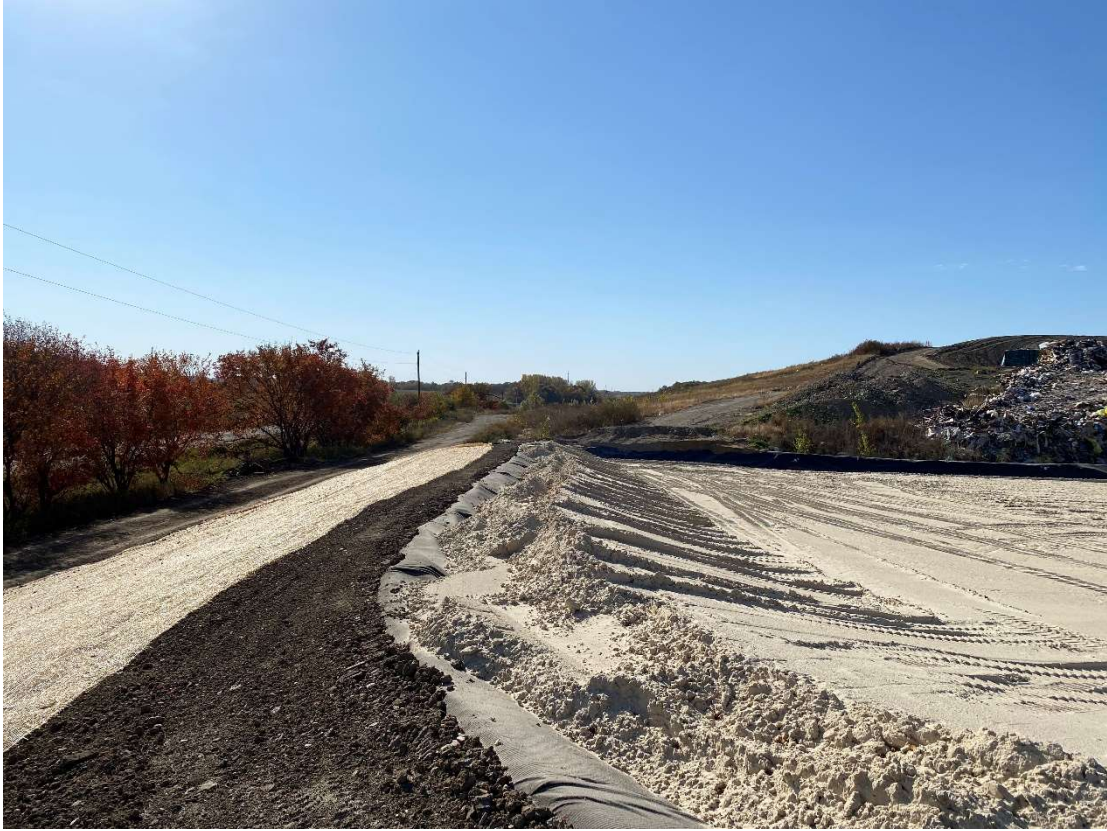
Location 13 – Looking South, Phase 5 Western Cell Limit

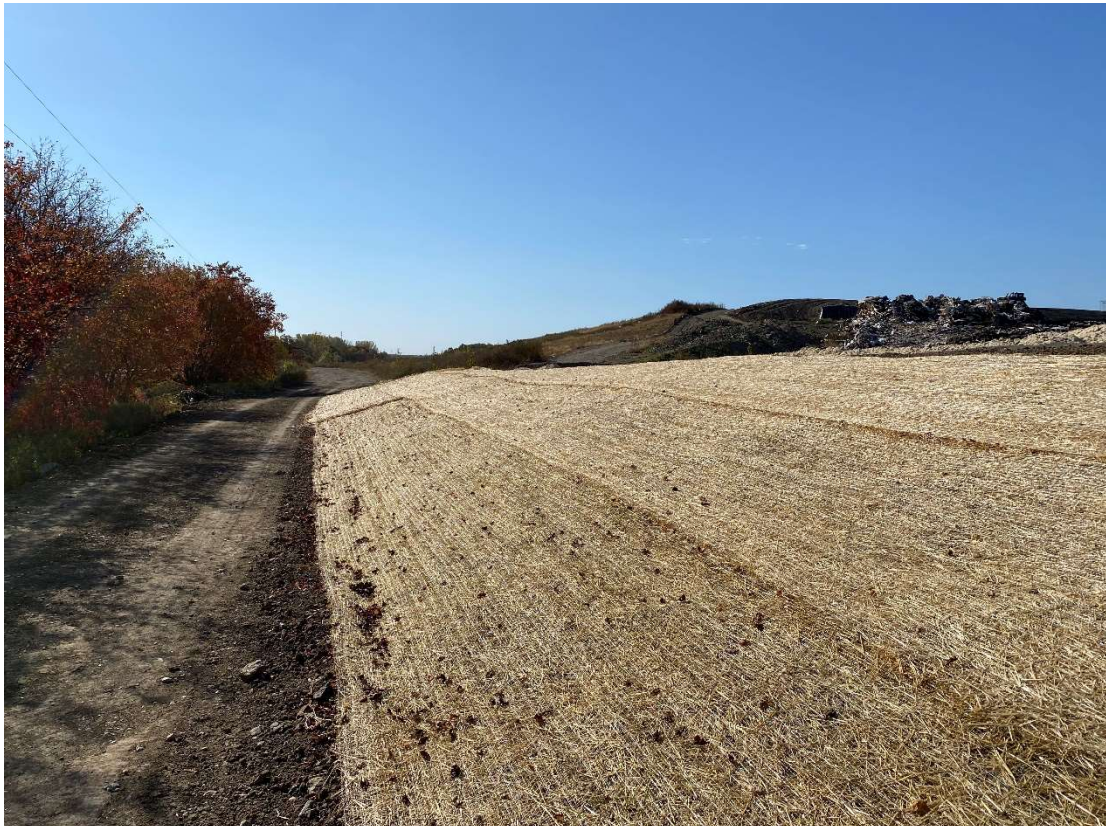
Location 13 – Looking South, Phase 5 Toe of Berm

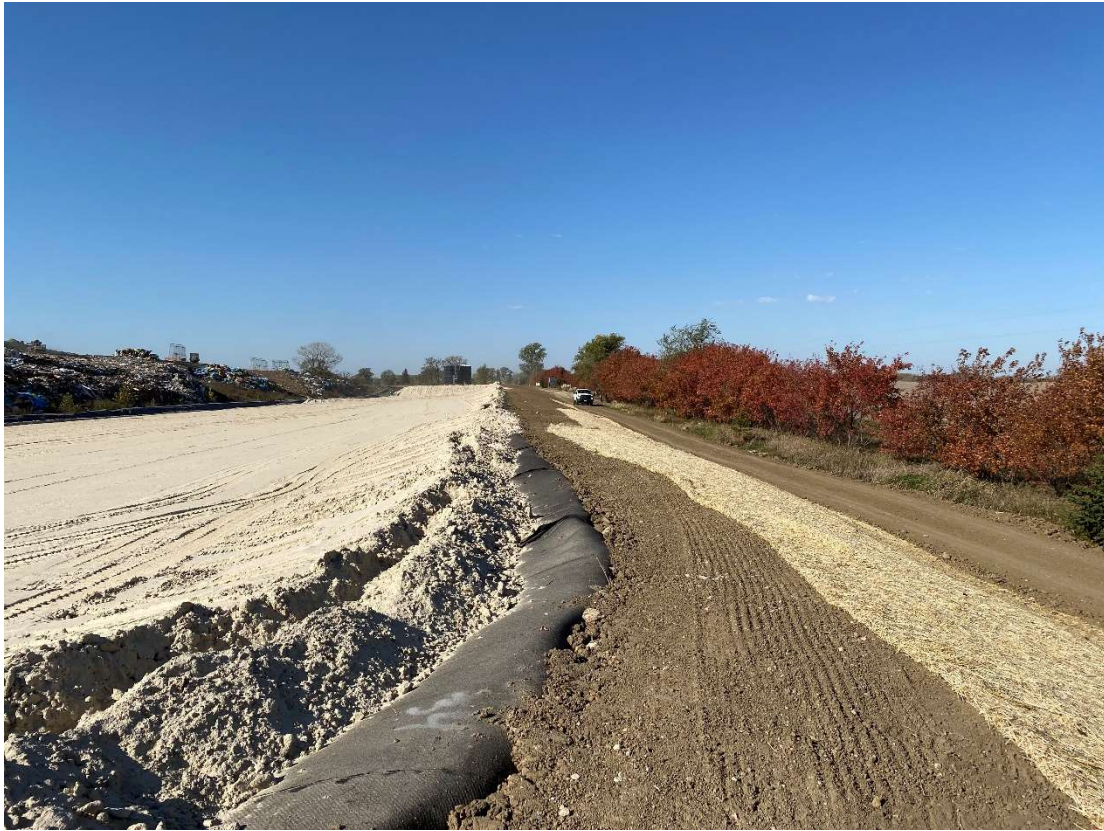
Location 13 – Looking West, Phase 5 Cell Limit

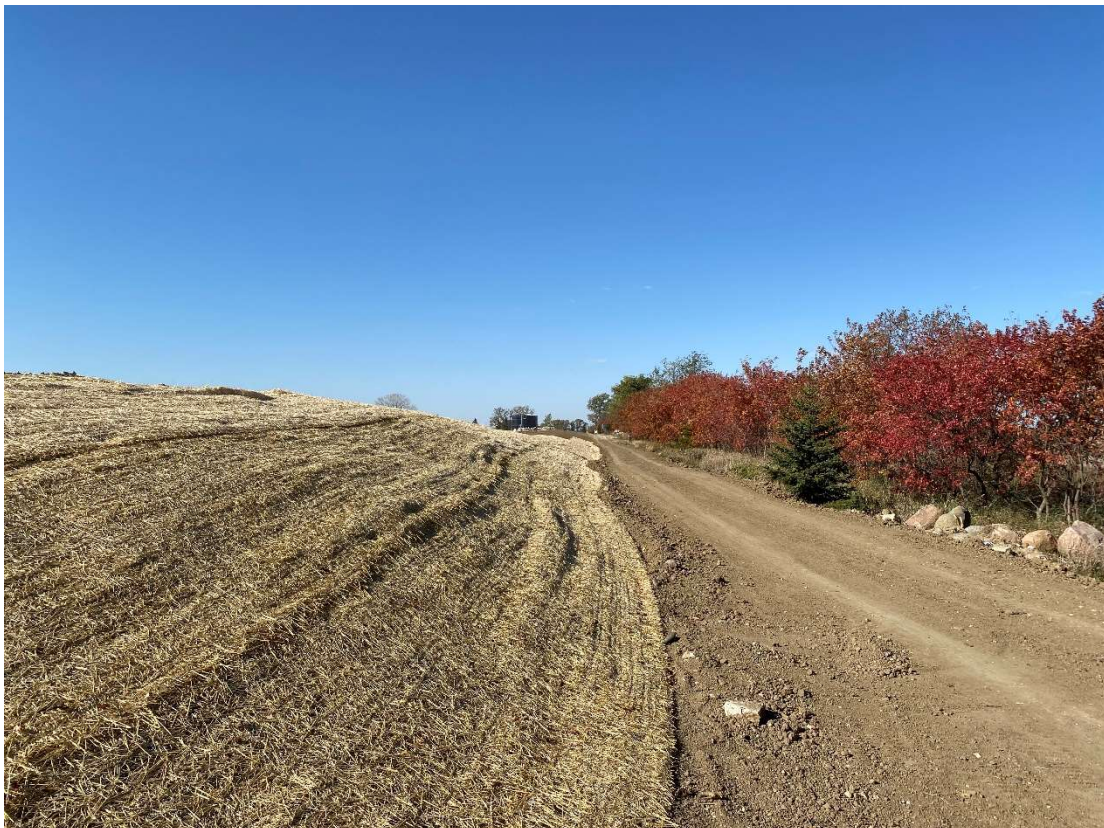
Location 13 – Looking West, Phase 5 Toe of Berm

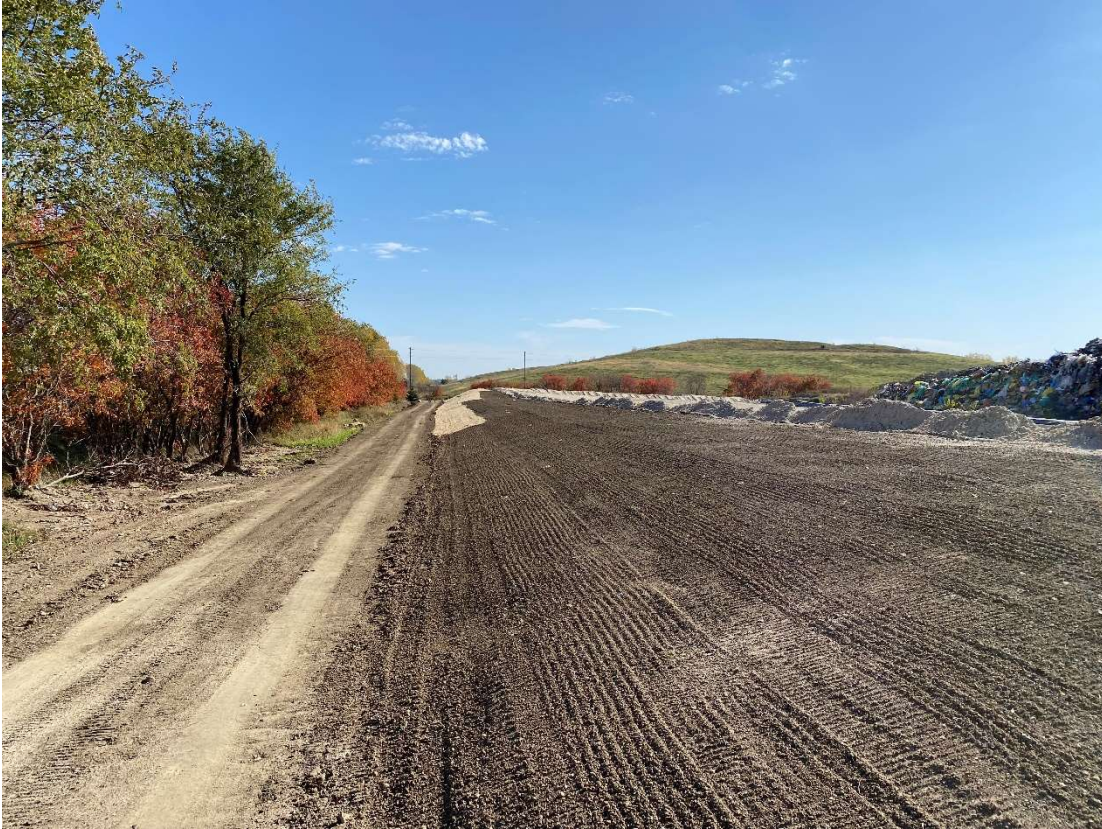
Location 14 – Looking East, Phase 5 Toe of Berm

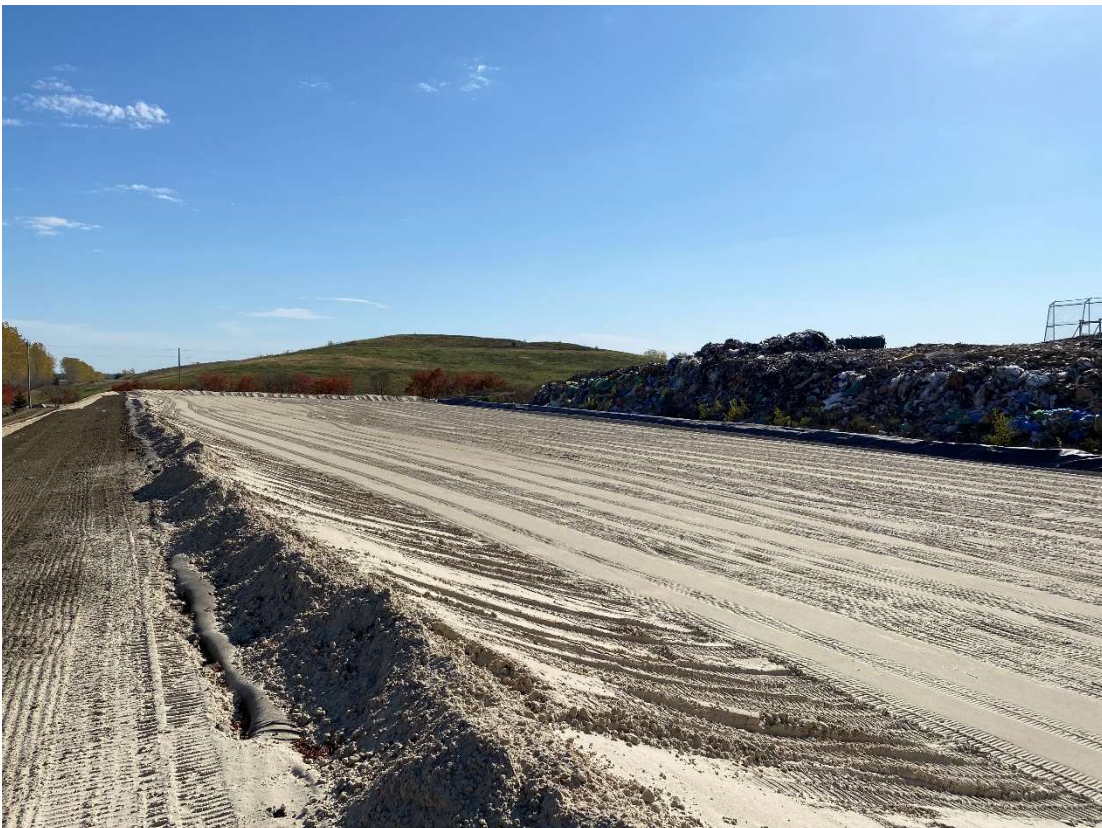
Location 14 – Looking East, Phase 5 Cell Limit

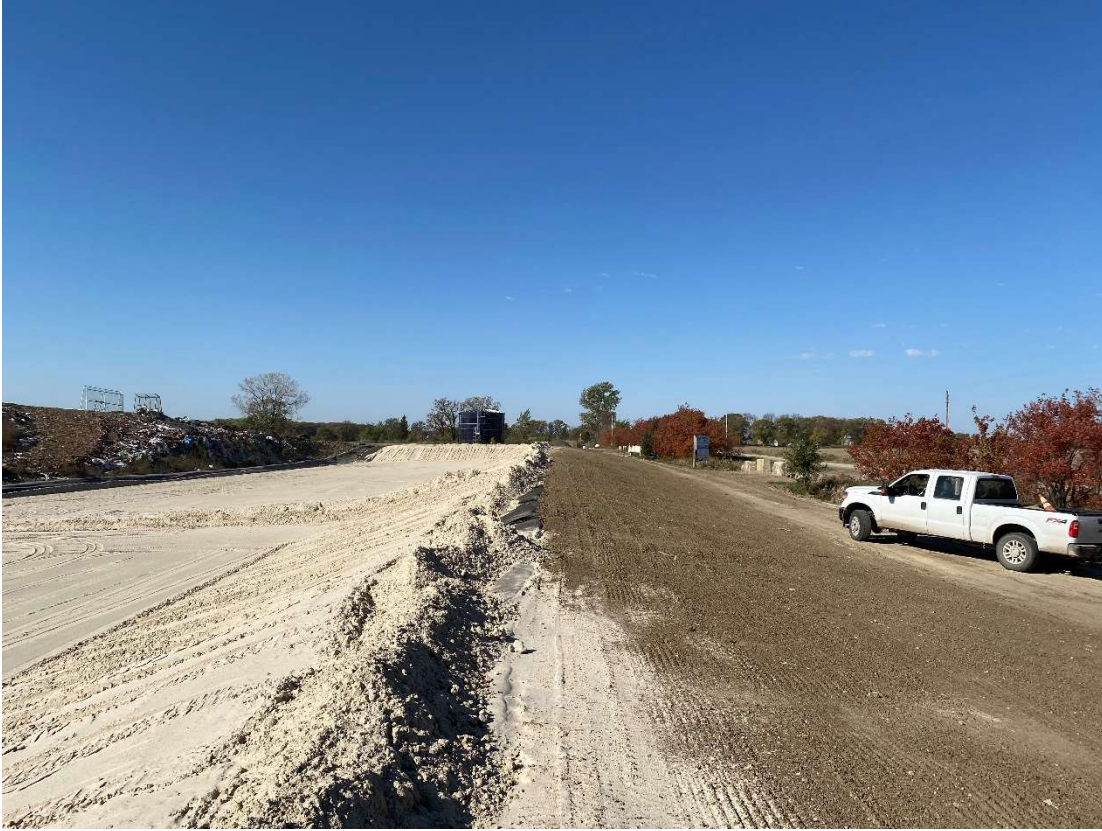
Location 14 – Looking West, Phase 5 Cell Limit

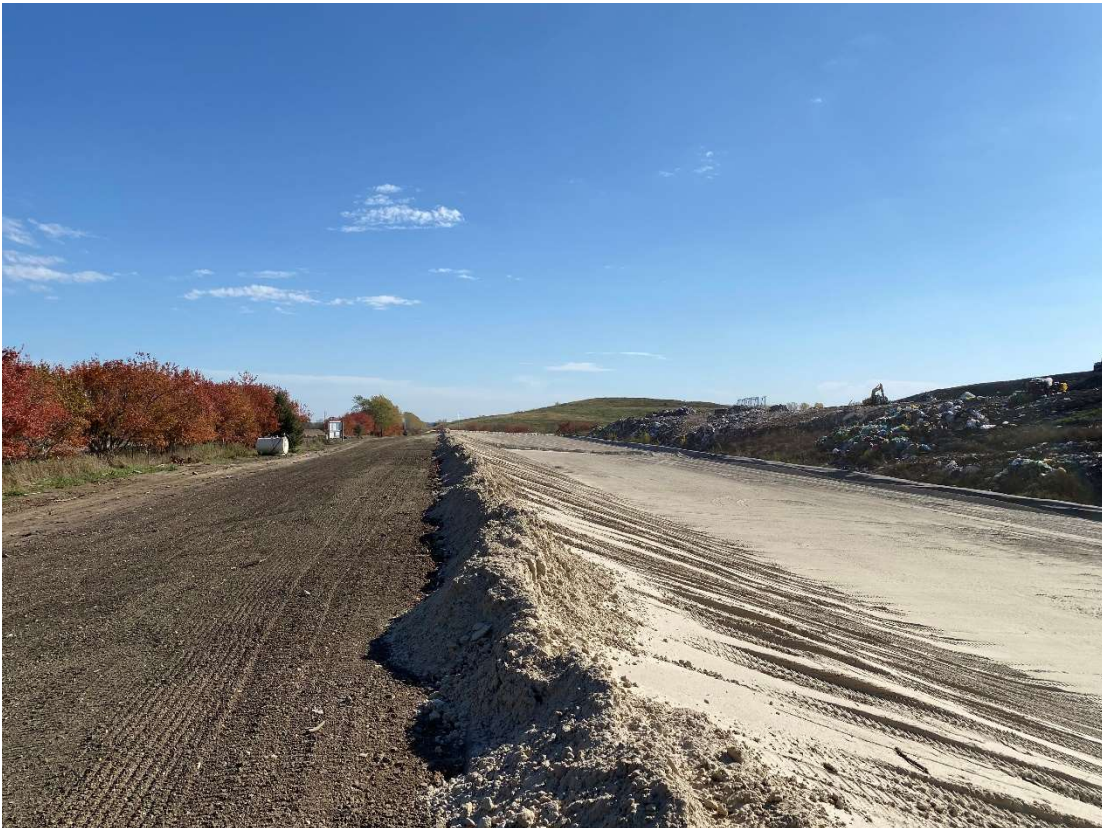
Location 15 – Looking East, Phase 5 Cell Limit

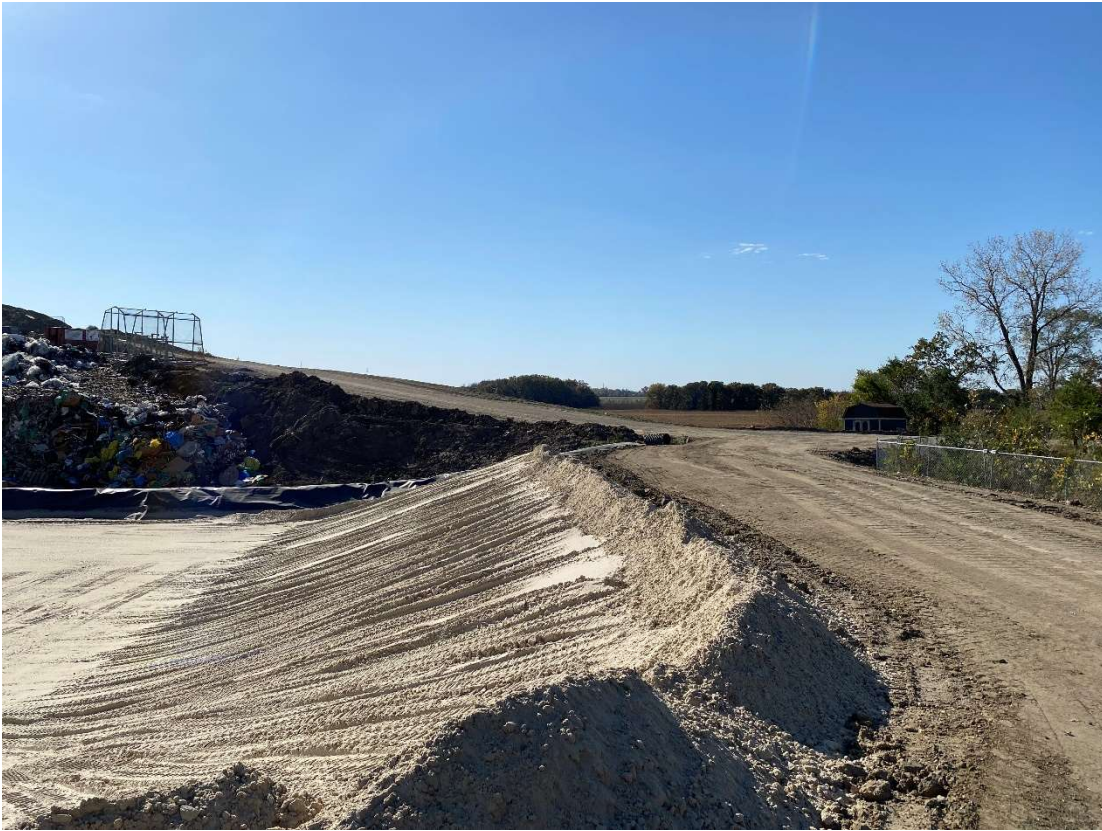
Location 15 – Looking South, Phase 5 Cell Limit
