To: Geoff Strack, PE, Waste Connections From: Brad Sullivan, PE, Stantec
File: 227704387 Date: January 7, 2023

Reference: WCI Austin Landfill, LLC 2022 Annual CCR Inspection Report

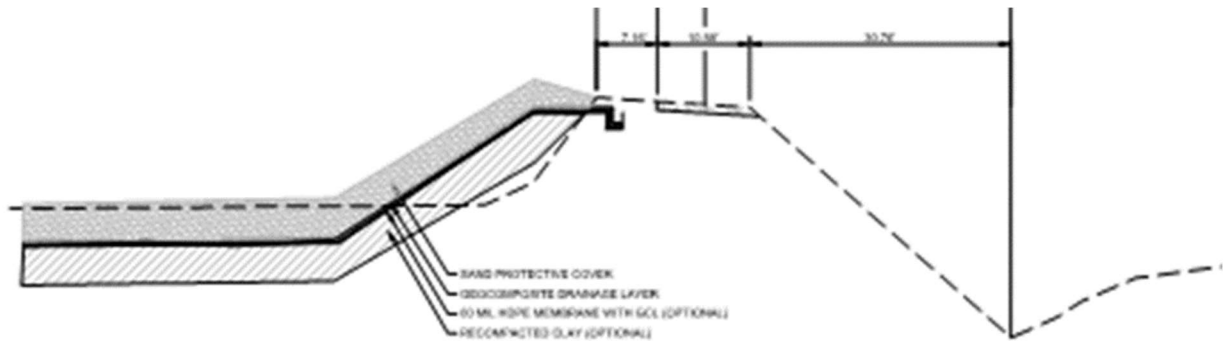
Typical Landfill Berm Detail

In general, the facility's landfill cell embankments were constructed using on-site and imported borrow materials. A typical perimeter section, taken from the Cell 2, Phase 2 Construction Documentation Report, prepared by CRA in November, 2012 is shown below.

During the inspection there were no signs of landfill cell embankment distress, no signs of waste slope instability, or other CCR landfill issues observed. The landfill embankments and interim covered slopes were generally in good condition with a well-established vegetation cover and no signs of significant erosion.

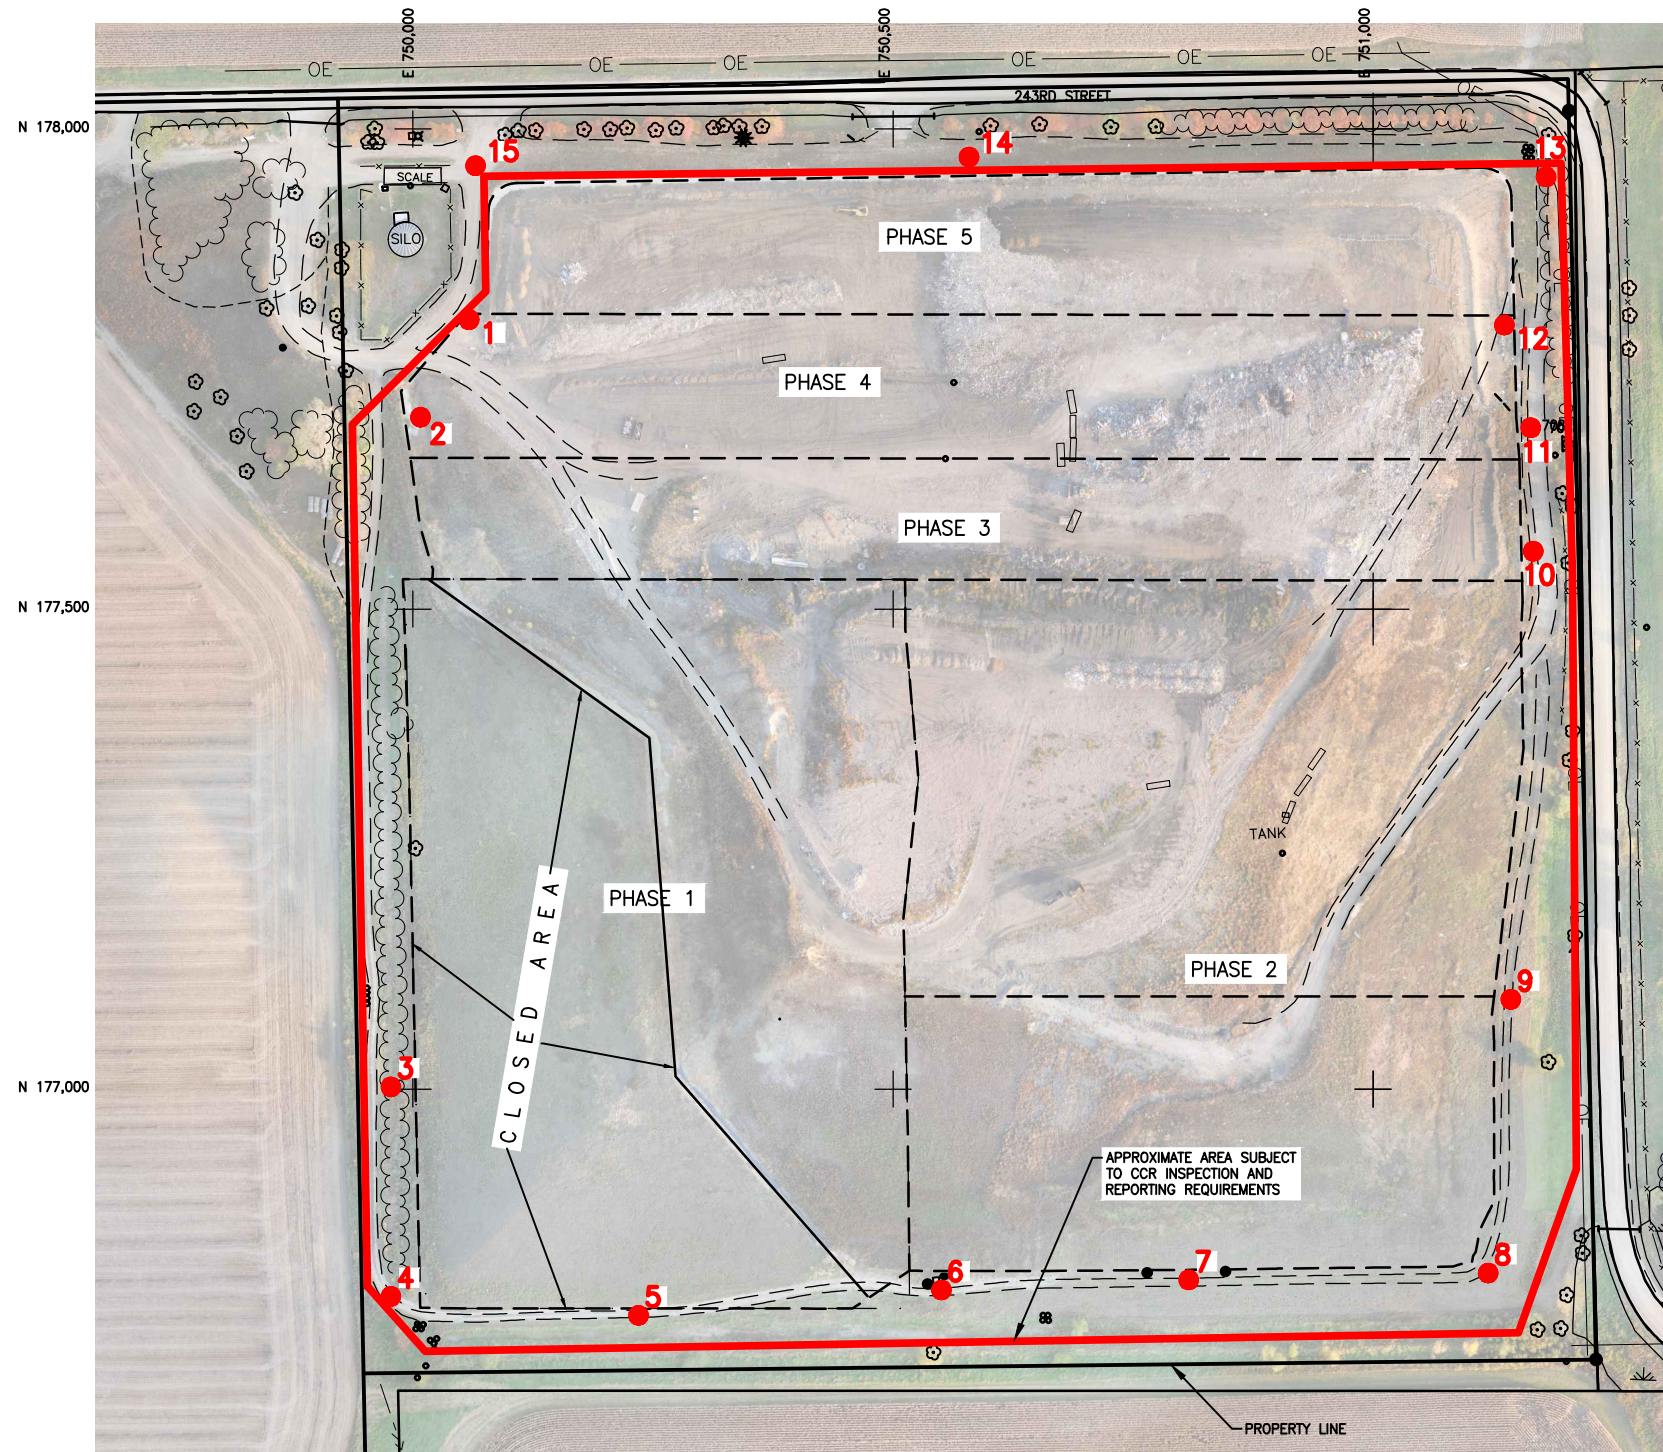
SHEET TITLE			
PHOTO LOCATIONS			
DWN BY	CHK'D	APP'D	DWG DATE
JVB	TJS	BWS	JAN. 2023
PROJECT NO.	SHEET NO.	SCALE	
227704387	FIGURE 1	AS NOTED	
			REV NO.
			0

Photos were taken during the inspection. Figure 1 presents the photo locations, and Attachment 1 contains a photo log and the photos taken.

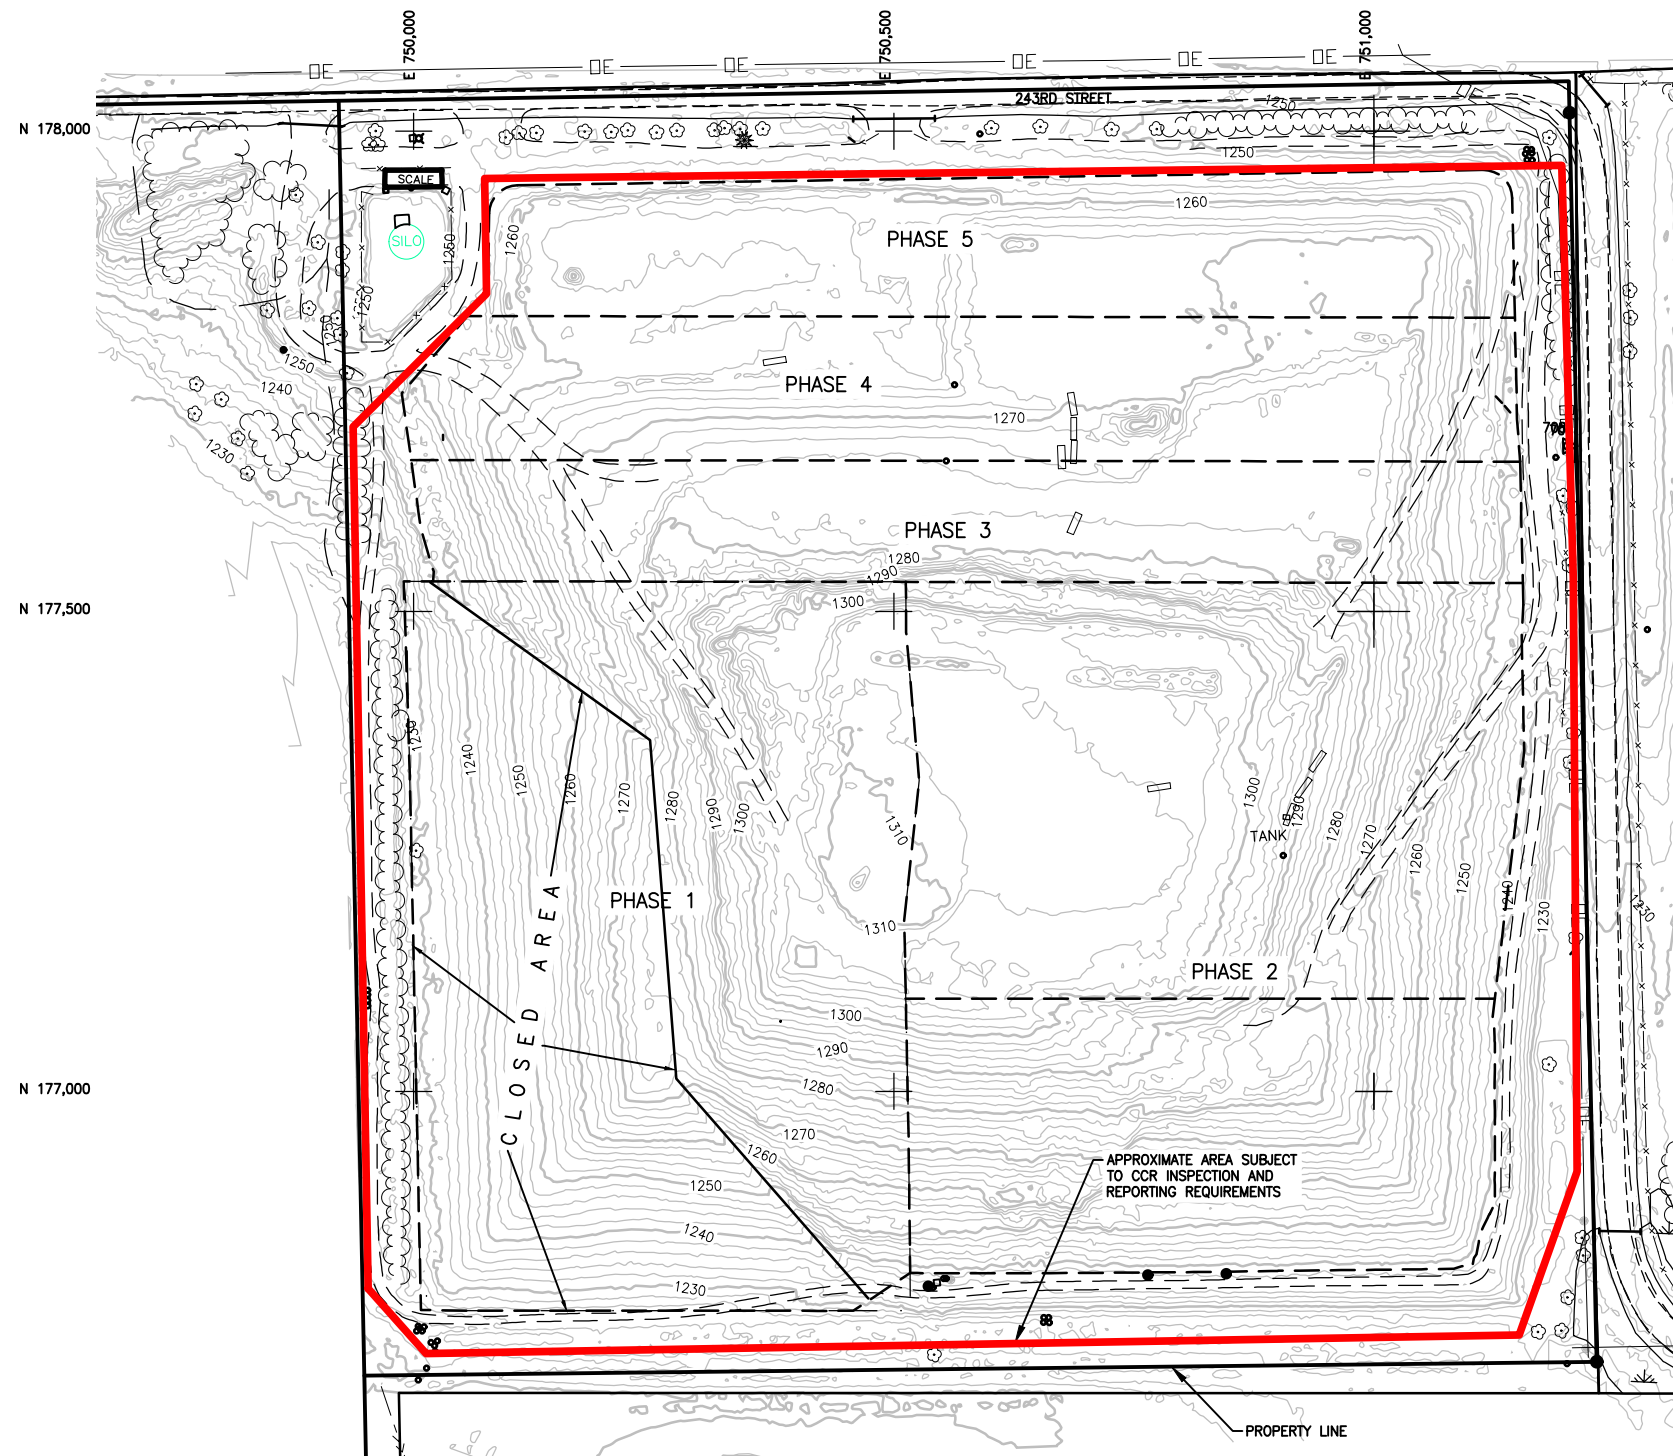
DWN BY	CHK'D	APP'D	DWG DATE
JVB	TJS	BWS	JAN. 2023
PROJECT NO.		SCALE	
227704387		AS NOTED	
SHEET NO.		REV NO.	
FIGURE 2		0

There were no apparent changes to the embankment geometry of Cells 1, 2, 3, 4, or 5 when compared to the design drawings or the past inspection reports. This year's annual aerial photogrammetry survey was performed on October 12, 2022, which the estimated in-place volume of total waste (including all accepted wastes) is based on. A comparison 2022 and 2021 aerial survey confirm that the embankment and slope topography is substantially unchanged with no significant movement. The 2022 aerial survey is included as Figure 2.

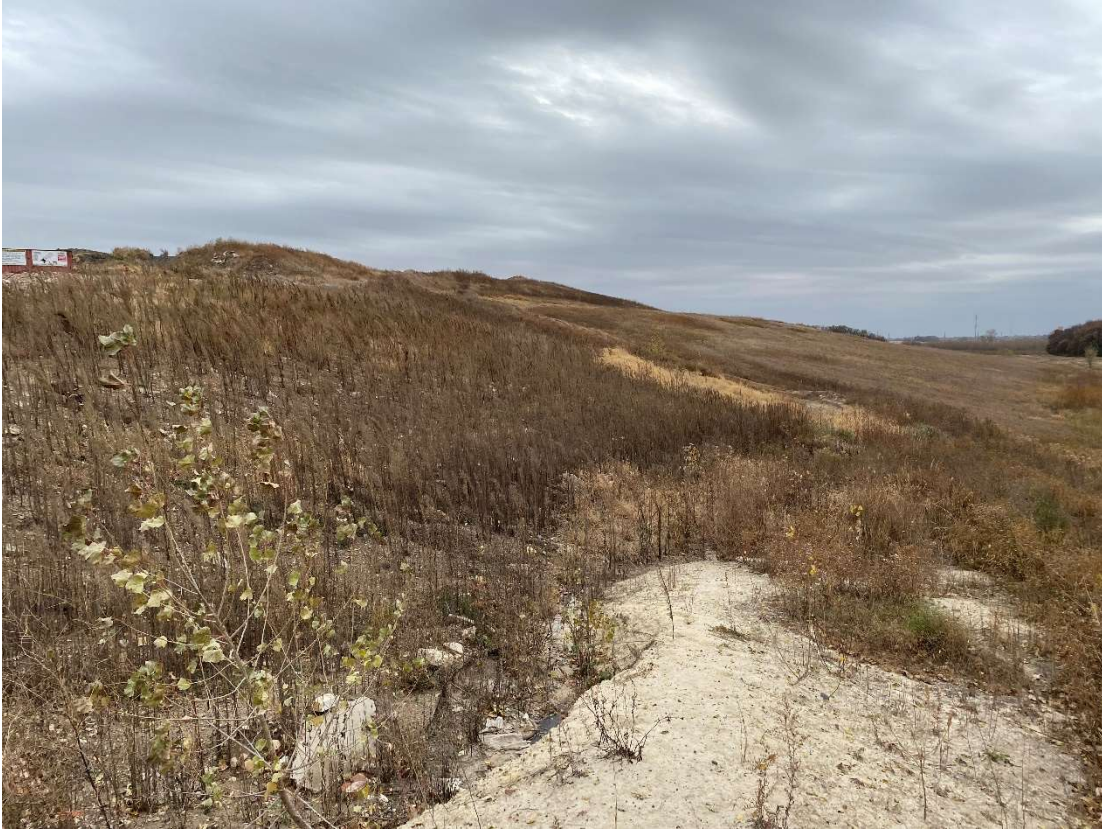
Location 1 – Looking Southwest, Phase 4 Anchor Trench

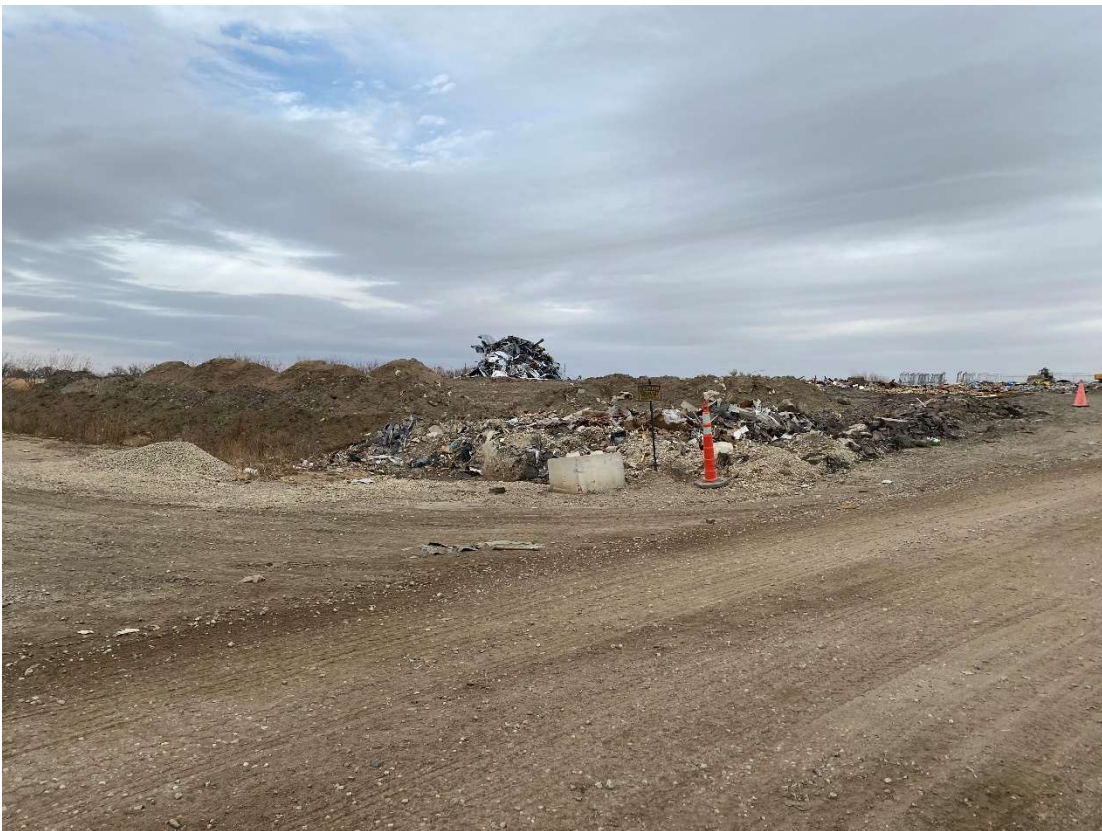
Location 2 – Looking Northeast, Phase 4 Anchor Trench

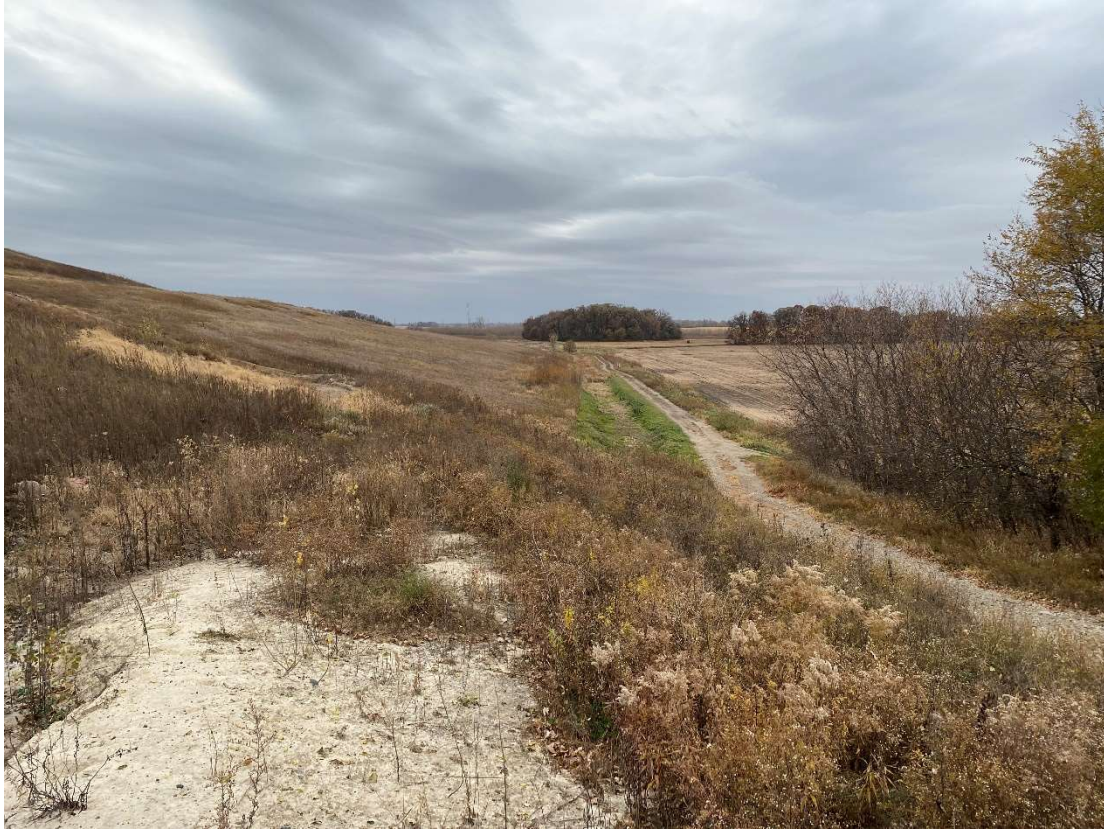
Location 2 – Looking South, Phase 3/1 Western Perimeter

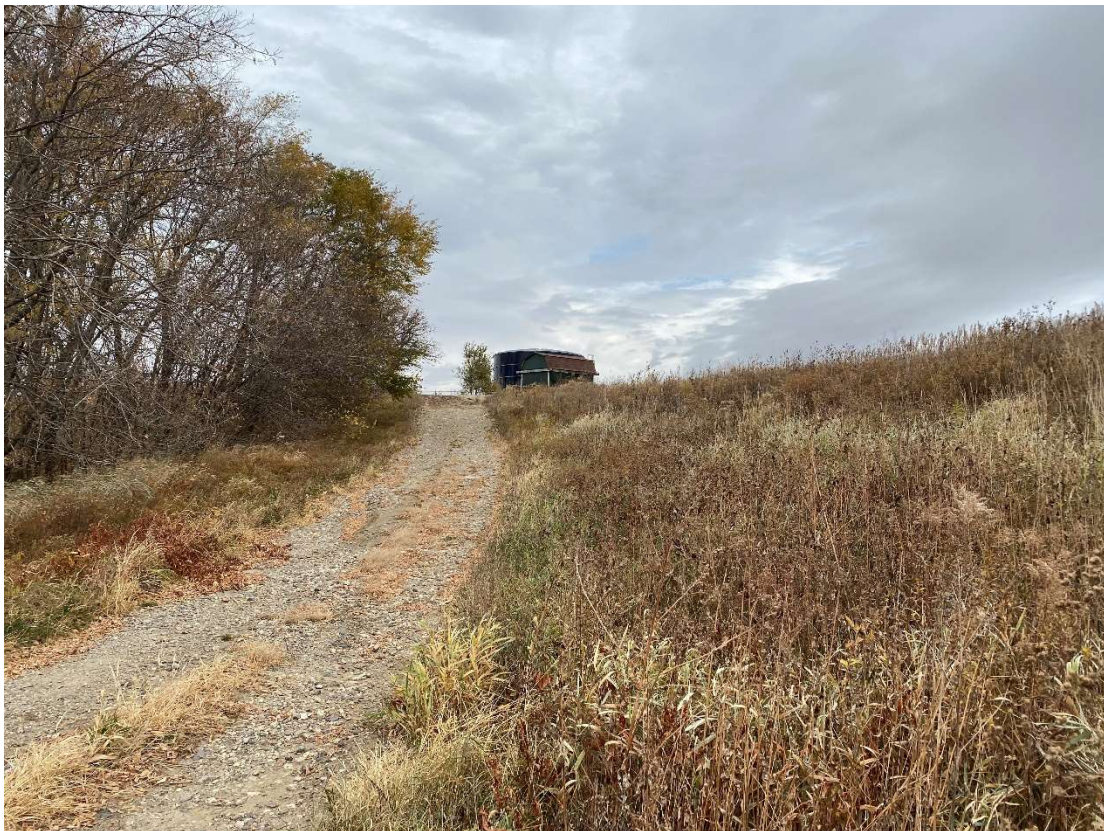
Location 2 – Looking North, Phase 4 West Perimeter

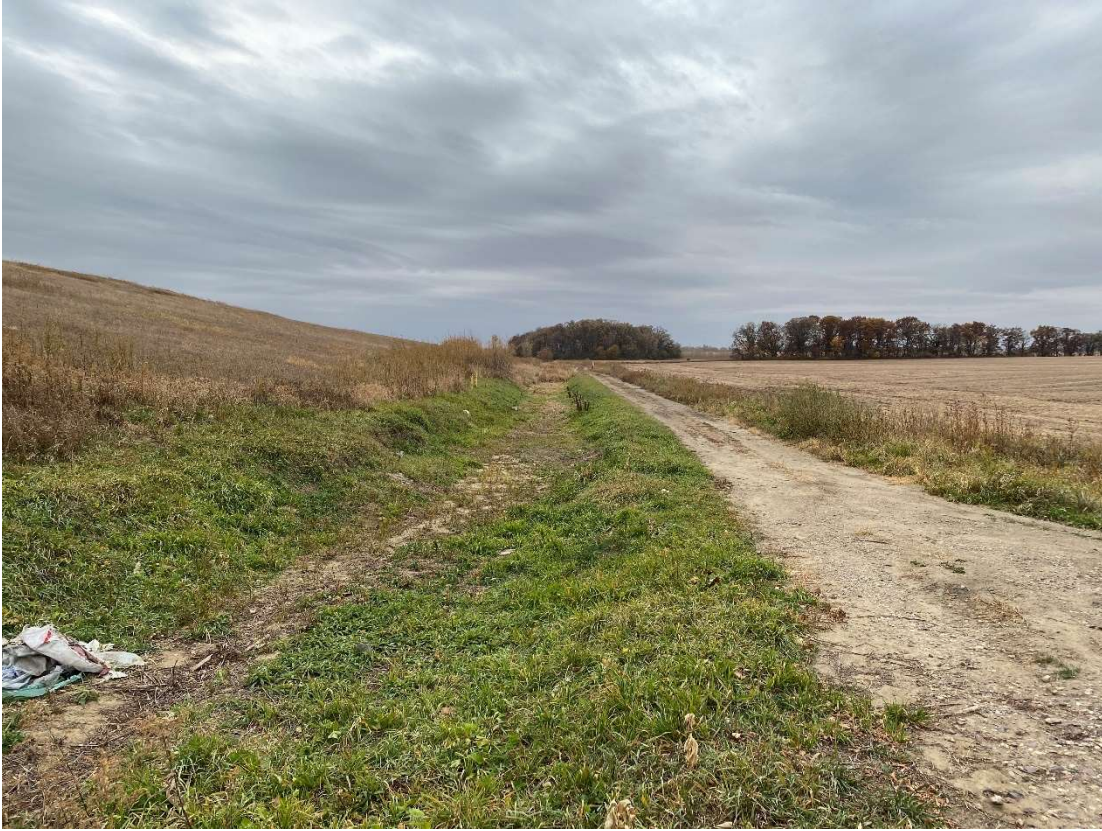
Location 3 – Looking South, Toe of Phase 1 Western Slope

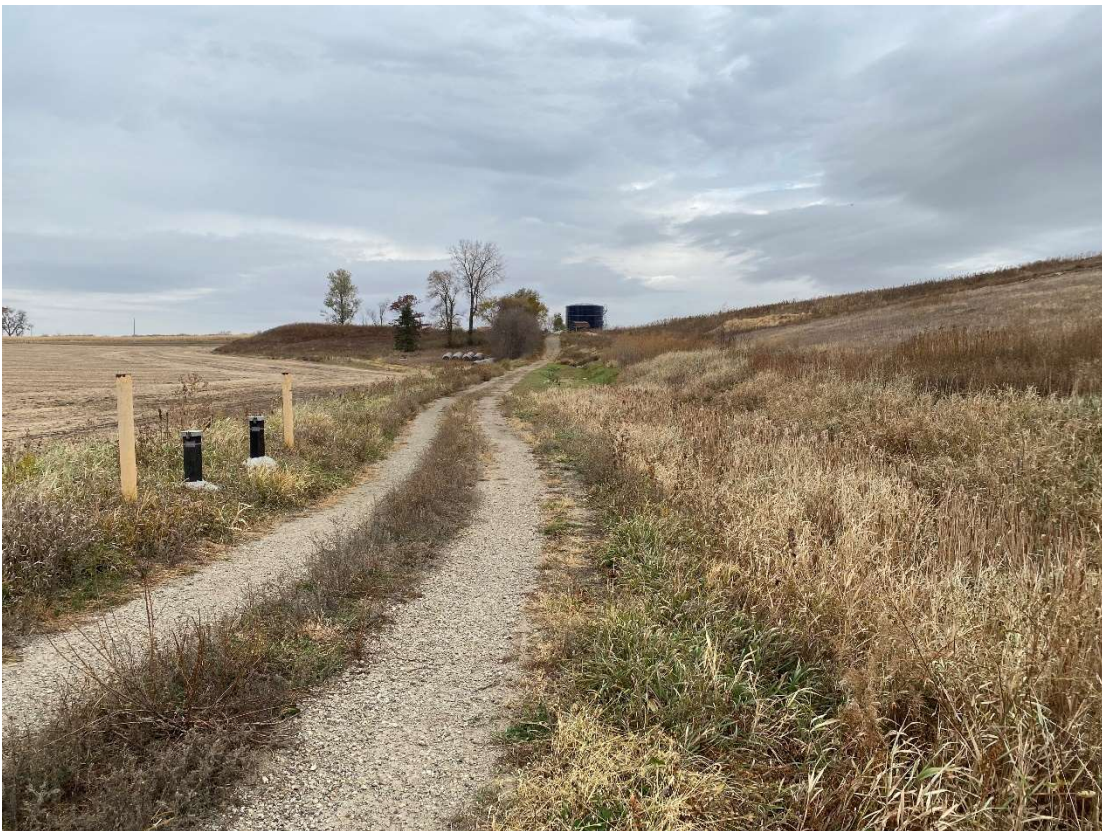
Location 3 – Looking North, Toe of Phase 1 Western Slope

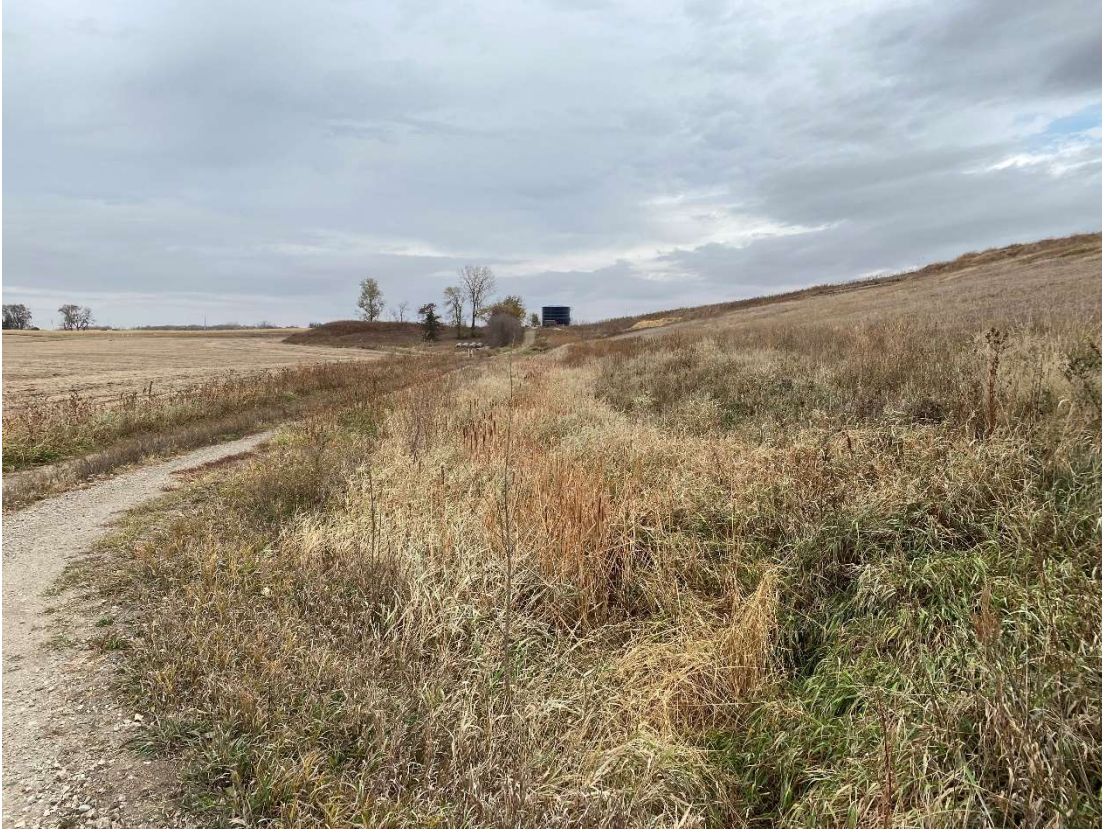
Location 4 – Looking North, Toe of Phase 1 Western Slope

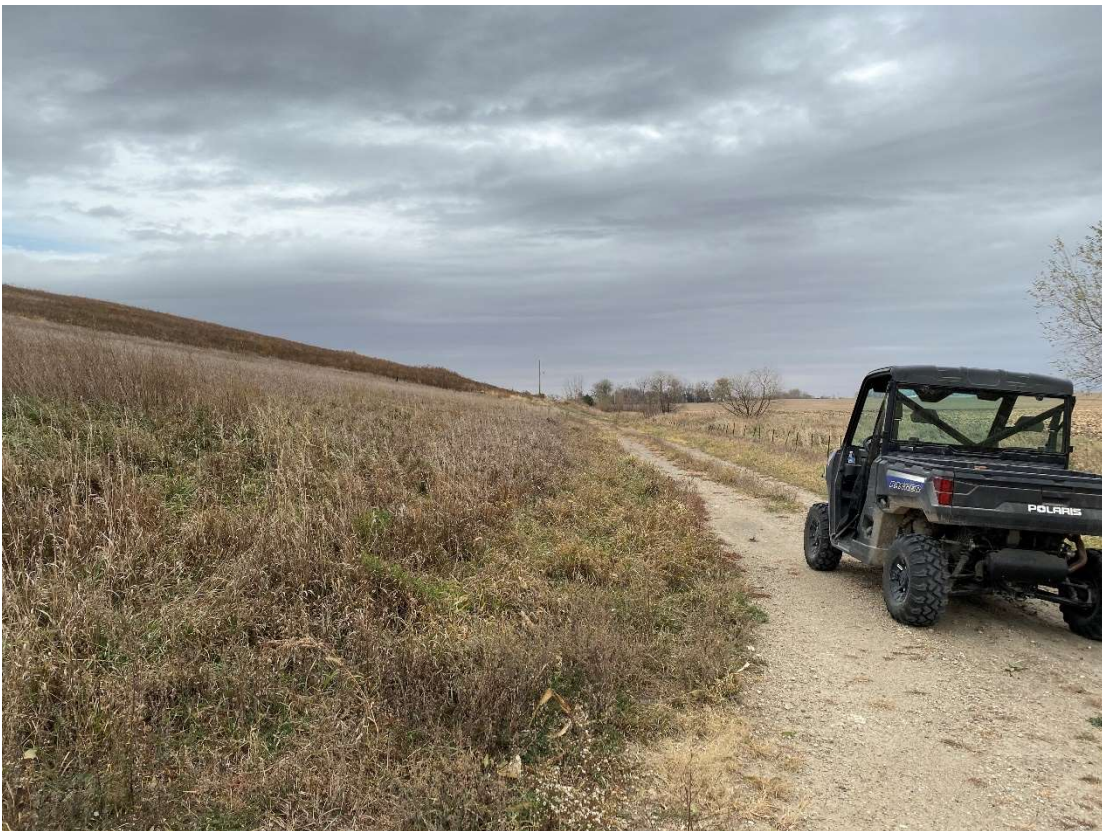
Location 4 – Looking East, Toe of Phase 1 Southern Slope

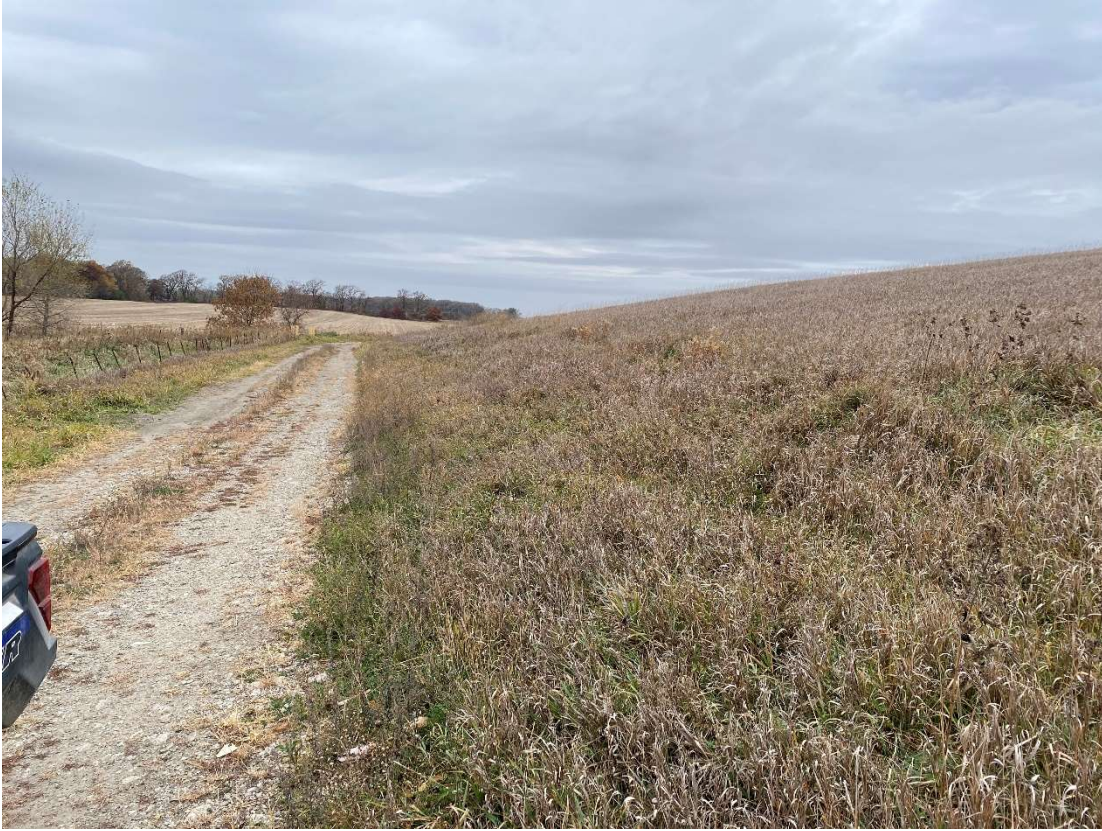
Location 5 – Looking West, Toe of Phase 1 Southern Slope

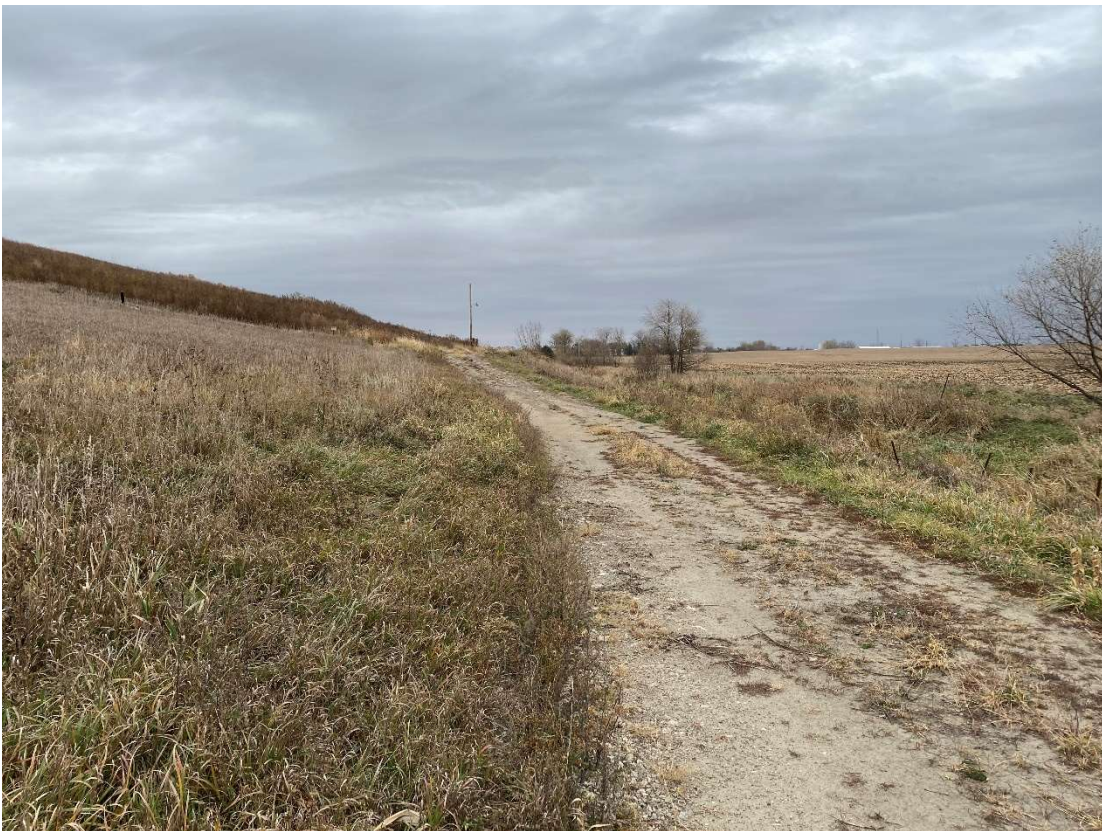
Location 5 – Looking East, Toe of Phase 1 Southern Slope

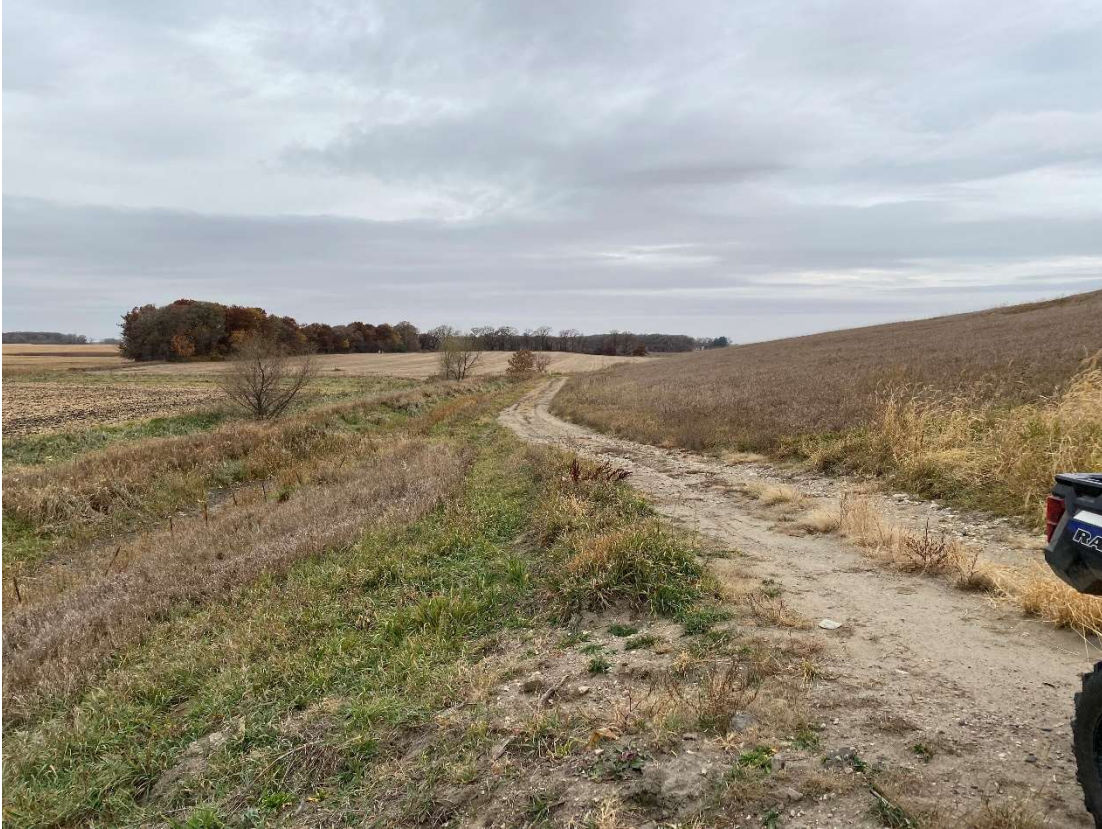
Location 6 – Looking West, Phase 1 Southern Slope

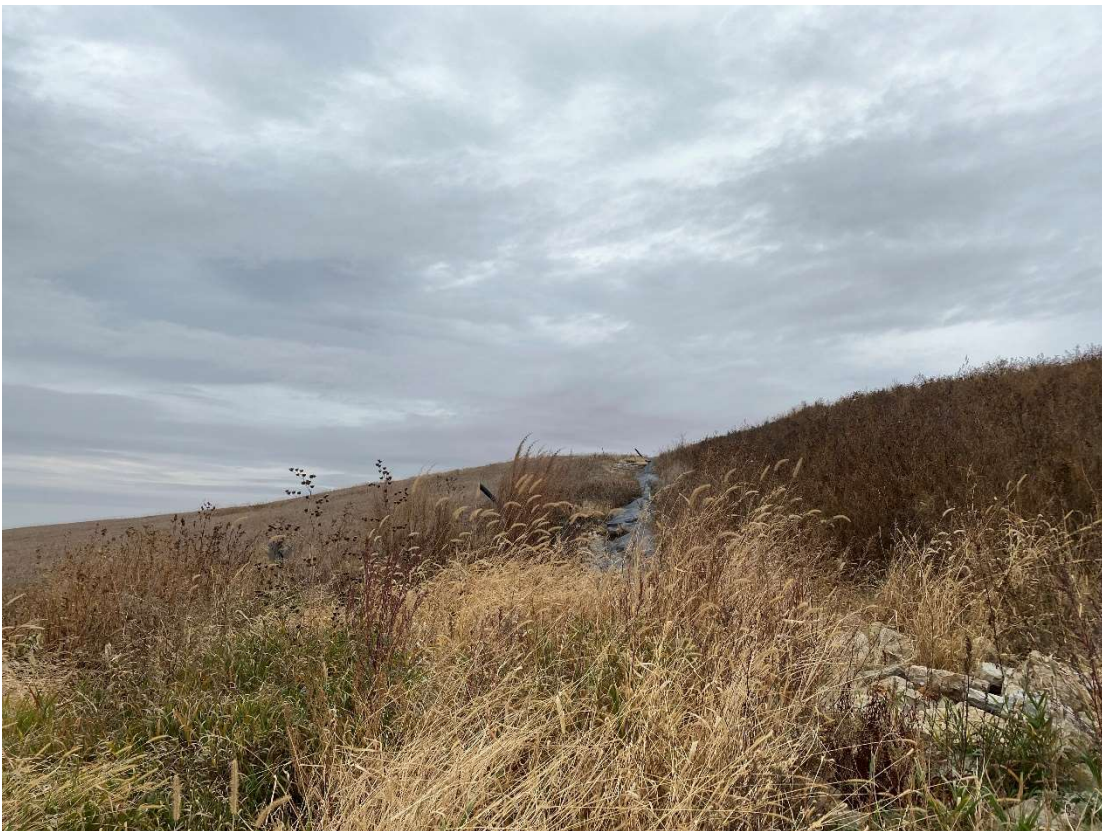
Location 6 – Looking West, Phase 1/2 Overlay Liner & Southern Slope

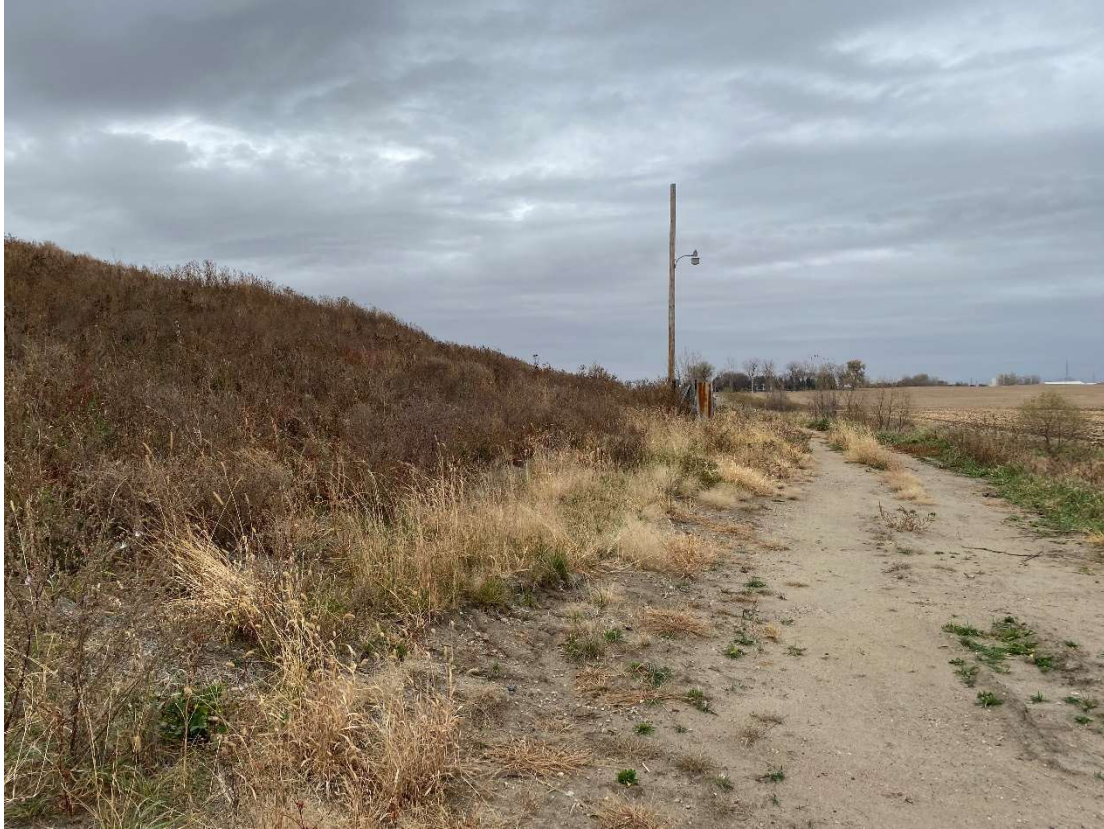
Location 6 – Looking East, Phase 2 Southern Slope

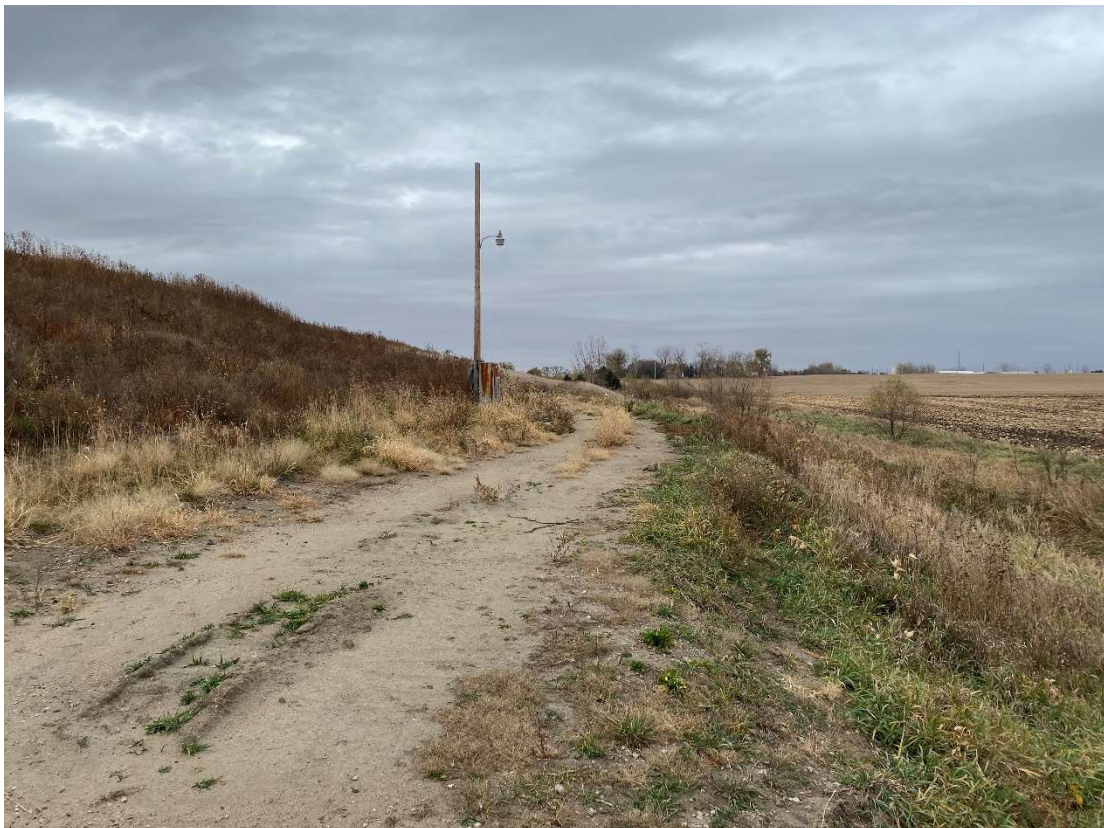
Photo 14: Location 6 – Looking East, Phase 2 Southern Berm

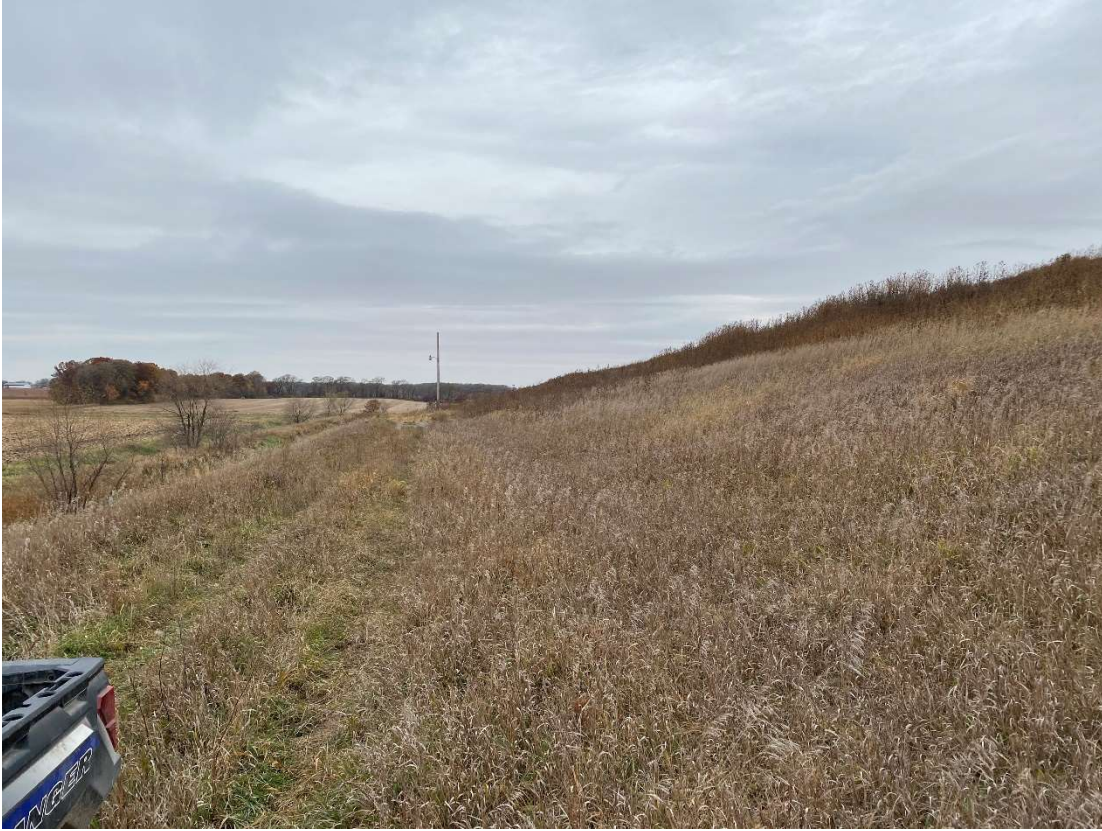
Location 7 – Looking West, Phase 2 Southern Perimeter Road and Slope

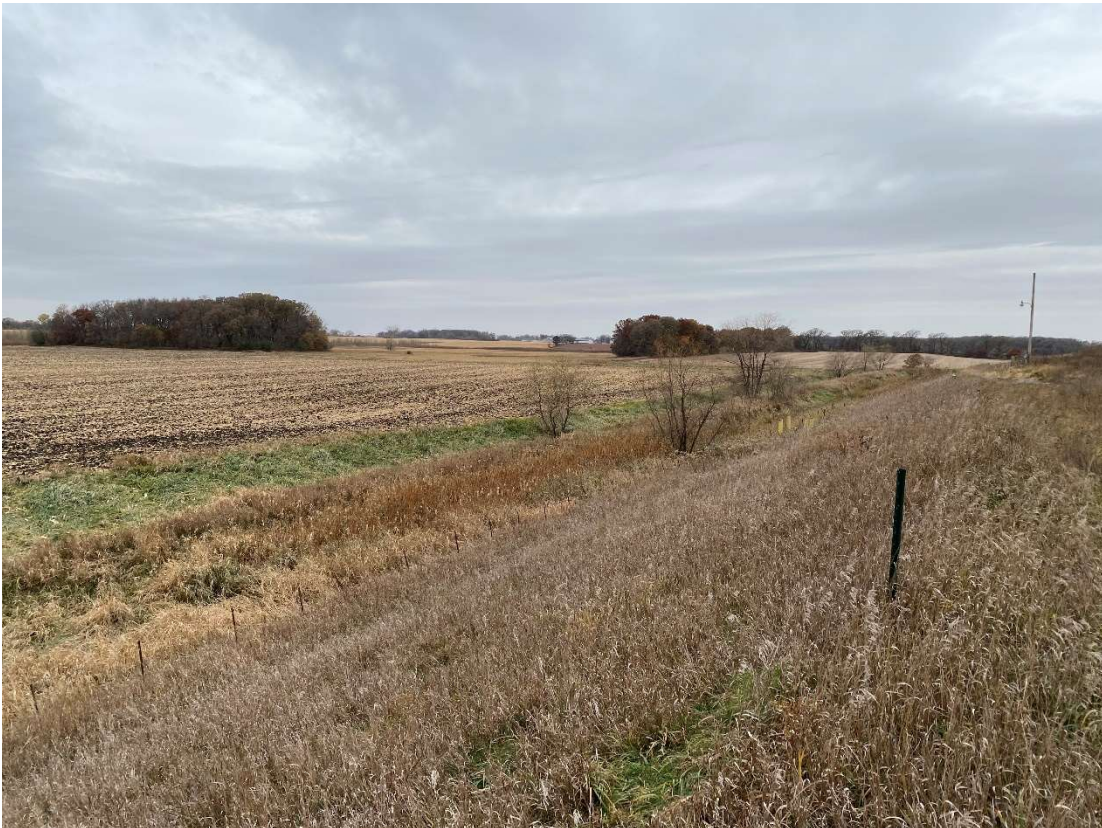
Location 7 – Looking West, Phase 2 Southern Berm

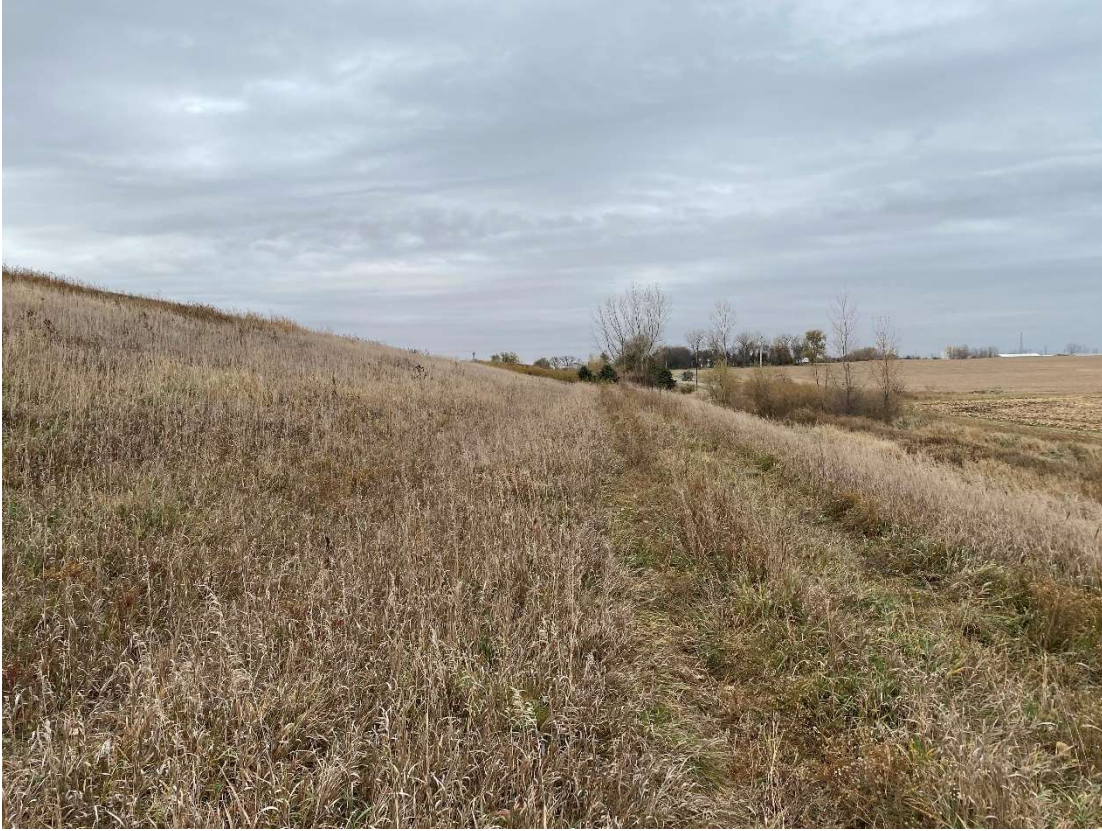
Location 7 – Looking East, Phase 2 Southern Perimeter Road and Slope

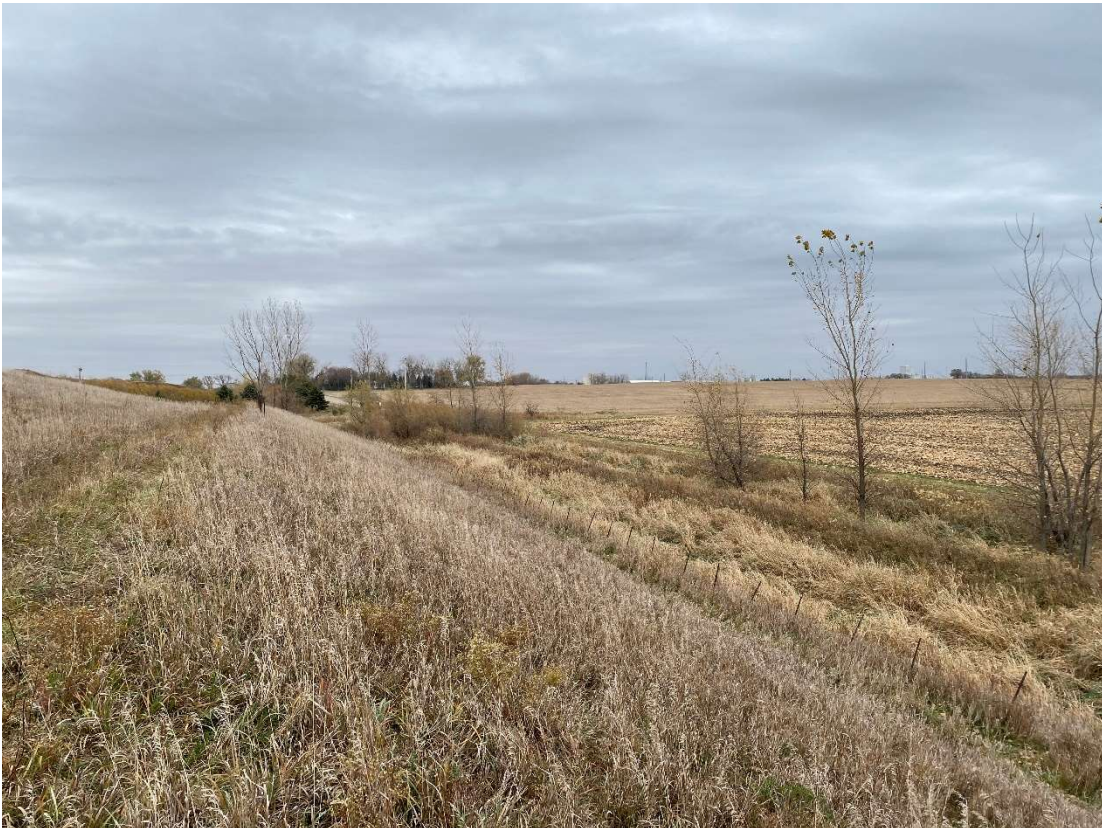
Location 7 – Looking East, Phase 2 Southern Berm
