To: Geoff Strack, PE, Waste Connections From: Brad Sullivan, PE, Stantec
File: 227704387 Date: January 7, 2023

Reference: WCI Austin Landfill, LLC 2022 Annual CCR Inspection Report

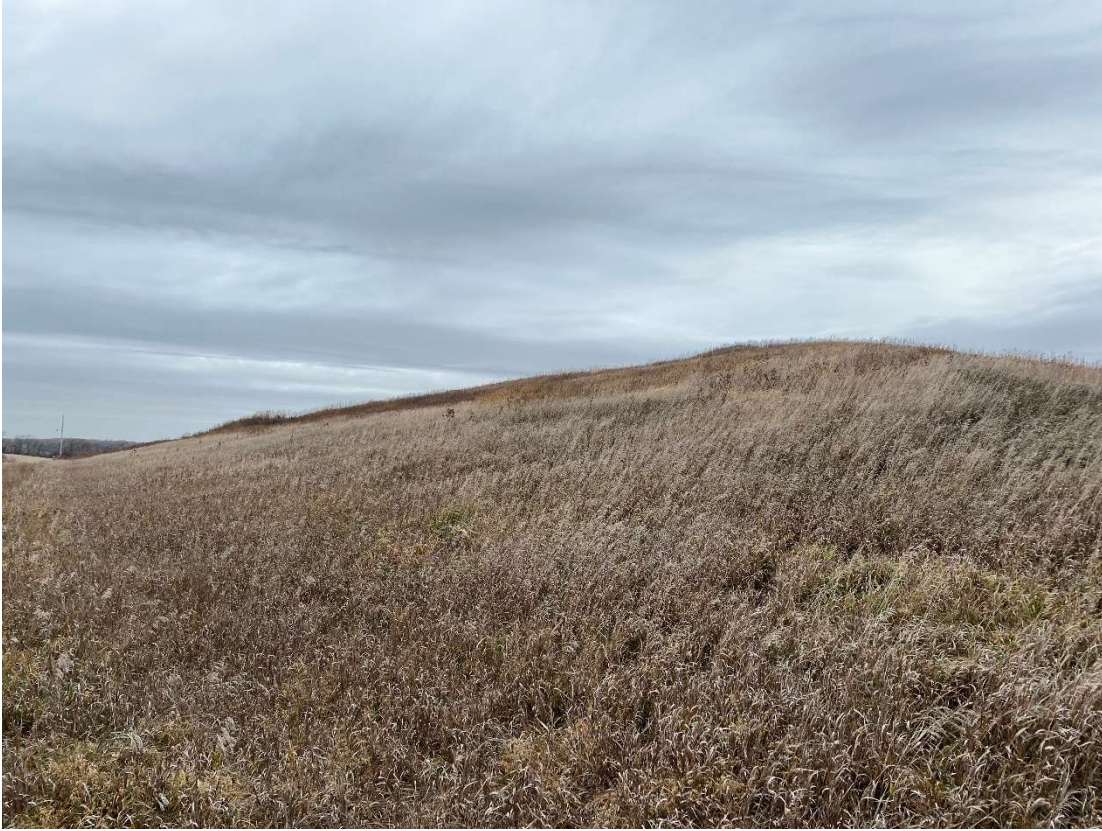
Location 8 – Looking West, Phase 2 Southern Perimeter Road and Slope

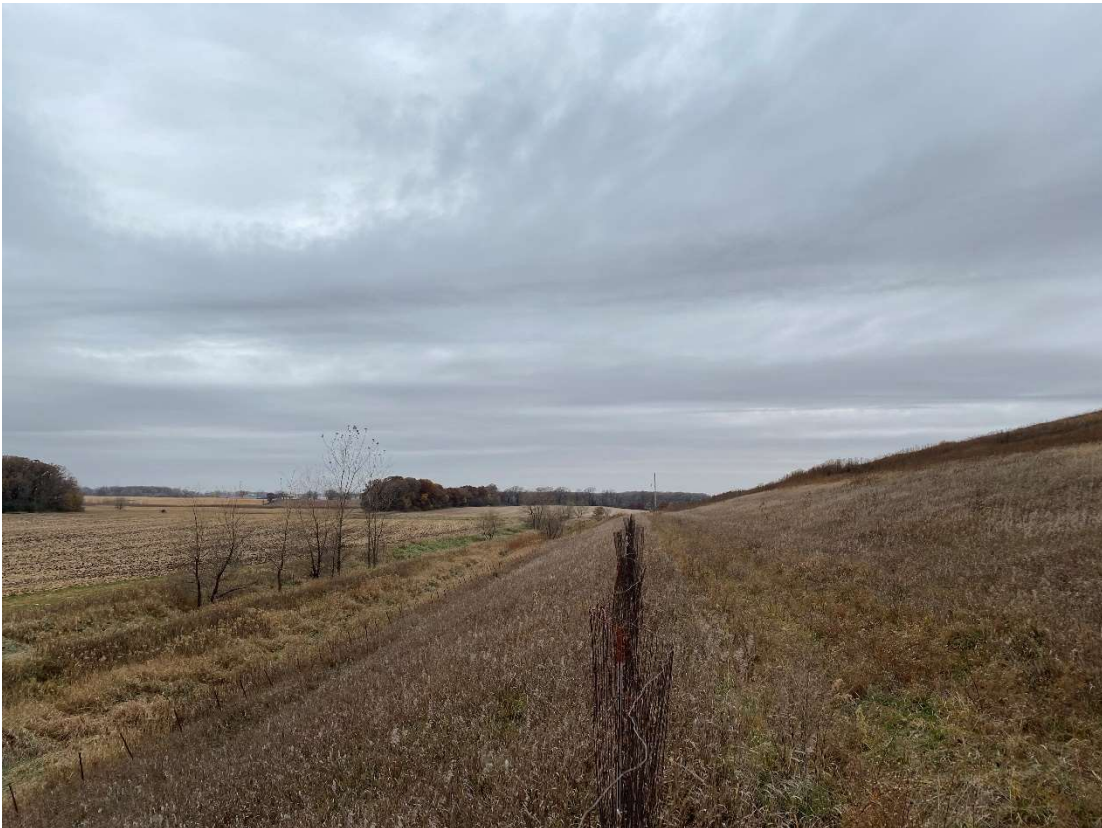
Location 8 – Looking West, Phase 2 Southern Berm

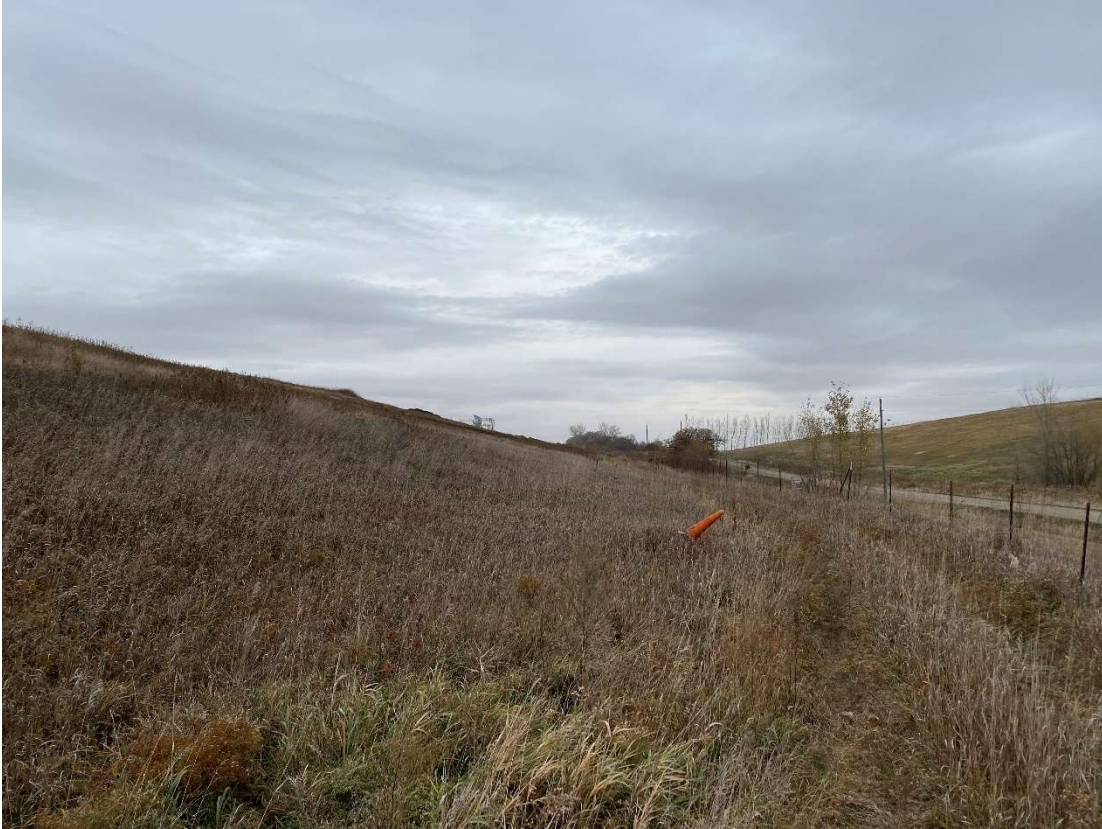
Location 8 – Looking North, Phase 2 Eastern Slope

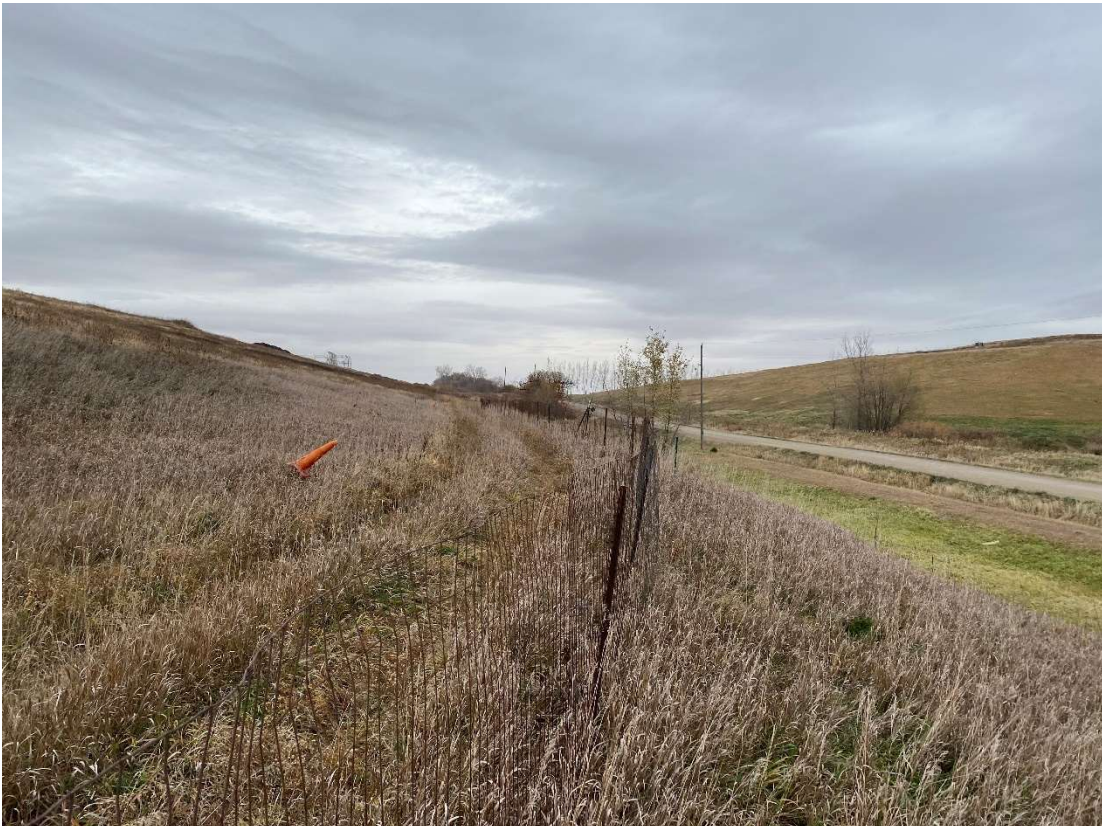
Location 8 – Looking North, Phase Eastern Berm

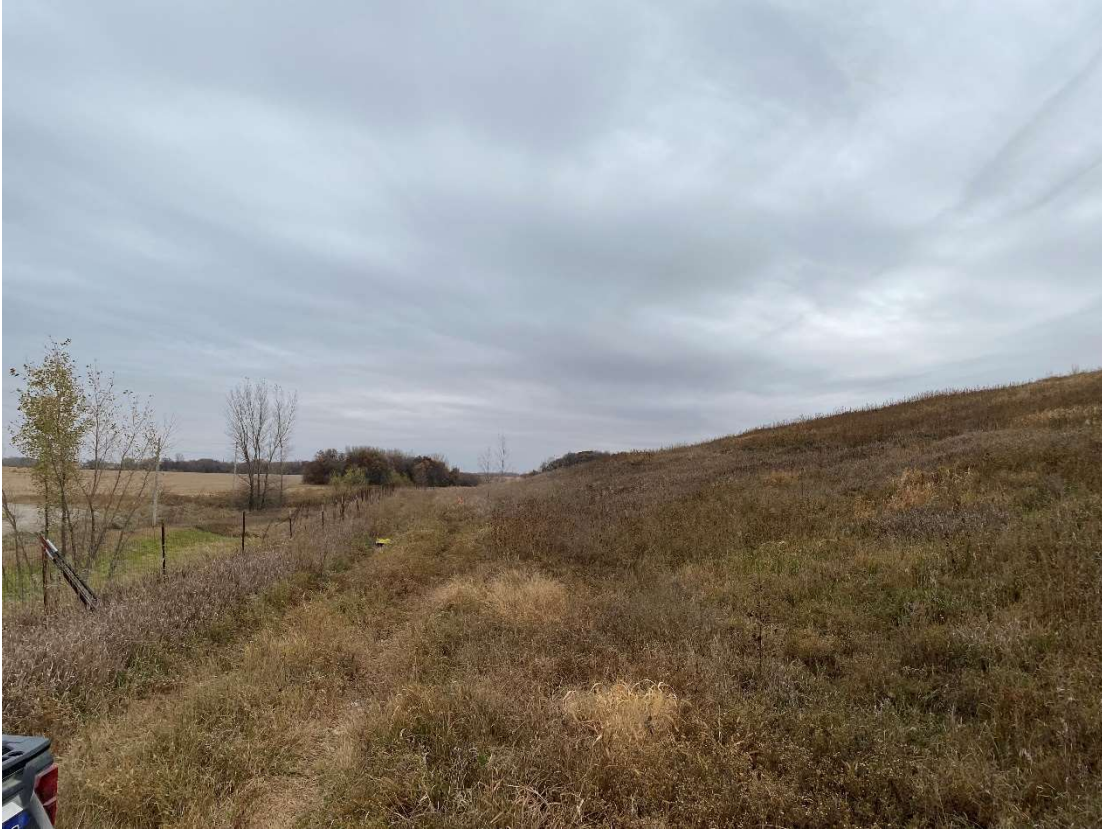
Location 9 – Looking South, Phase 2 Eastern Perimeter Road & Slope

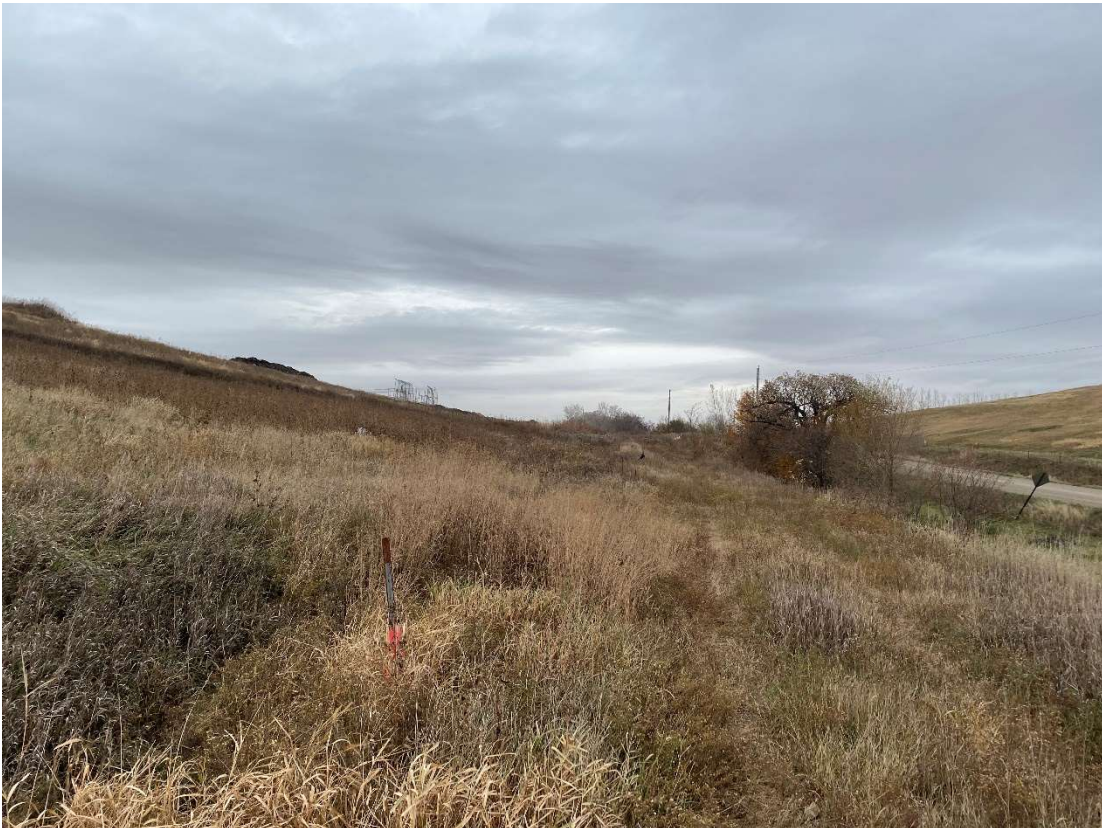
Location 9 – Looking North, Phase 2 Eastern Perimeter Road & Slope

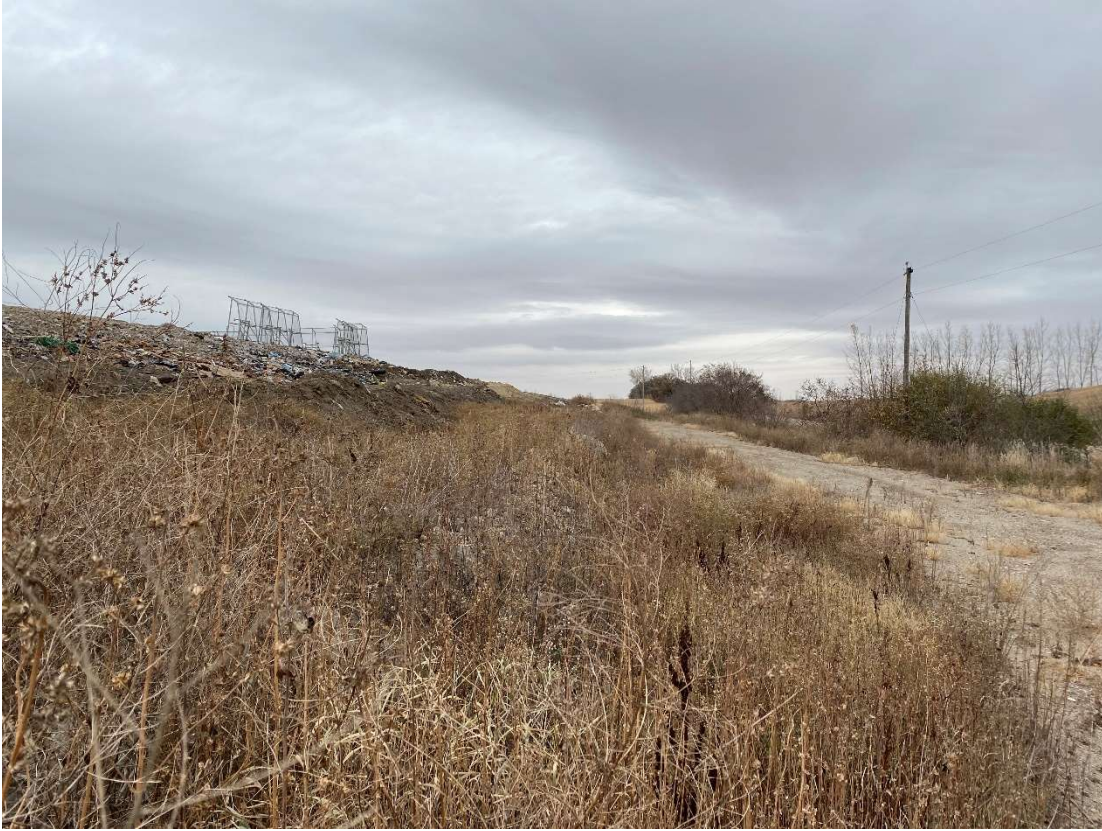
Location 10 – Looking North, Eastern Perimeter Road

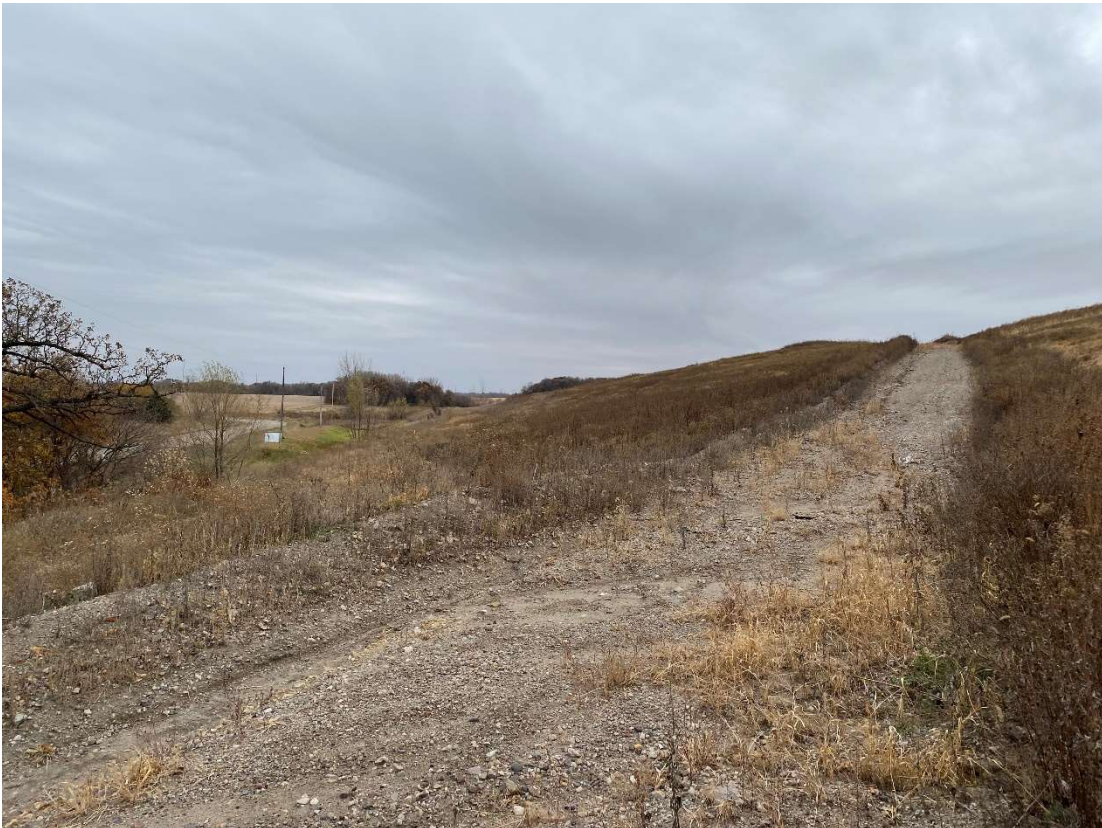
Location 10 – Looking South, Phase 2 Eastern Slope and Interior Access Road Entrance

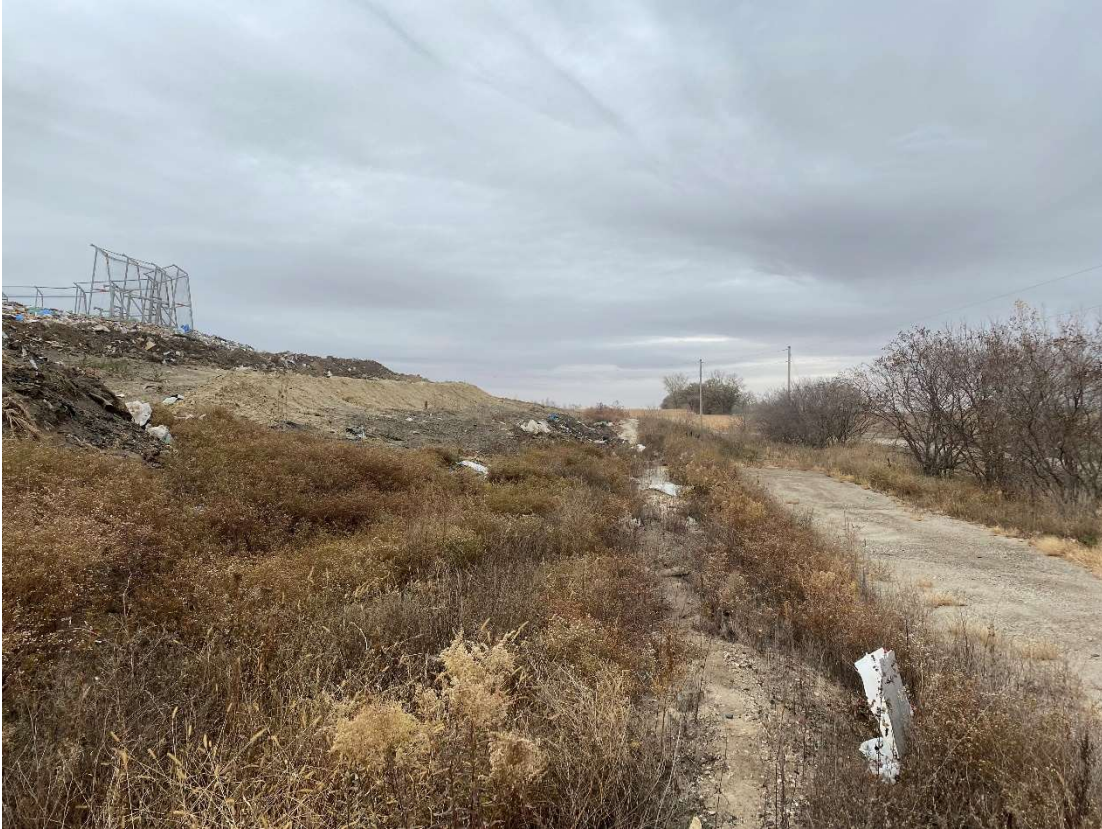
Location 11 – Looking North, Phase 4 Eastern Anchor Trench

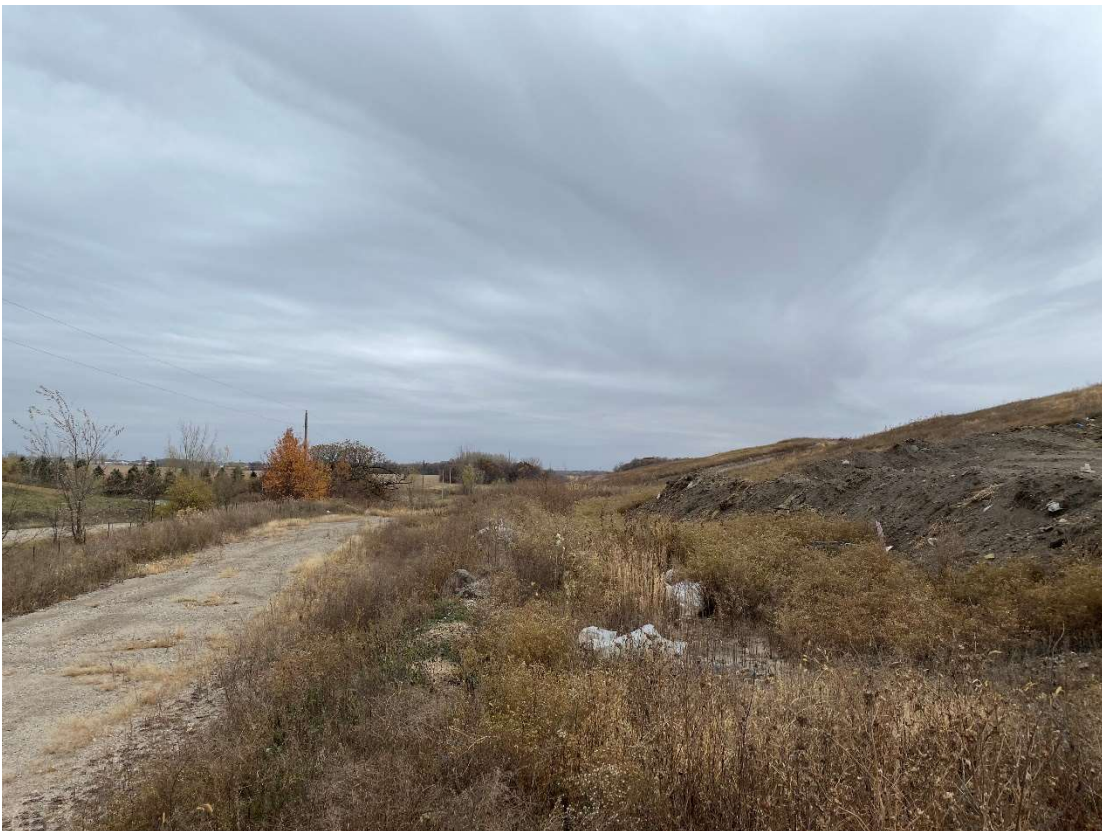
Location 11 – Looking South, Phase 4 Eastern Anchor Trench

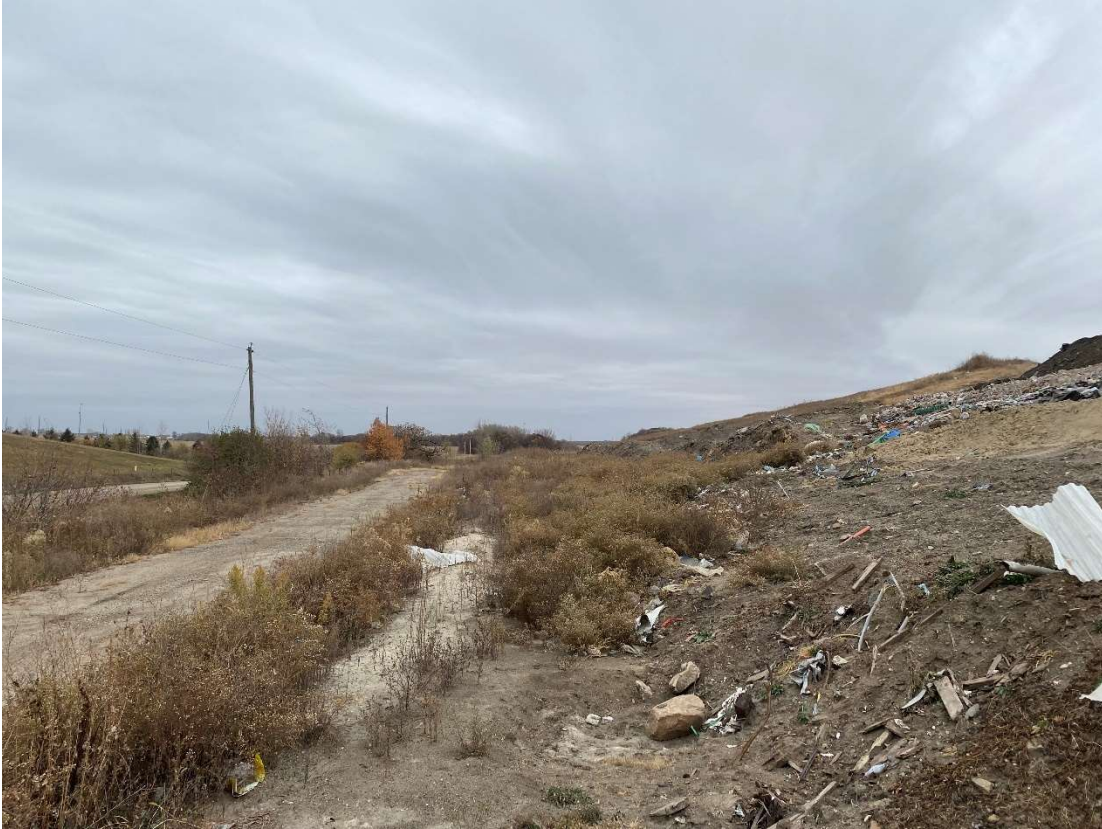
Location 12 – Looking South, Phase 4 Eastern Anchor Trench & Phase 3 Eastern Waste Slope

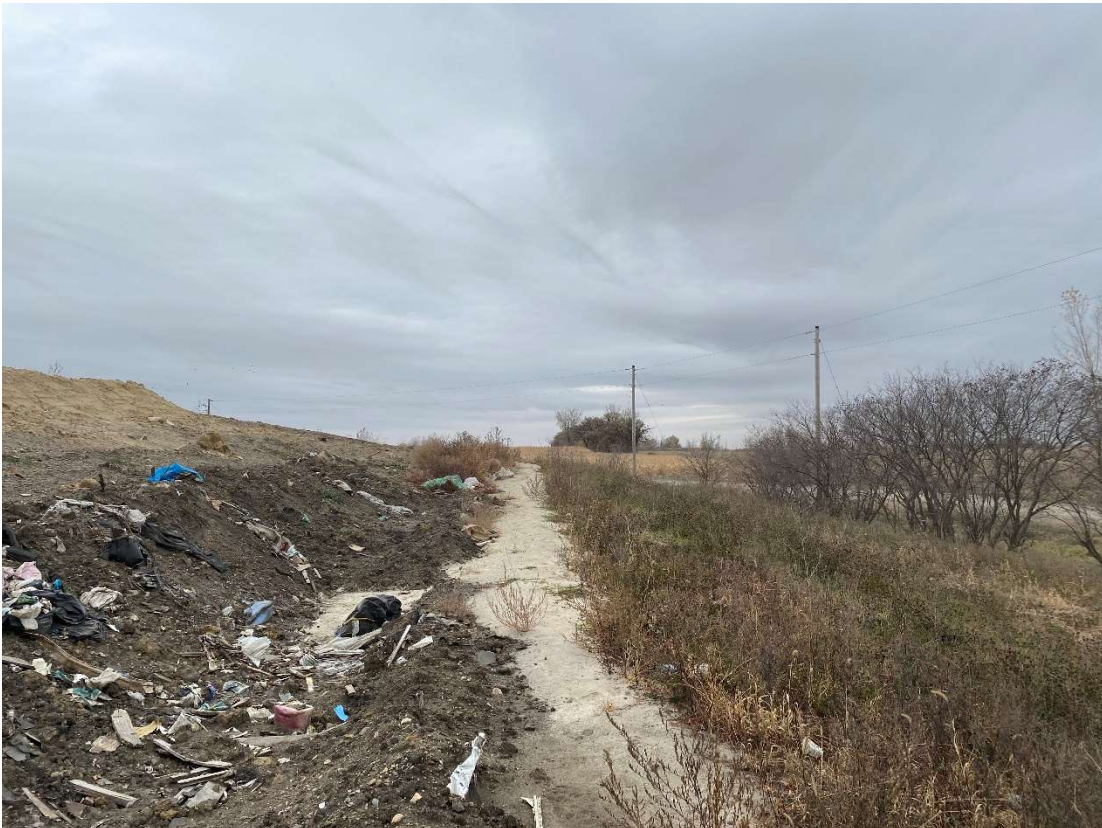
Location 12 – Looking North, Phase 5 east anchor trench

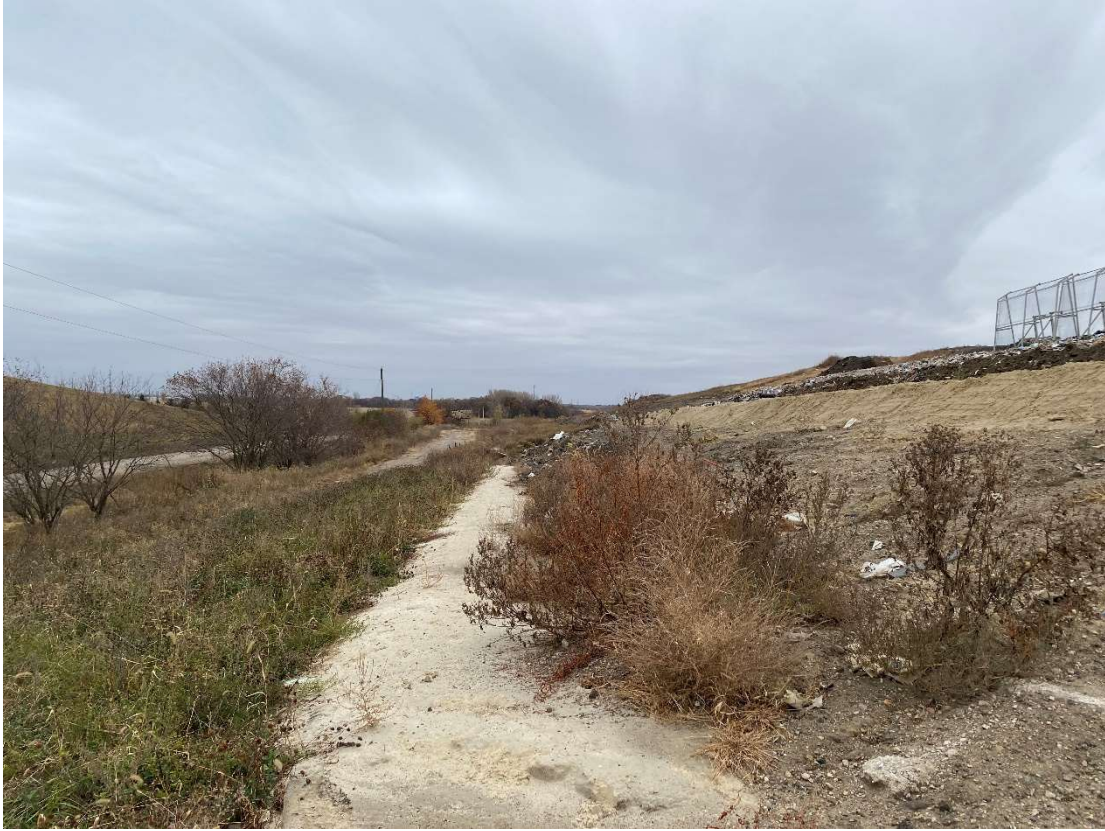
Location 13 – Looking South, Phase 5 Western Cell Limit

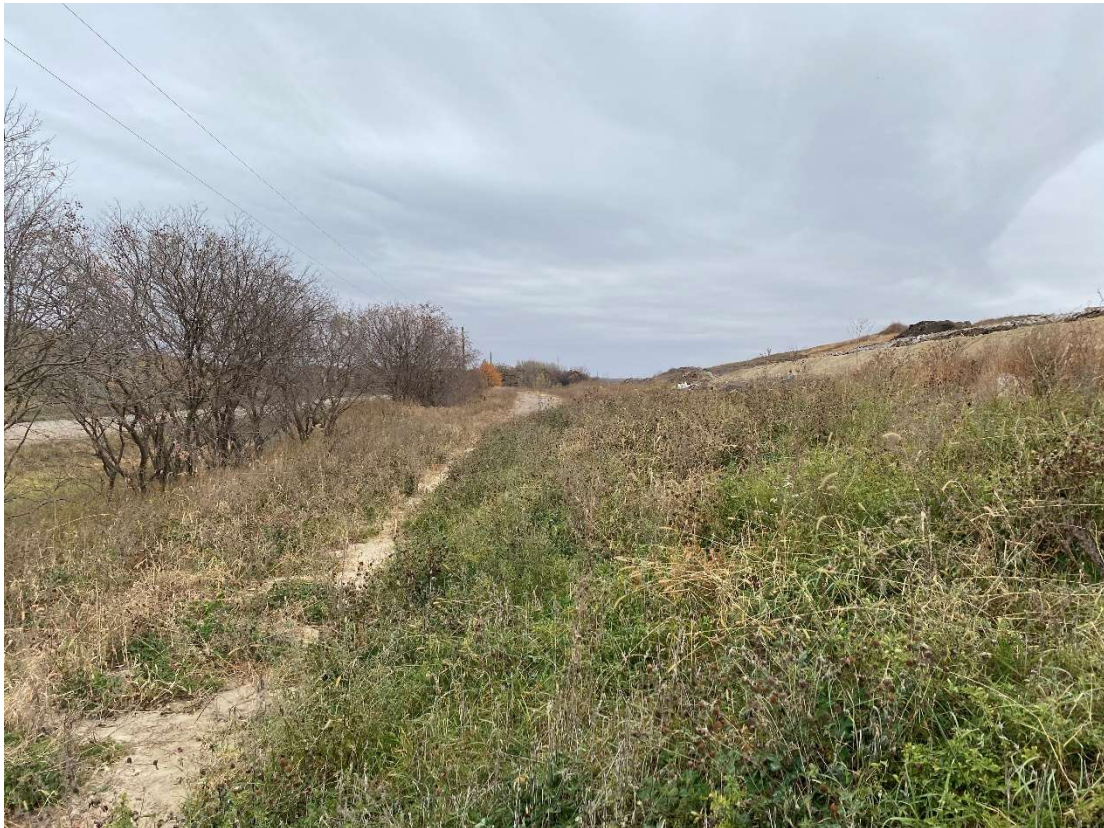
Location 13 – Looking South, Phase 5 Toe of Berm

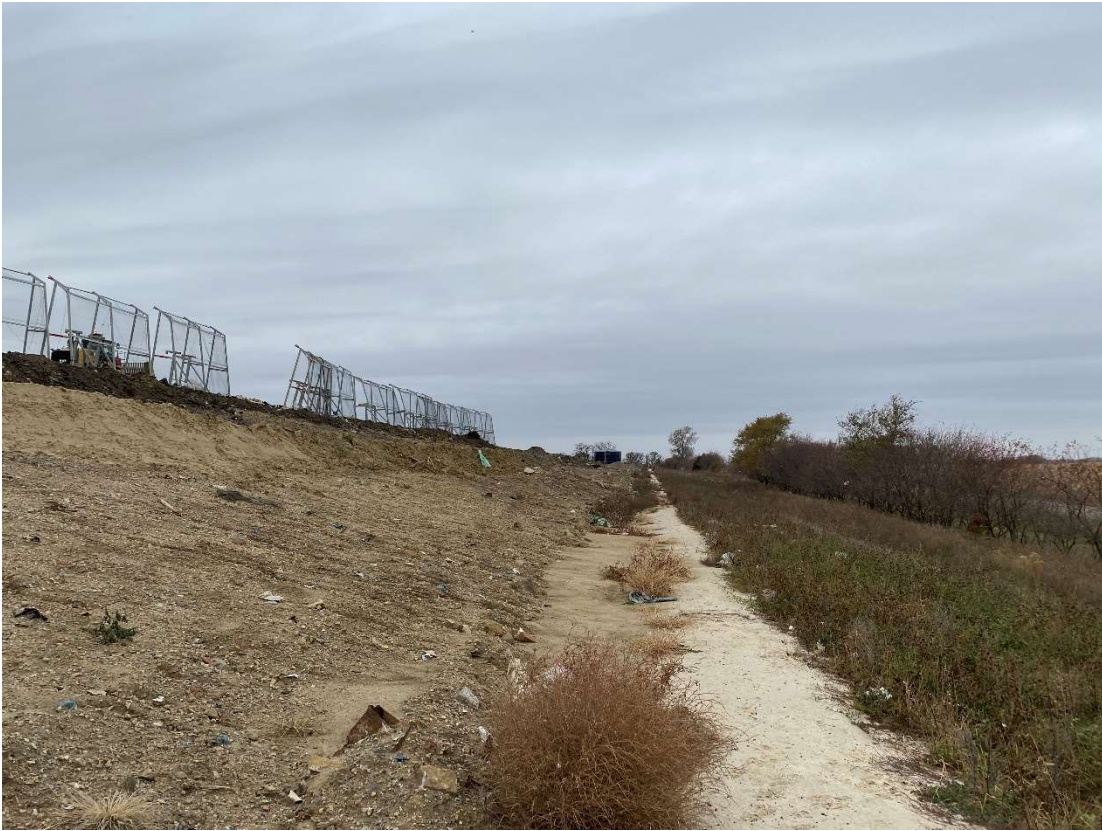
Location 13 – Looking West, Phase 5 Cell Limit

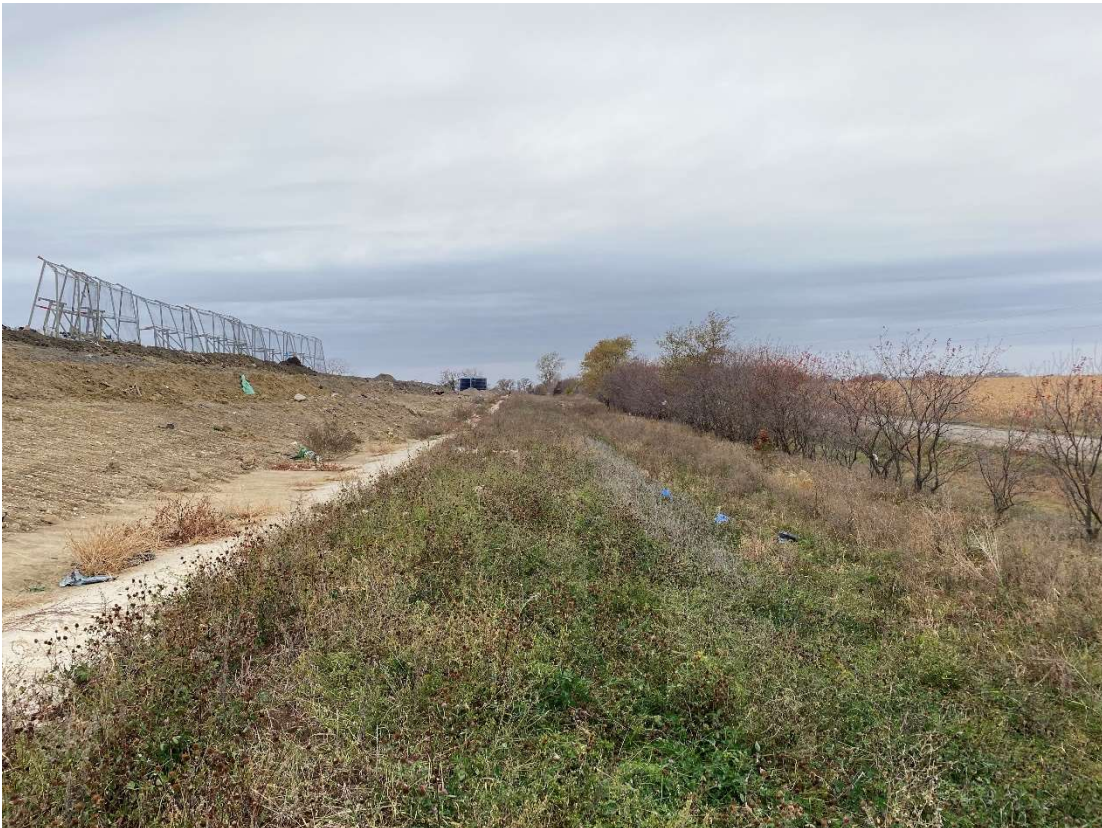
Location 13 – Looking West, Phase 5 Toe of Berm

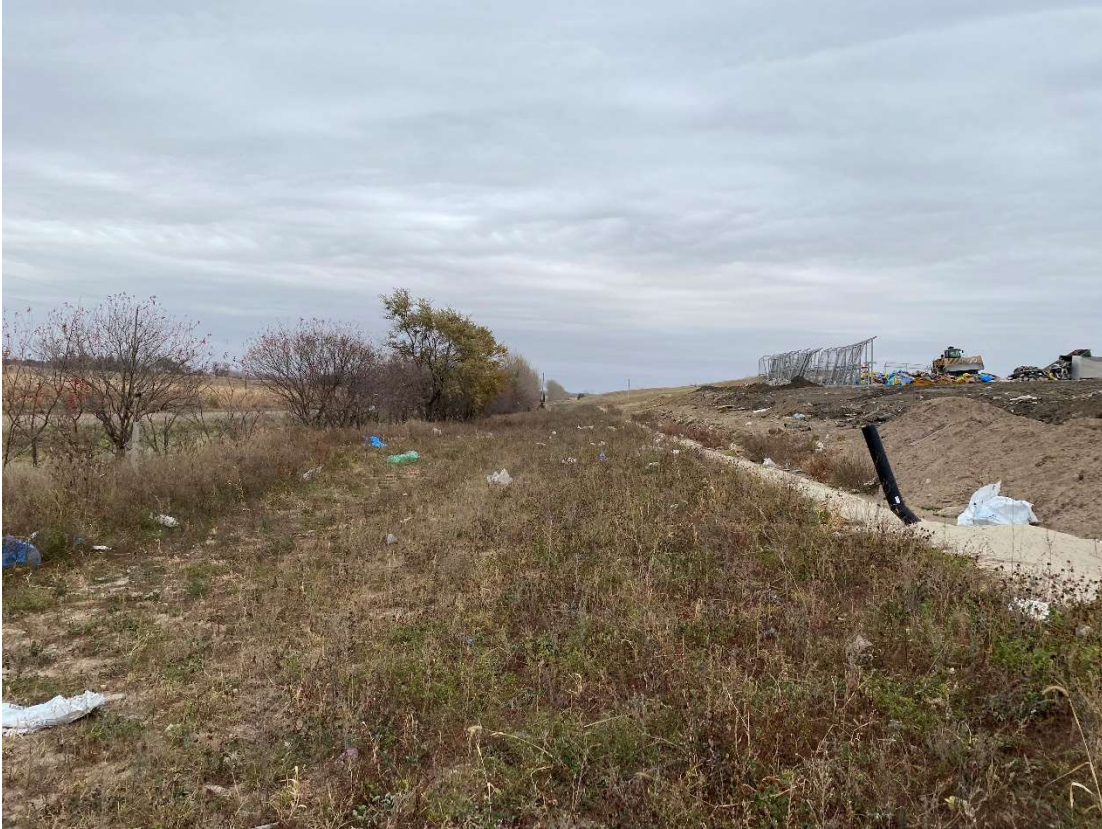
Location 14 – Looking East, Phase 5 Toe of Berm

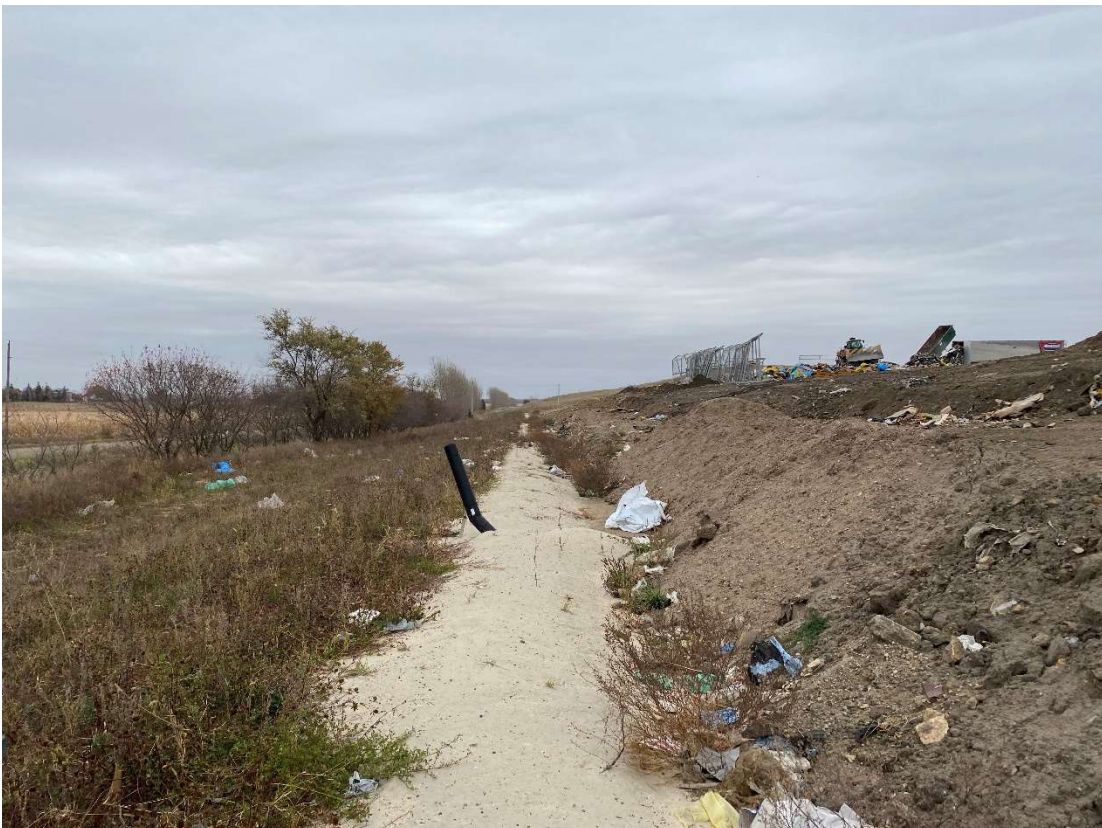
Location 14 – Looking East, Phase 5 Cell Limit

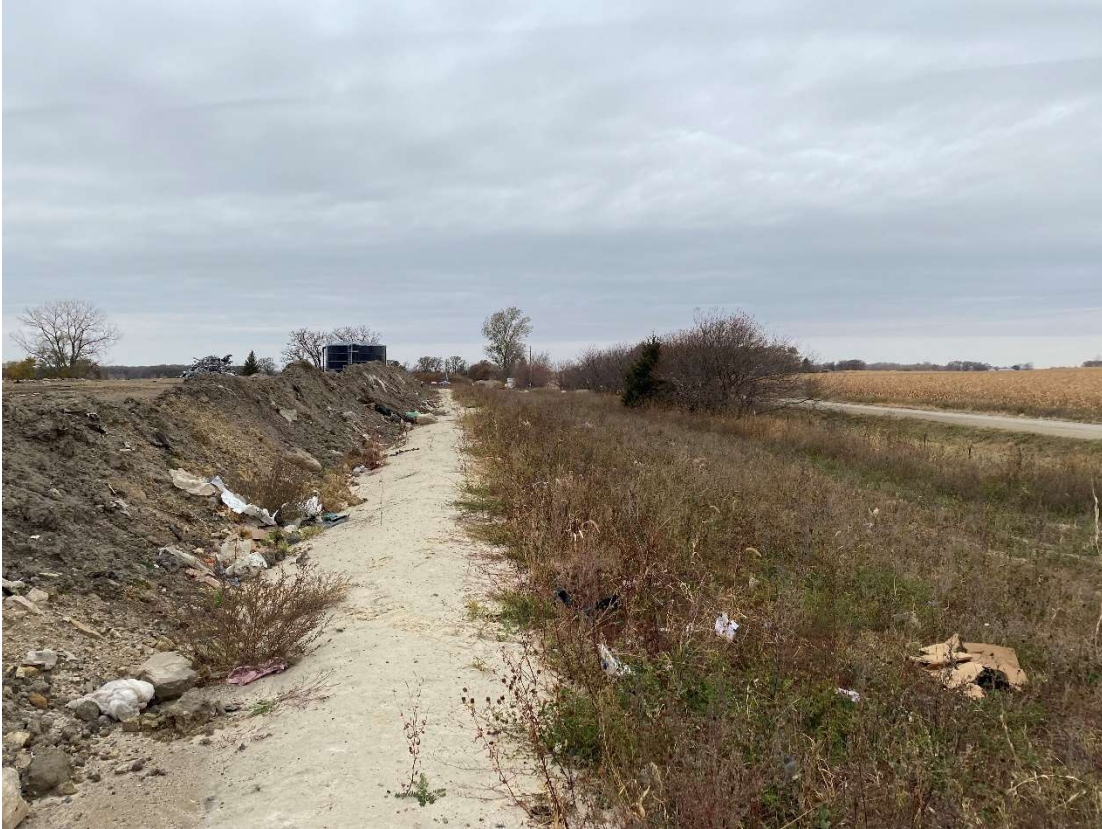
Location 14 – Looking West, Phase 5 Cell Limit

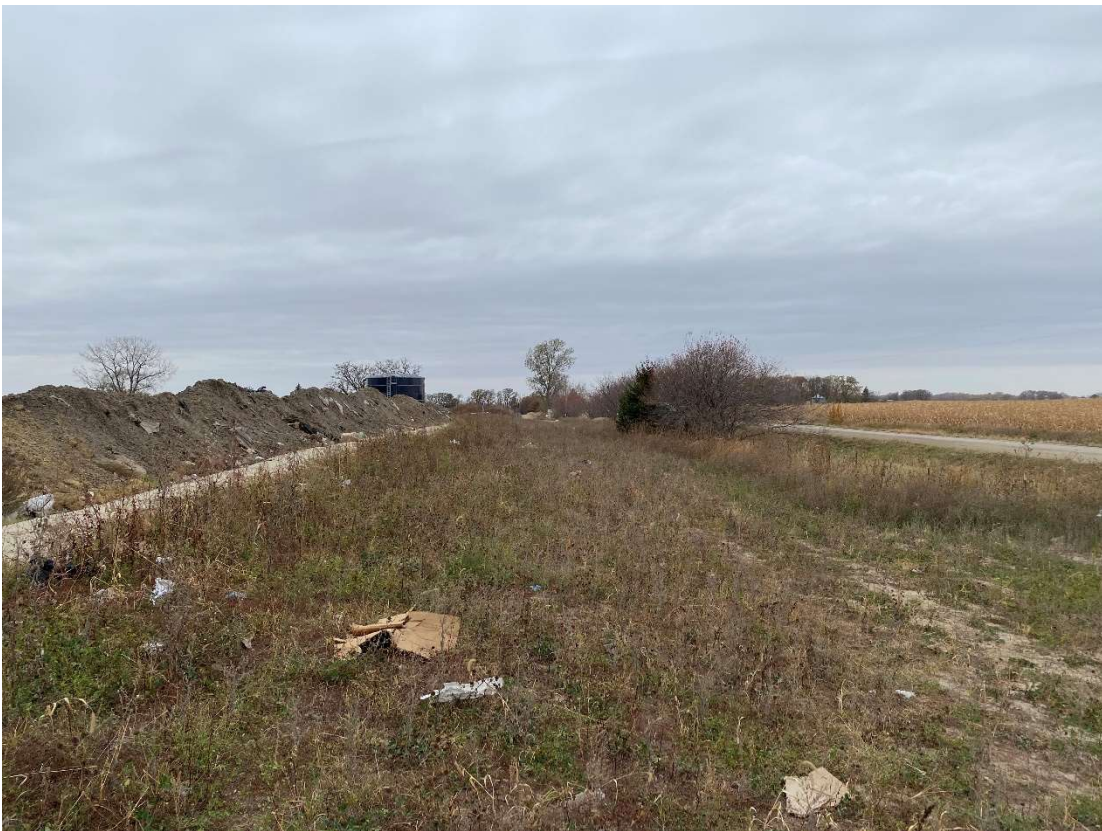
Location 14 – Looking West, Cell 5 Landfill Berm

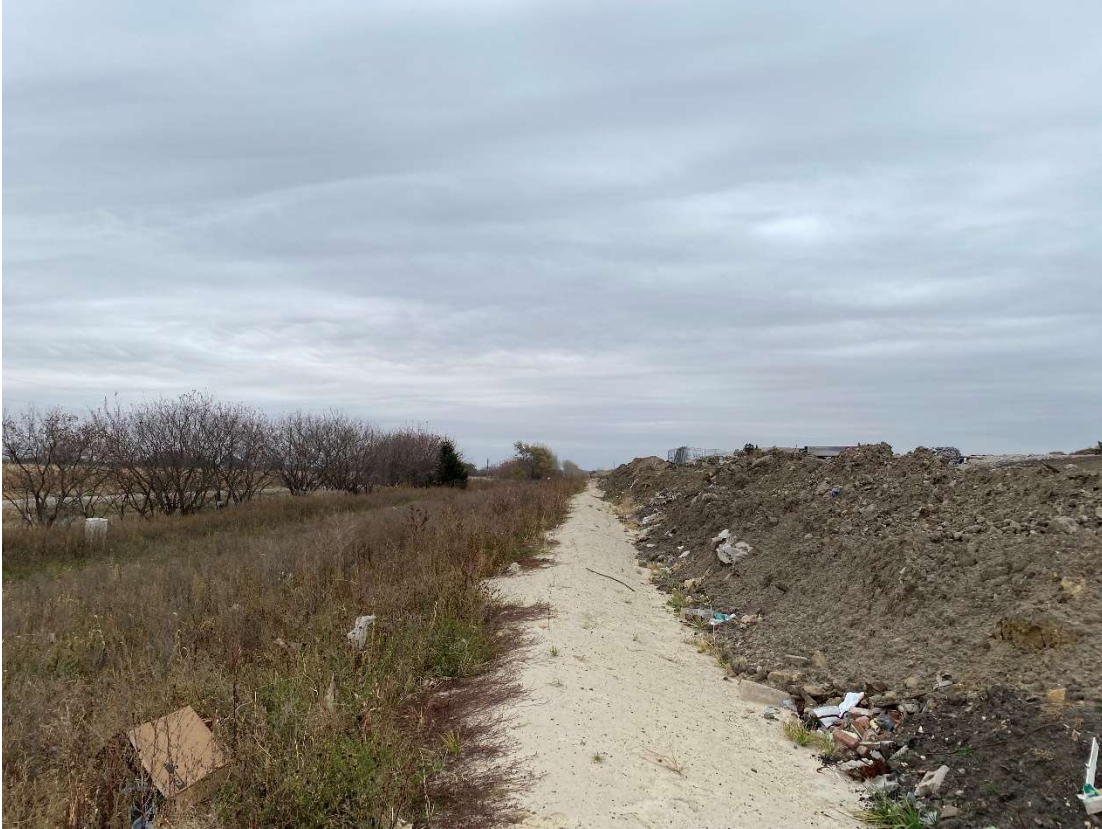
Location 15 – Looking East, Phase 5 Cell Limit

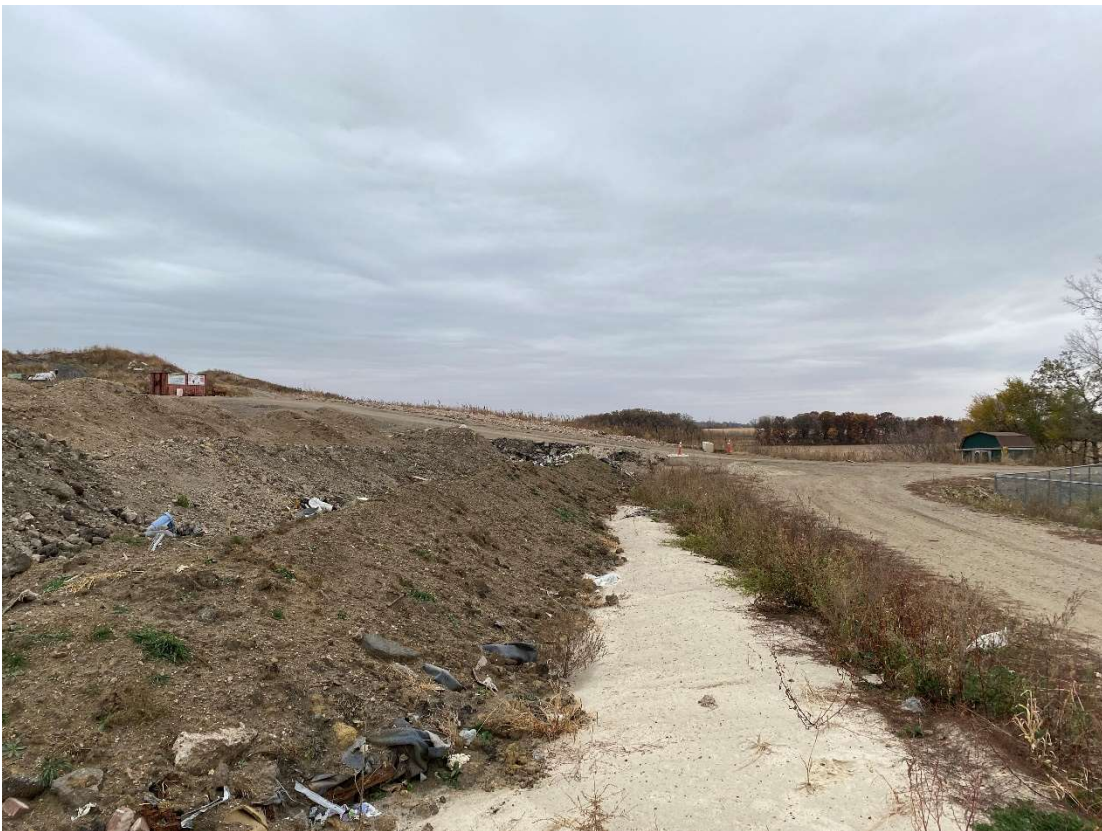
Location 15 – Looking South, Phase 5 Cell Limit
