To: Geoff Strack, PE, Waste Connections From: Brad Sullivan, PE, Stantec
File: 227704387 Date: January 7, 2026

Reference: WCI Austin Landfill, LLC 2025 Annual CCR Inspection Report

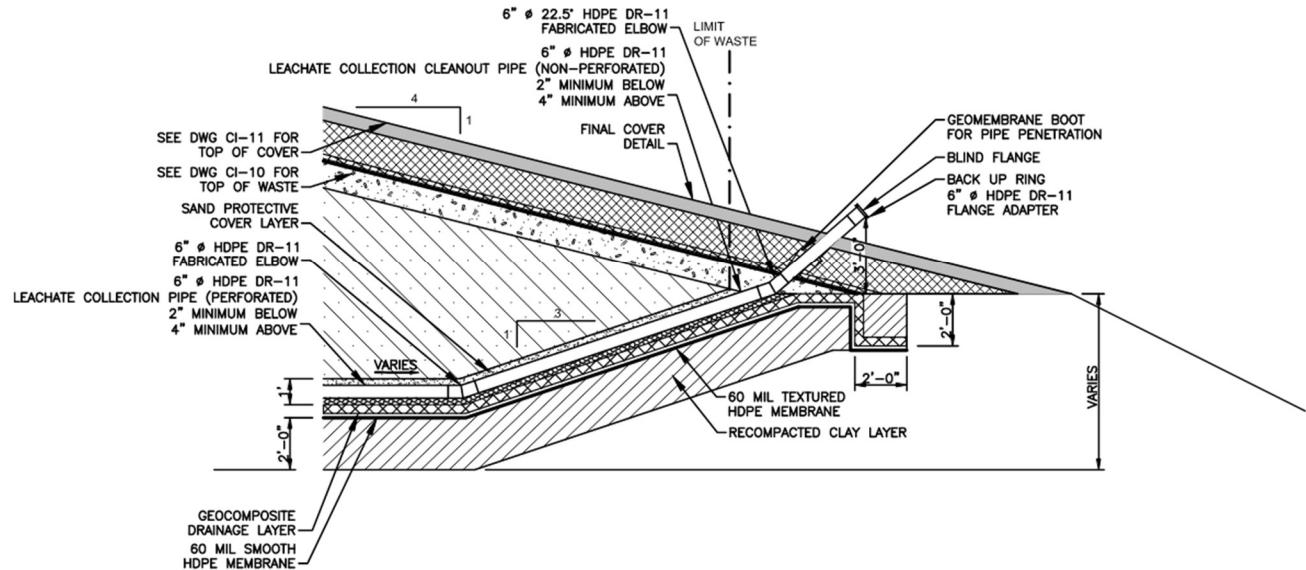
In general, the facility's landfill cell embankments were constructed using on-site and imported borrow materials. A typical perimeter section taken from the 2024 MPCA Solid Waste Facility Permit design drawings is shown below.

During the inspection there were no signs of landfill cell embankment distress, no signs of waste slope instability, or other CCR landfill issues observed. The landfill embankments and interim covered slopes were generally in good condition with a well-established vegetation cover and no signs of significant erosion.
