To: Geoff Strack, PE, Waste Connections      From: Brad Sullivan, PE, Stantec  
File: 227704387      Date: January 7, 2025

**Reference: WCI Austin Landfill, LLC 2024 Annual CCR Inspection Report****Purpose**

This memorandum fulfills the requirements of 40 CFR § 257.84 Inspection Requirements for CCR Surface Landfills, Part b, regarding an annual inspection by a qualified professional engineer.

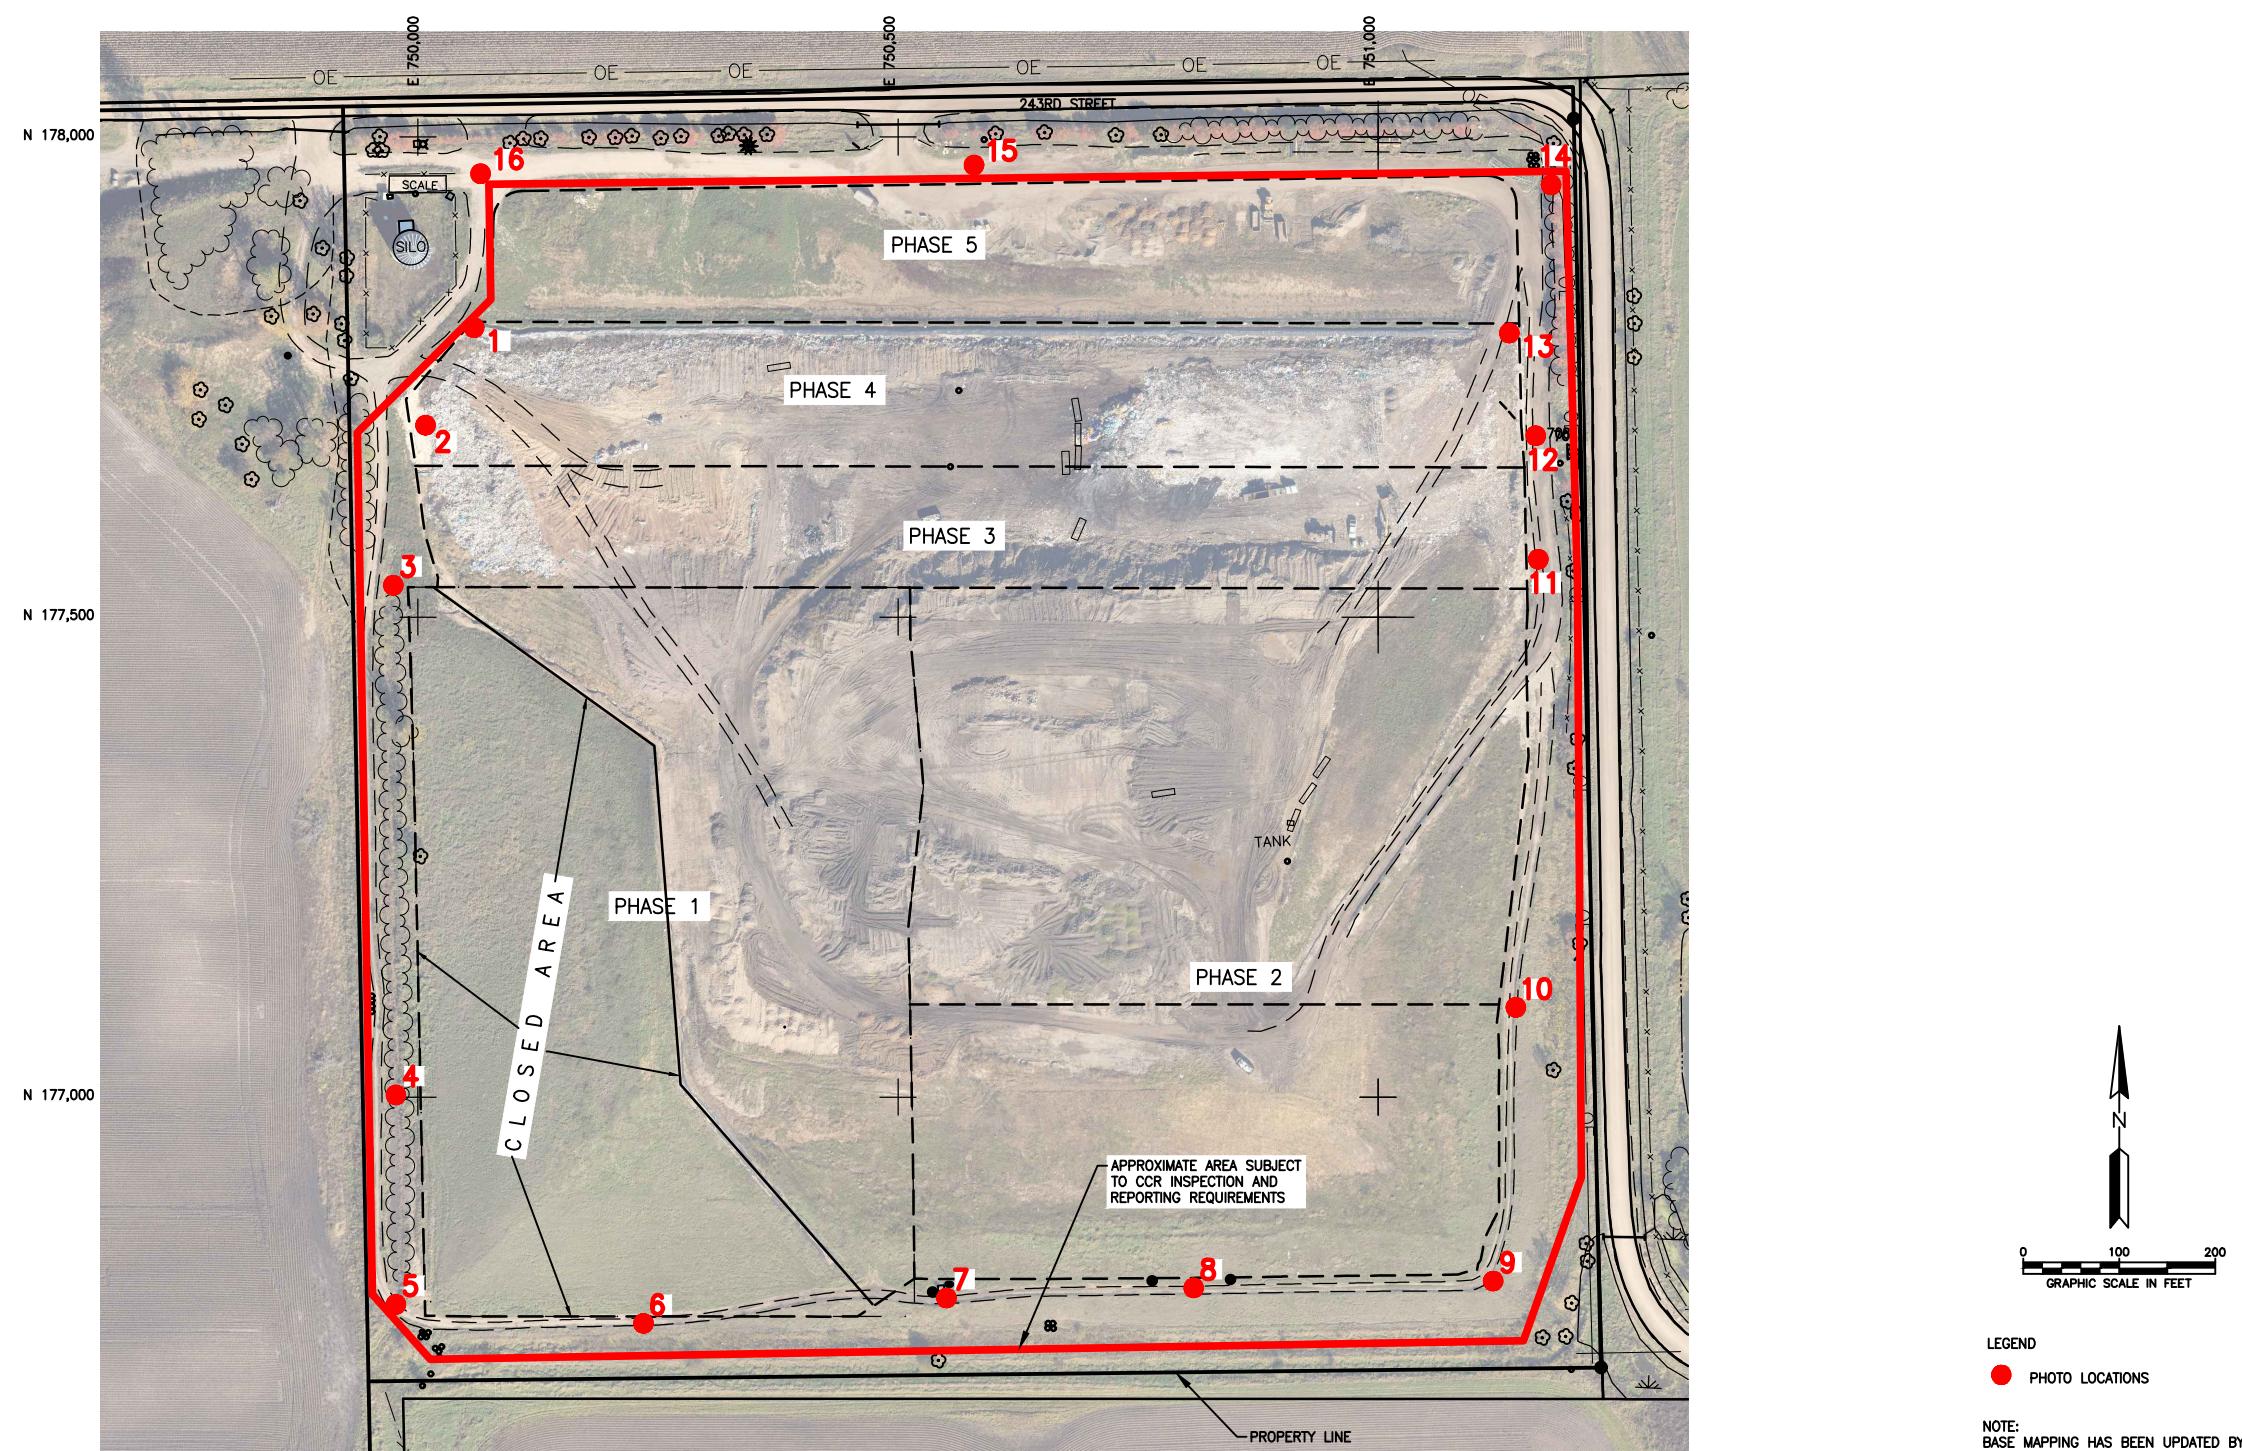
| <b>FIGURE 1</b> | | | | | |

See Figure 1 which is a facility site plan, which also includes the locations the photographs were taken as part of this inspection.

There were no apparent changes to the embankment geometry of Cells 1, 2, 3, 4, or 5 when compared to the design drawings or the past inspection reports. This year's annual aerial photogrammetry survey was performed on October 10, 2024, which the estimated in-place volume of total waste (including all accepted wastes) is based on. A comparison 2024 and 2023 aerial survey confirm that the embankment and slope topography is substantially unchanged. The 2024 aerial survey is shown on Figure 1.
