Technical Memo

To: Geoff Strack, SKB (Austin) Environmental, LLC.
From: Dave Parenteau, PE (MN), Wenck Associates, Inc.
Date: January 14, 2016
Subject: Annual Inspection SKB Lansing - Report of CCR Landfill Inspection
Wenck Project # B3053-0034

**Photos of Coal Ash Inspection
SKB Environmental Landfill, Lansing, MN
December 21, 2015**

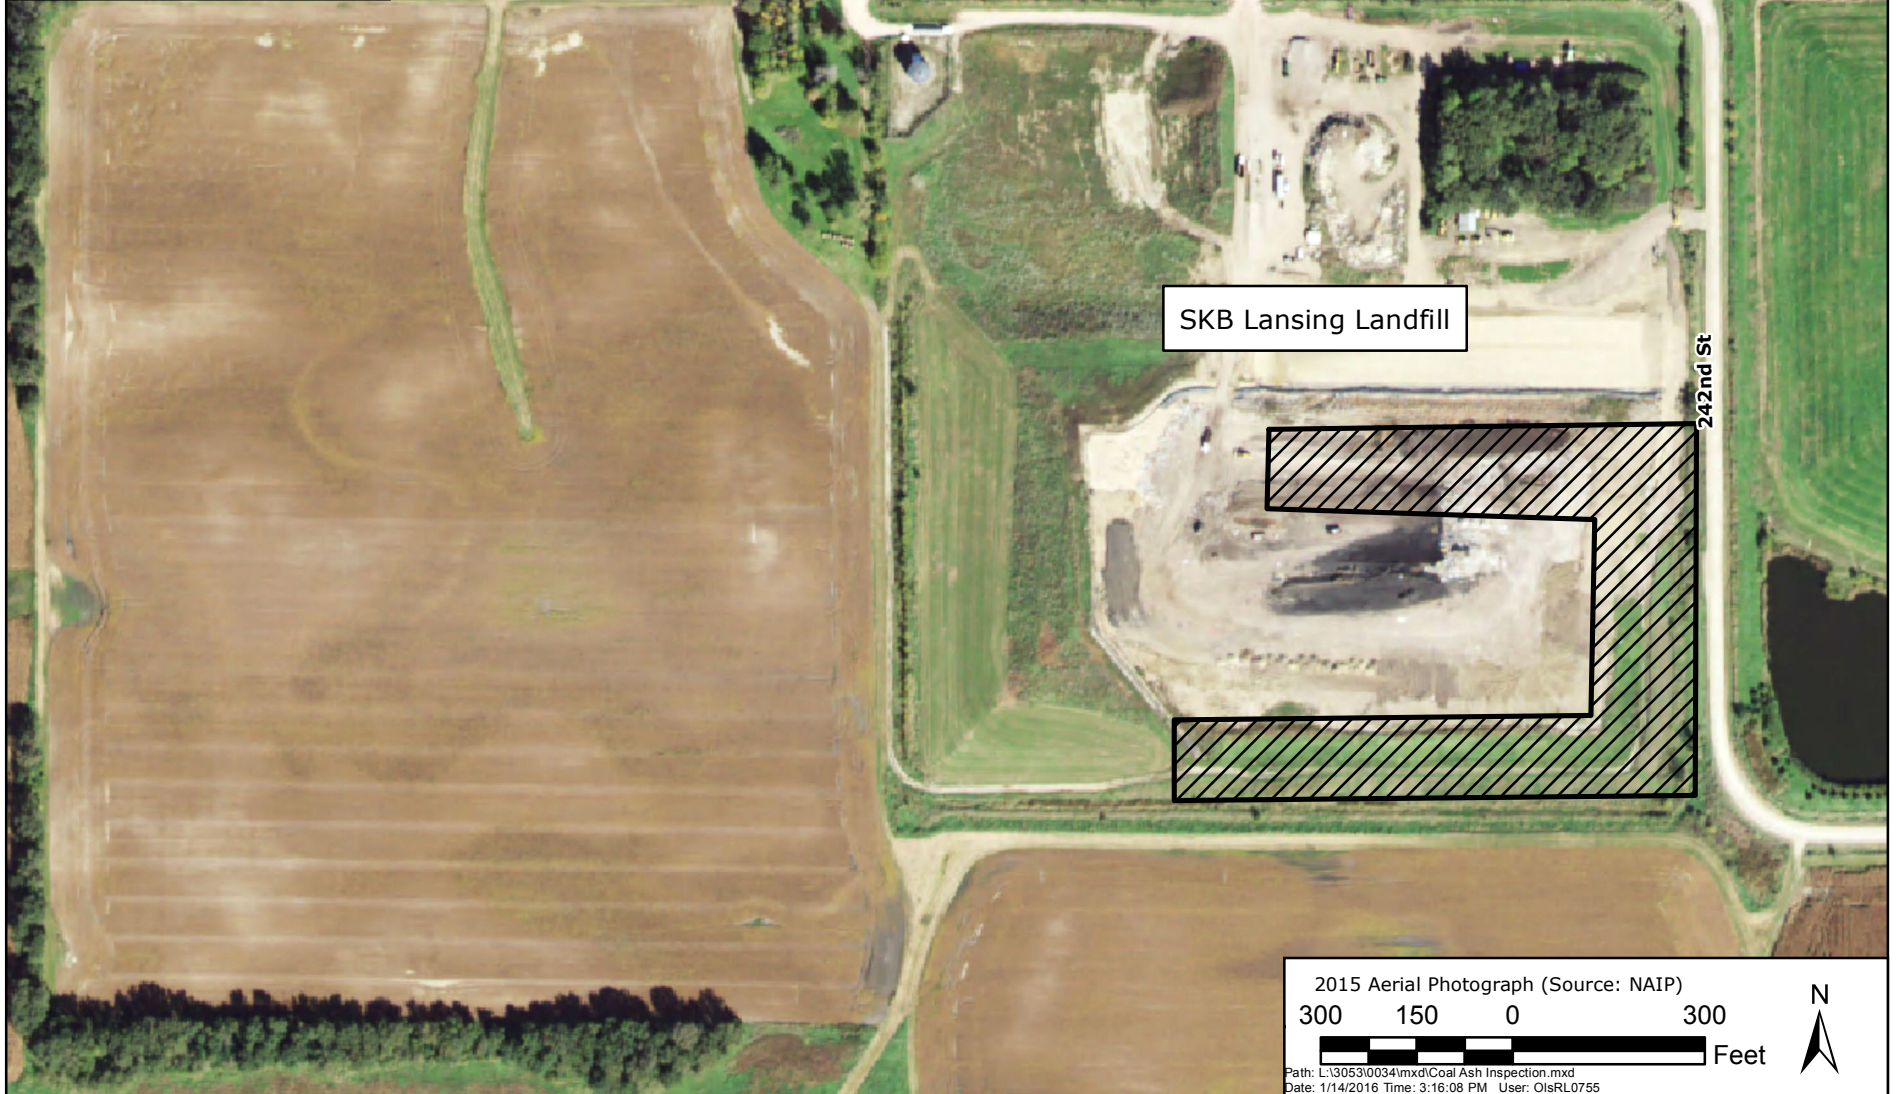
Figure 1

Area of Inspection

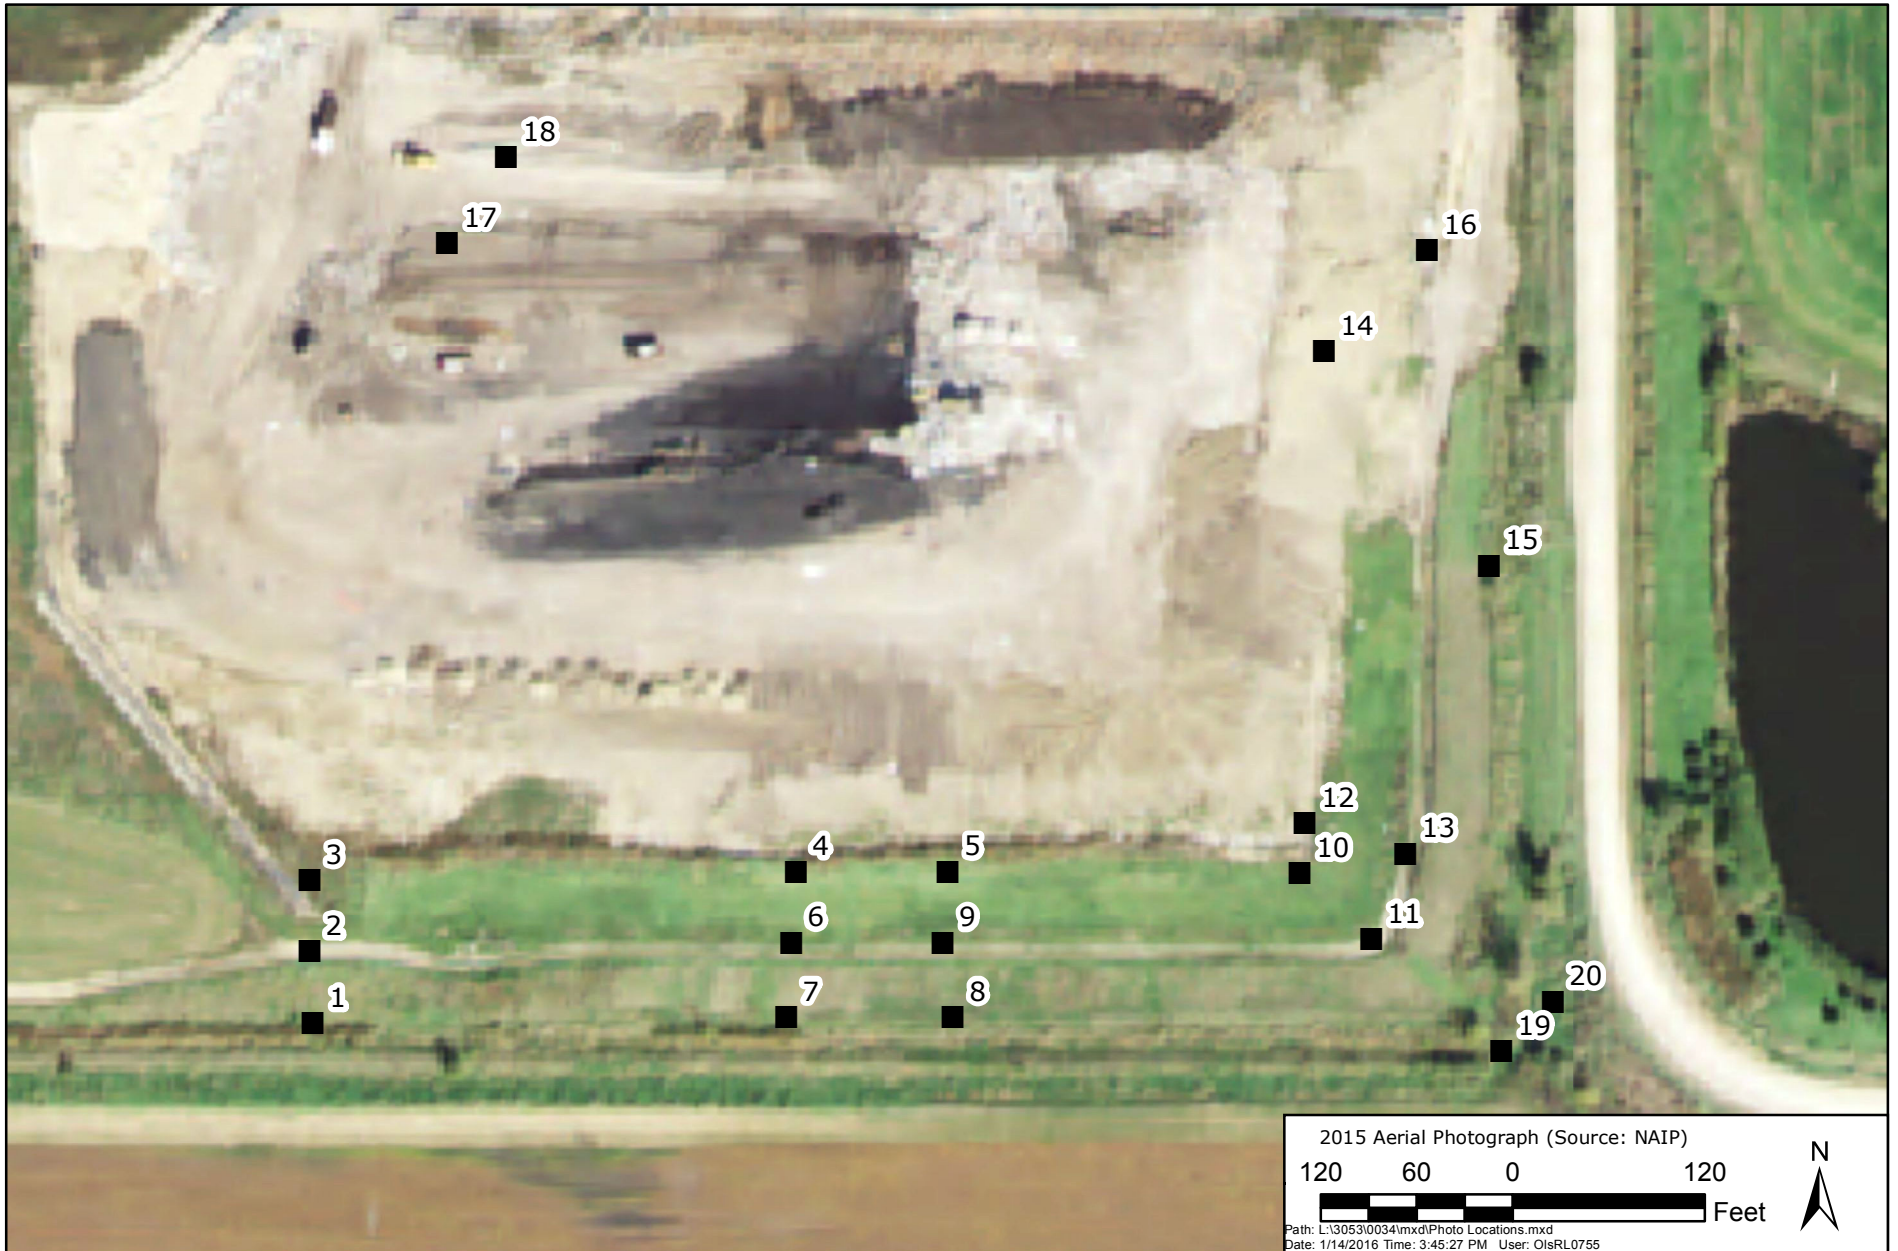
There were no observed signs of distress or malfunction on either the CCR Impoundment or the CCR Landfill and their corresponding appurtenant structures. Photos taken during the inspection are provided in Attachment 1 and Figure 2 shows where the photos were taken.

Photo Locations of Coal Ash Inspection
