Technical Memo

Date: January 9, 2018

Subject: 2018 Annual Inspection SKB Lansing - Report of CCR Landfill Inspection
Wenck Project # B3053-0094

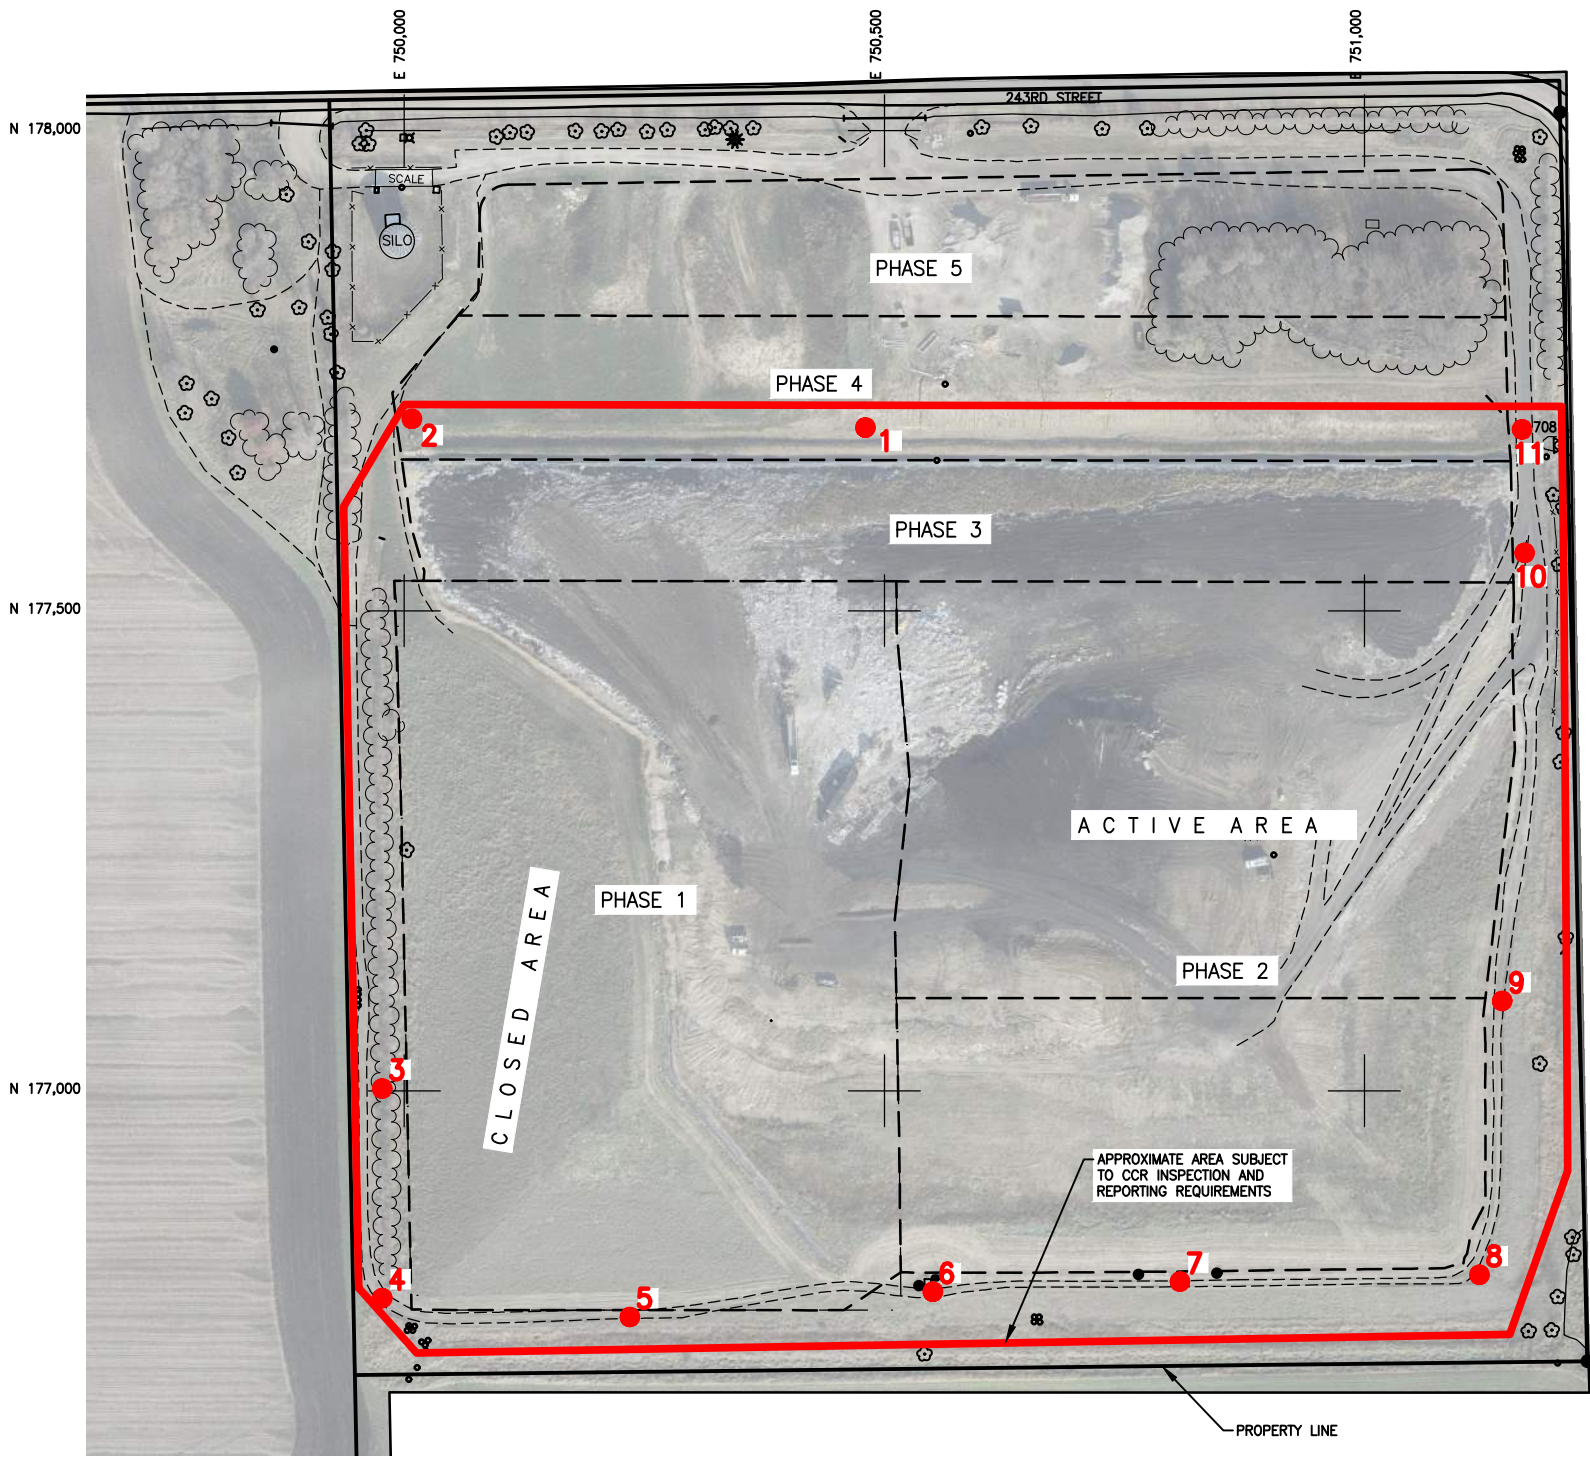
DWN BY	CHK'D	APP'D	DWG DATE	DEC. 2017
JVB	DMP	DMP	SCALE	AS NOTED
PROJECT NO.	SHEET NO.	REV NO.		
3052-0094	FIGURE 2			0

There were no observed signs of distress or malfunction on the CCR Landfill and their corresponding appurtenant structures. Photos taken during the inspection are provided in Attachment 1 and Figure 2 shows where the photos were taken.
