To: Geoff Strack, PE, Waste Connections From: Brad Sullivan, PE, Stantec
File: 227704387 Date: January 7, 2026

Reference: WCI Austin Landfill, LLC 2025 Annual CCR Inspection Report

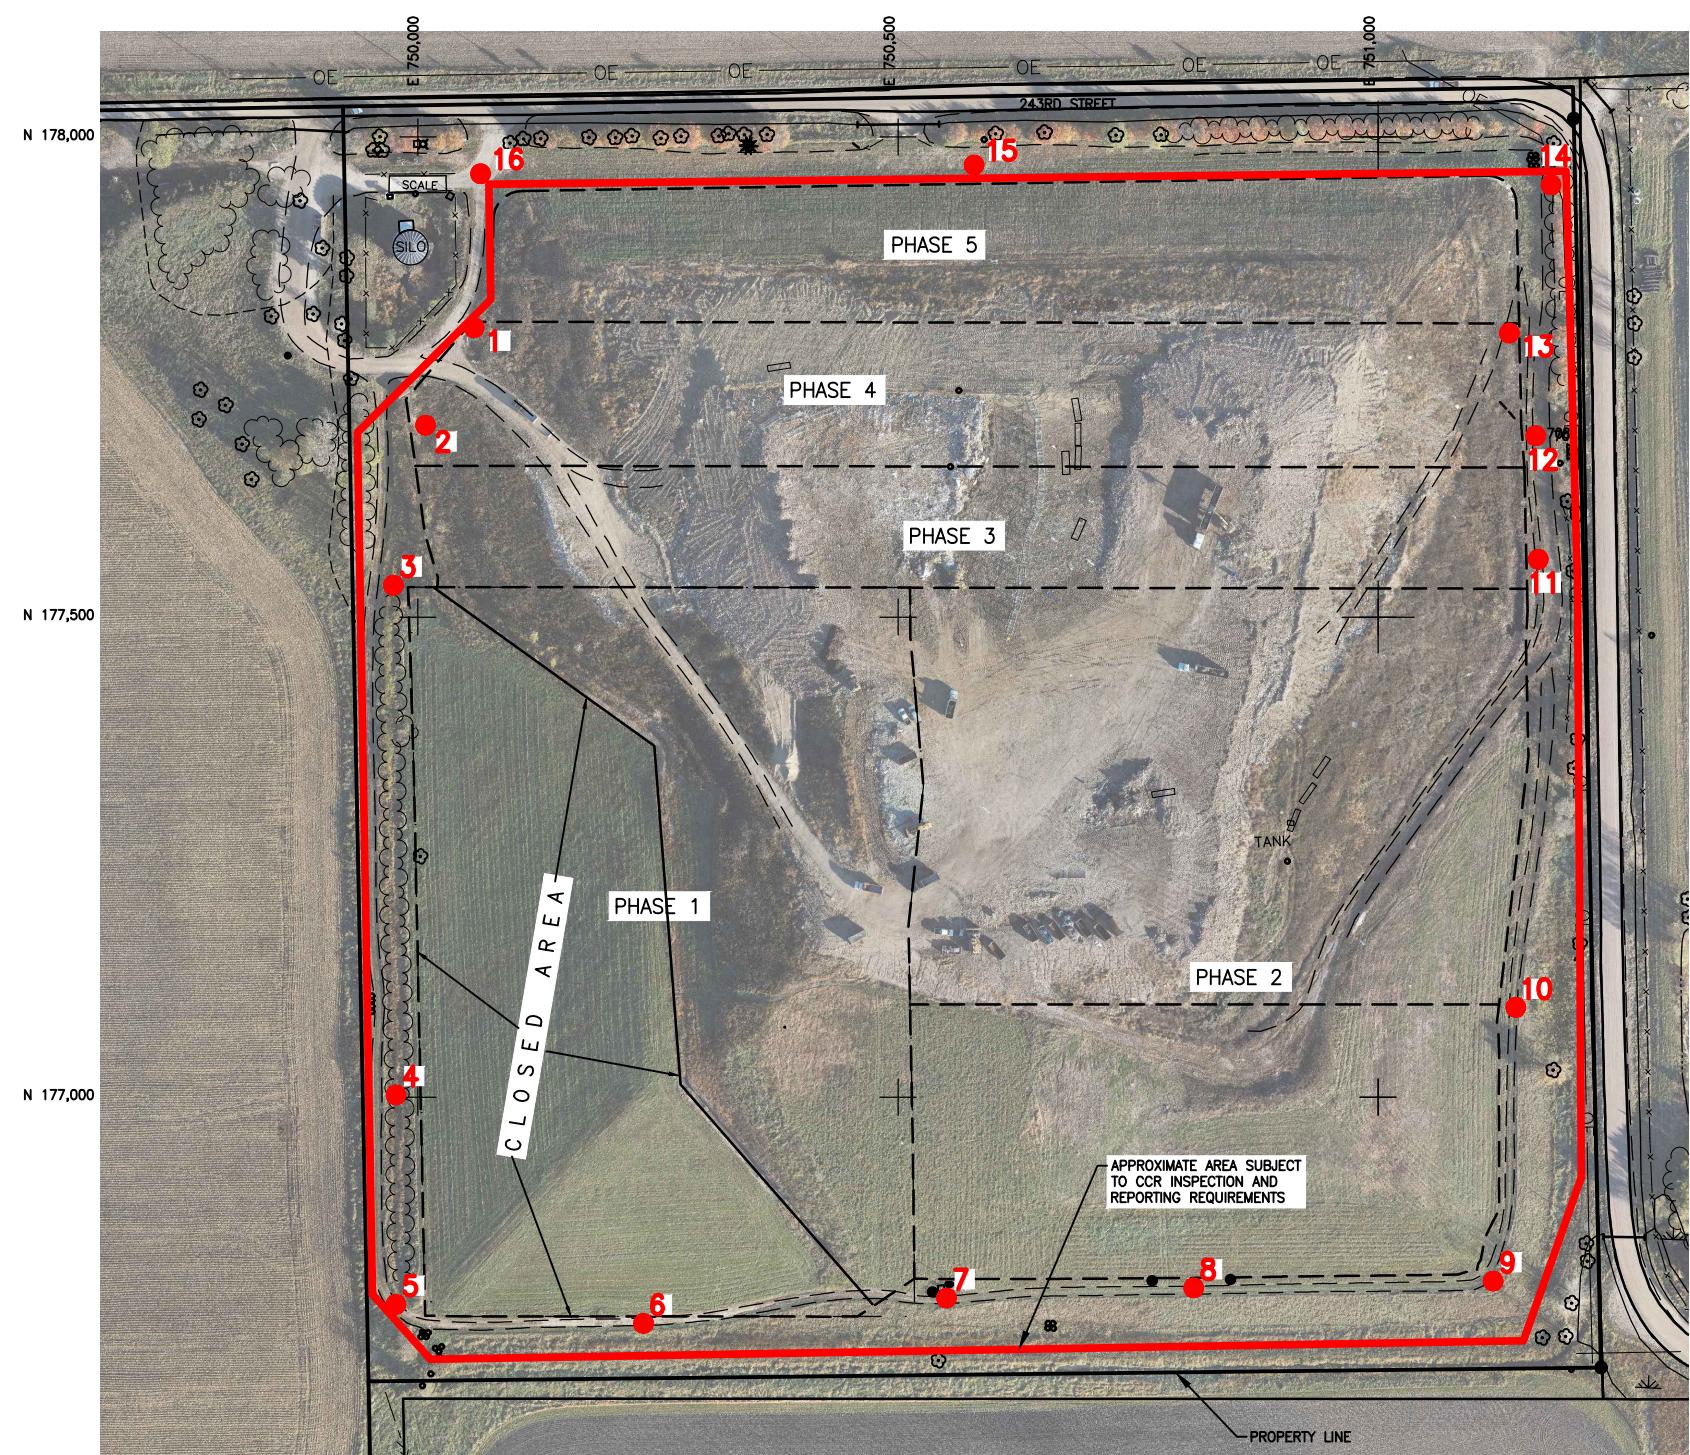
SEAL	SUB CONSULTANT	PRIME CONSULTANT	PROJECT TITLE 2025 CCR INSPECTION REPORT	SHEET TITLE PHOTO LOCATIONS		
REV	REVISION DESCRIPTION			DWN APP	REV DATE	Stantec	DWN BY JJT	CHK'D TJS	APP'D BWS	DWG DATE JAN. 2026
							PROJECT NO. 227704387	SHEET NO. FIGURE 1	REV NO. 0

There were no apparent changes to the embankment geometry of Cells 1, 2, 3, 4, or 5 when compared to the design drawings or the past inspection reports. This year's annual aerial photogrammetry survey was performed on October 24, 2025, which the estimated in-place volume of total waste (including all accepted wastes) is based on. A comparison 2025 and 2024 aerial survey confirm that the embankment and slope topography is substantially unchanged. The 2025 aerial survey is shown on Figure 1.
